SUBJECT: Dam Inspection Report for MEMA #111 – Toddy Pond Dam

#111 Toddy Pond Dam
Town of Orland, Hancock County, ME

Hazard & Condition Report
Date of Inspection – 10/12/2021

RE: Condition Assessment of #111 Toddy Pond Dam, Town of Orland, Hancock County, ME

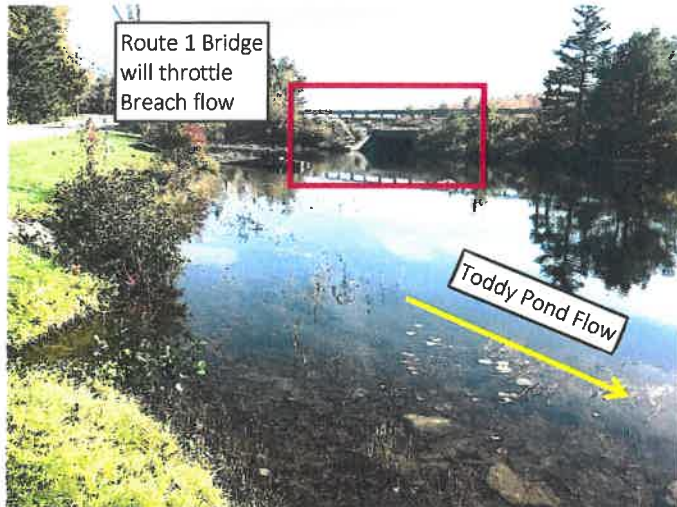
1. Toddy pond head pond drawn down about 12". No new development was seen in the basin that would increase runoff. No new development seen along Pond shoreline.

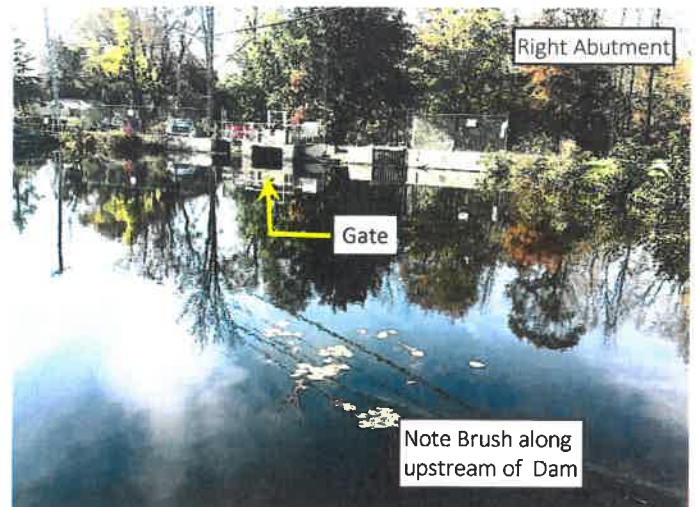
2. Dam headpond. No debris on screen. Concrete deteriorated throughout dam. Gate leaking. Fishway flowing & functional. Brush upstream on embankments left & right of concrete wall.

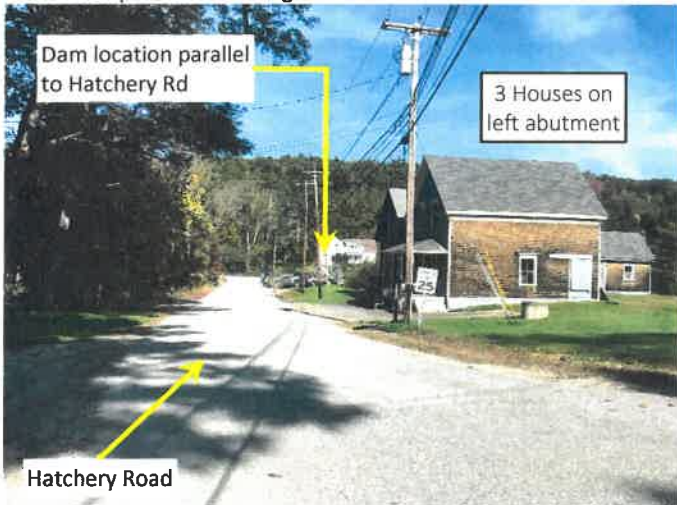
3. Road over bridge immediately downstream of dam.

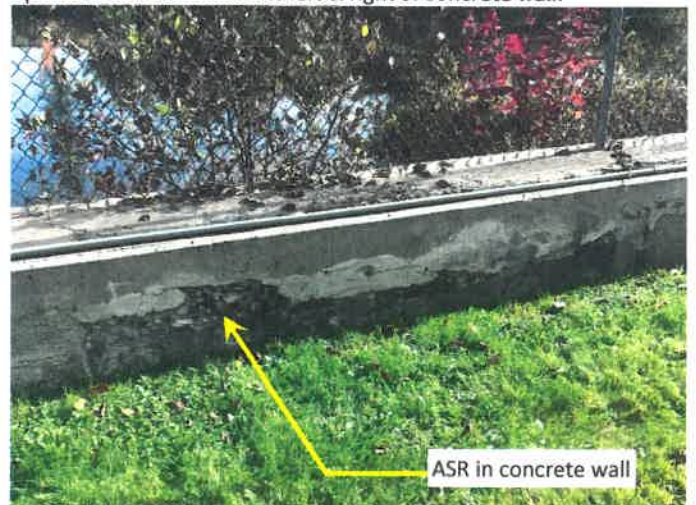
4. Concrete wall between left abutment & bridge.

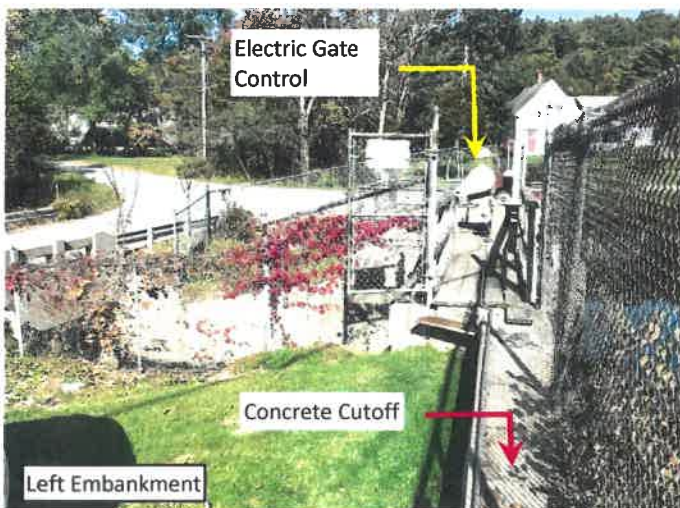
5. Gate opened for inspection. Concrete cutoff wall leads to bridge & gate control. Note fenced channel from spillway to bridge. The lawn is the left embankment.

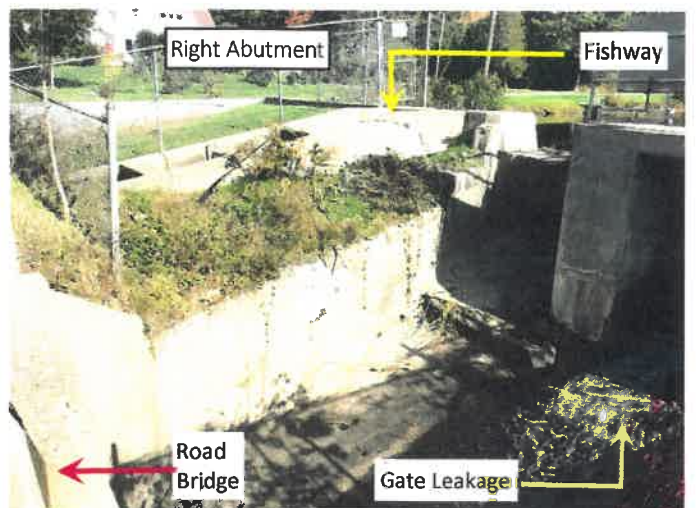
6. Concrete outlet channel. Note close proximity of dam to Hatchery Road & bridge. All concrete serviceable but deteriorated.

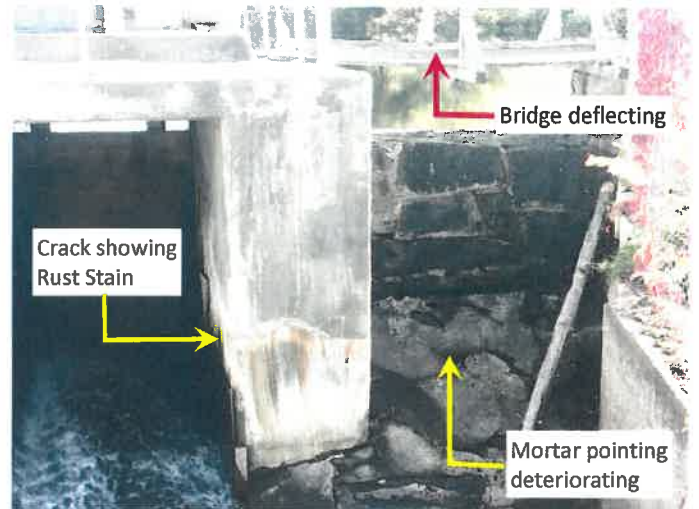
8. Gate & Left uncontrolled spillway. Concrete mortar at gate breaking up. Bridge deflecting. Gate operational.

- 1) Correct & update the EAP per paragraph 11) of this report.
- 2) Arrange a table-top exercise (TTX) to test the edited EAP before the 2022 spring runoff.
- 3) Write an "operation & maintenance plan" (O&M) for the dam before 2023.
- 4) Copy the O&M plan to MEMA, the dam EAP, the Town & shorefront property owners association.
- 5) Submit as-built construction records of the dam to MEMA for record purposes.
- 6) Root out all brush growing on the dam & downstream road embankment before 2023. Replace with grass.
- 7) Rehabilitate all decayed concrete & mortar in the dam, especially at the base of the gate piers, before 2023.

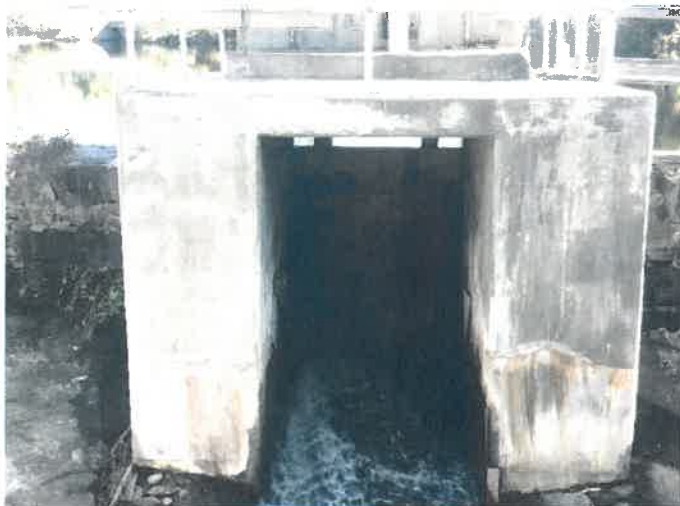
9. Concrete piers & slab housing sluice gate & electric hoist. Rust streaks are likely at construction joints.

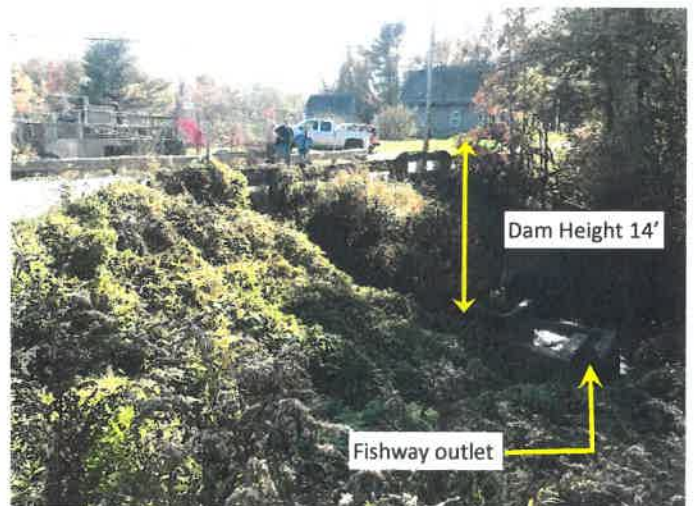
10. Downstream road embankment which merges with the road embankment. Fishway outlet lower right. Toe of dam assumed at channel outlet to bridge.

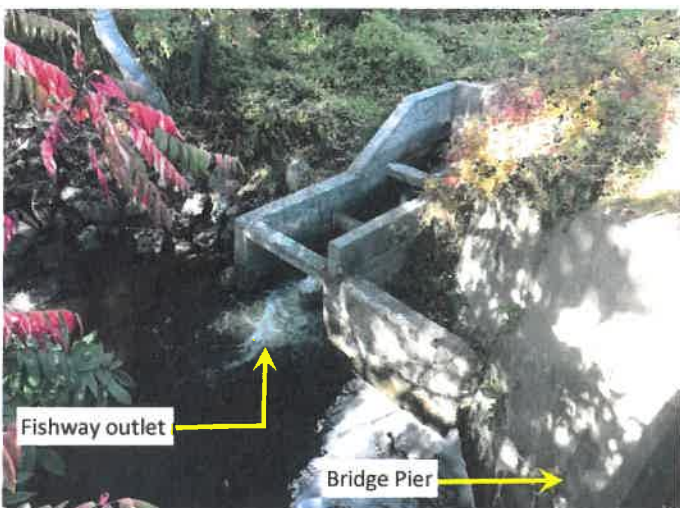
11. Fishway outlet.

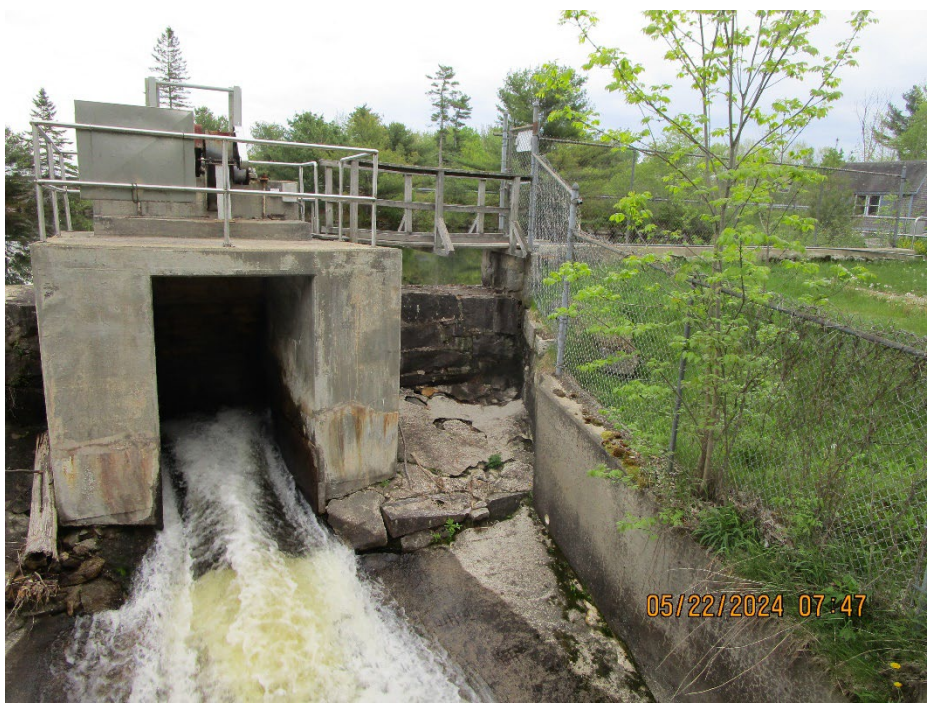
Photo No. 9

Photo Date: May 22, 2024	
Site Location: Toddy Pond Dam, Orland, Maine	
Description: Concrete Spillway, Apron and Retaining Wall With Elevated Deterioration	
Photo By: PJT

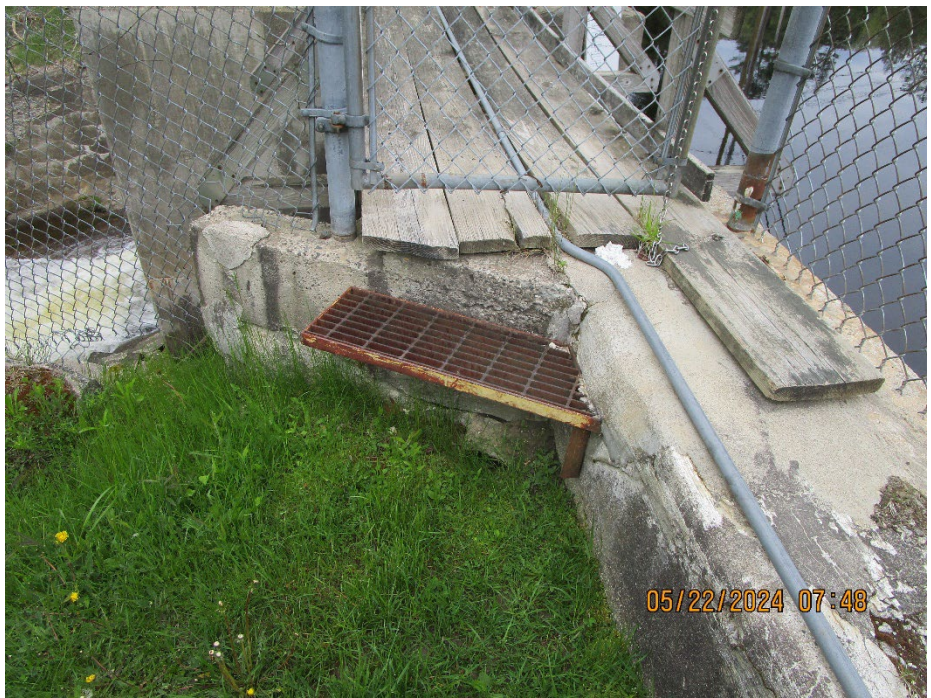
Photo No. 10

Photo Date: May 22, 2024	
Site Location: Toddy Pond Dam, Orland, Maine	
Description: Concrete Dam Section with Deterioration	
Photo By: PJT

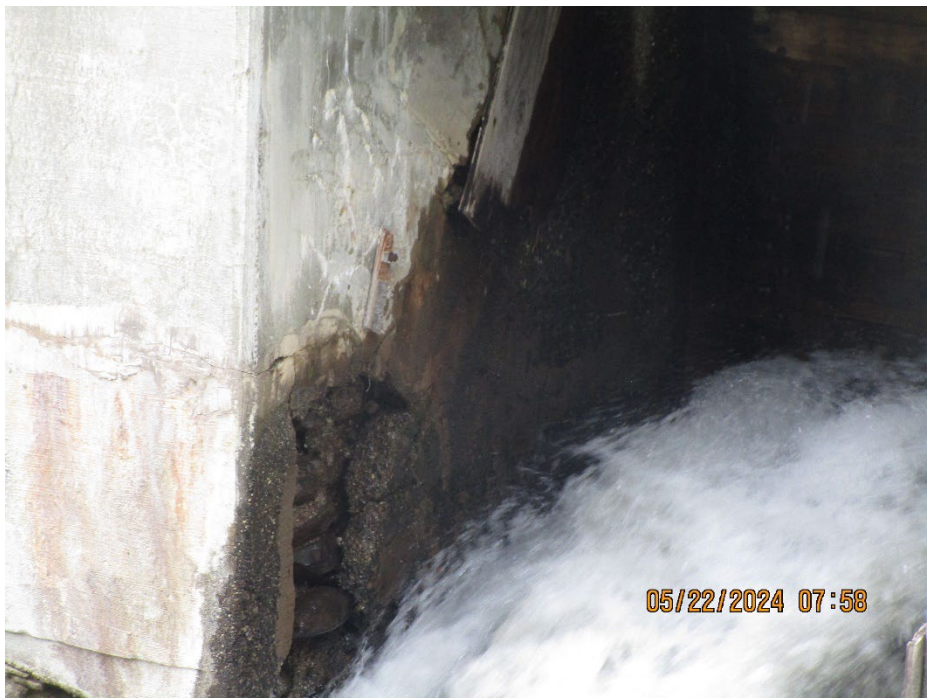
Photo No. 14

Photo Date: May 22, 2024	
Site Location: Toddy Pond Dam, Orland, Maine	
Description: Elevated Deterioration of Head Gate Structure at Base	
Photo By: PJT
