Maine CDC's Response to an Outbreak of Hepatitis A on Swan's Island.

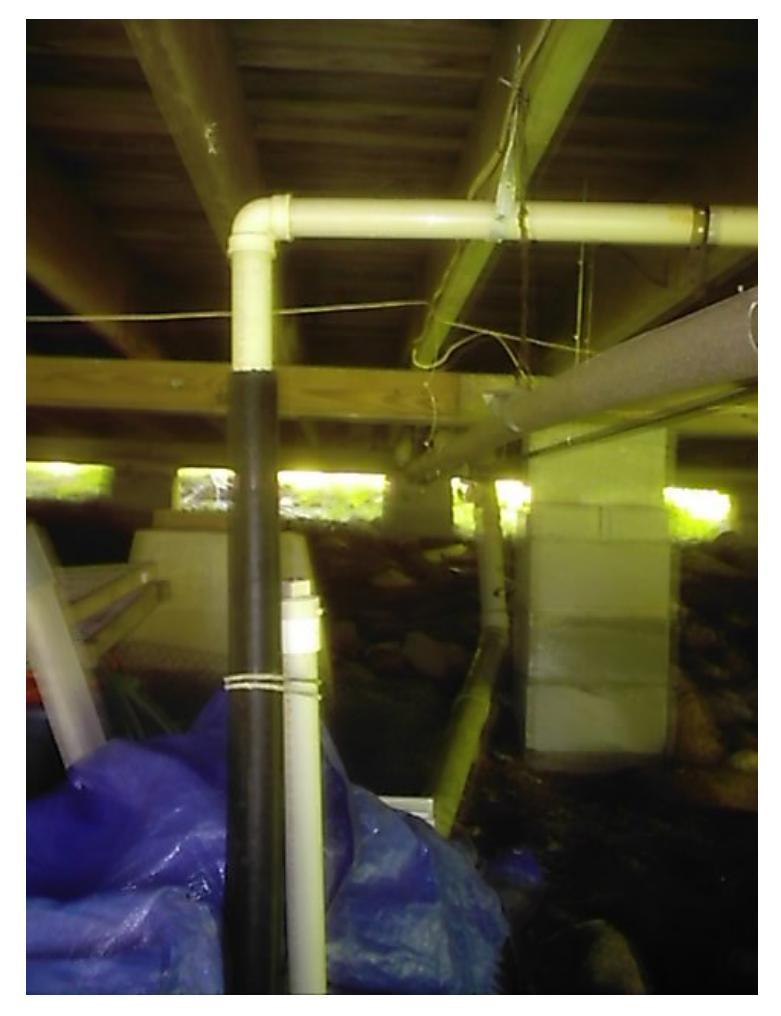
The property was unoccupied during the inspection. Access to the property was given by an abutter on behalf of the owners. Division staff inspected beneath the dwelling, which rests on piers, since the Division had been advised that there may be a leaking building drain beneath a toilet. There was no evidence under the building drain of any leaks.
