GREAT POND

WATERSHED-BASED MANAGEMENT PLAN

(2021-2031)

Kennebec County
Soil and Water
Conservation District

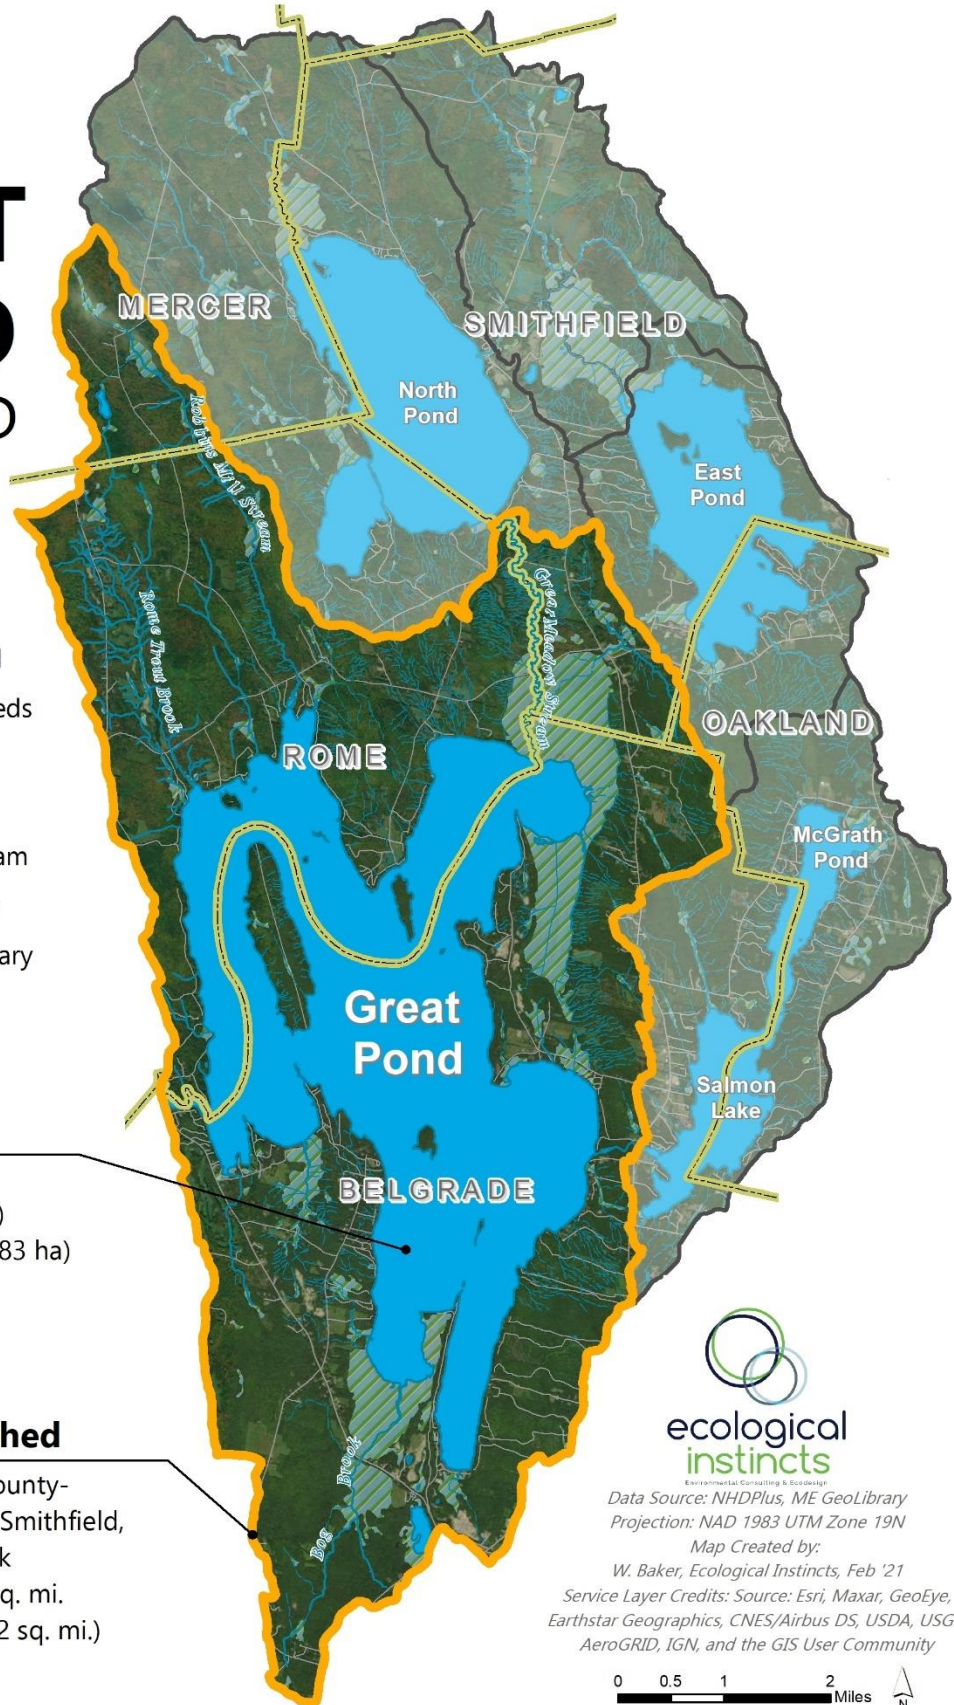
Great Pond Watershed

Kennebec & Somerset County-
 Belgrade, Rome, Mercer, Smithfield,
 Oakland, & Norridgewock
 Total Drainage Area: 70 sq. mi.
 (direct drainage area = 32 sq. mi.)

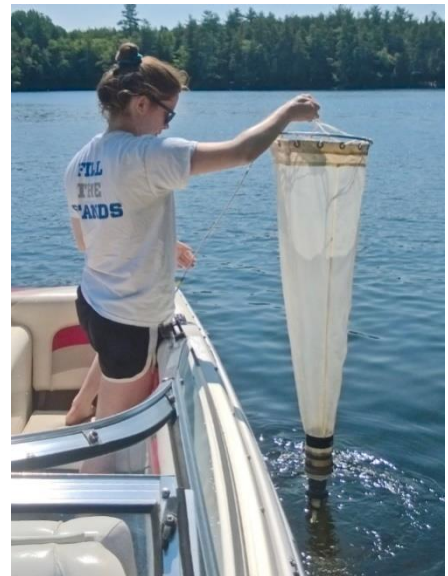
Plankton sample collection in Great Pond. Photo Credit: BLA

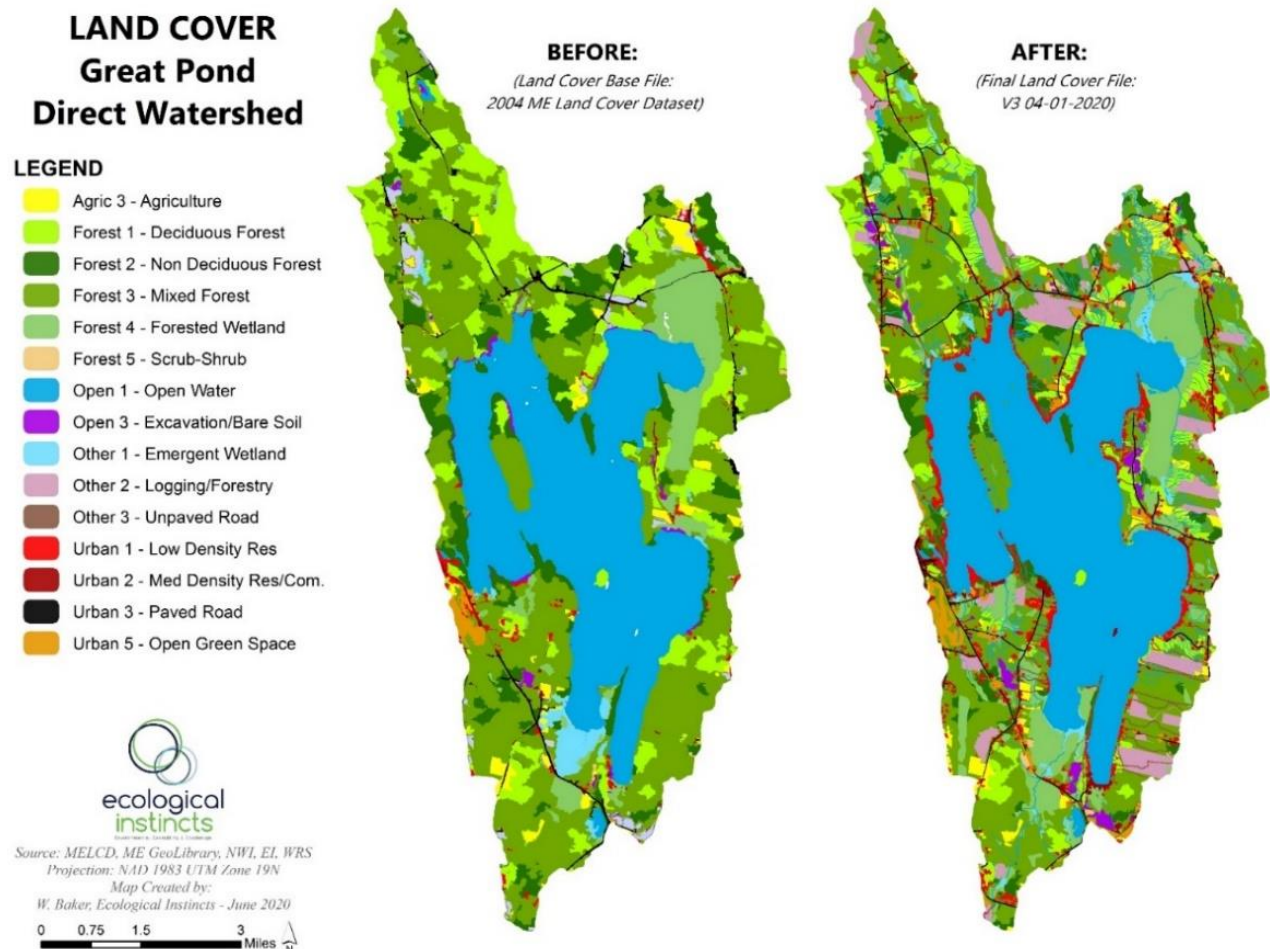
Figure 6. "Before" (left) and "After" (right) land-cover file modifications.

between the aerials and the MELCD file were found, changes were made by manually editing polygons. The State road layer (NG911 roads), stream layer, and an NWI wetlands layer were overlaid on the updated land-cover layer and relabeled appropriately.

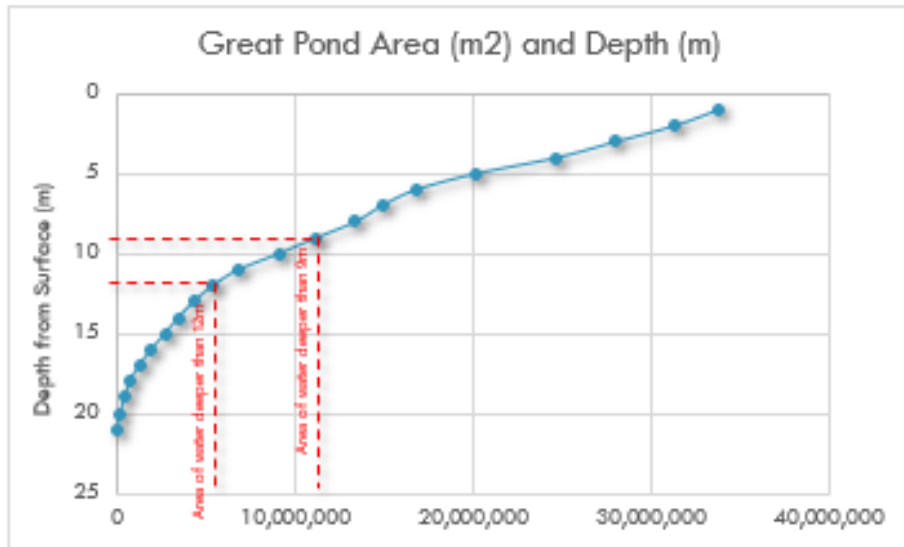
Figure 11. Hypsographic curve displaying the relationship between depth (m) and area (m²) in Great Pond.

could increase substantially (Figures 11 and 12). After thorough review and comparison of temperature and dissolved oxygen data collected at Station 1 and Station 2, it was clear that the thermal dynamics at each deep hole in Great Pond are different. The project Technical Advisory Committee has recommended dividing the lake into two separate regions before finalizing a phosphorus mass analysis for Great Pond to better understand the concentration and distribution of phosphorus in the water column May – September.

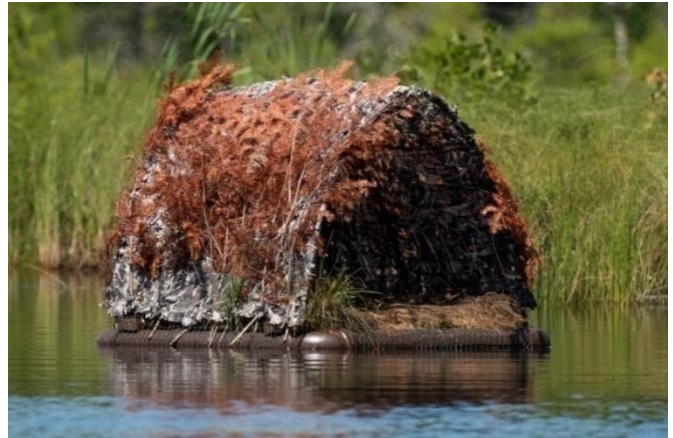
Floating artificial nest deployed on Great Pond in 2020. (Photo Credit: Dick Greenan, BLA)

A symbol of summertime on Maine lakes, loons are common on Great Pond, with 61 adult loons and 2 chicks counted on the lake in 2019 (ME Audubon, 2020). BLA kicked off the Loon Preservation Project in 2019 and hired Loon Conservation Associates (LCA) to conduct a study of loons on Great Pond and Long Pond between 2019 – 2021. 2020 loon monitoring results indicate 12 territorial pairs on Great Pond. Of the 12 pairs identified, four nested, and one nest was successful in hatching a single chick that survived to fledge. As part of this project BLA constructed and installed four floating artificial nests in Long Pond and Great Pond in 2020. Two of the artificial nests were used with a 100% success rate (LCA, 2020).²⁴

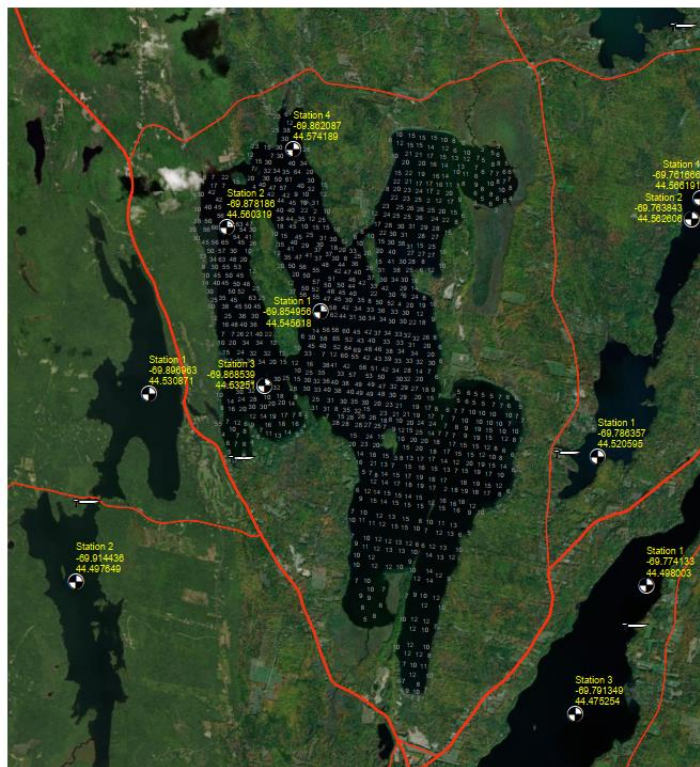
Figure 20. Water quality monitoring stations in Great Pond (Source: LakesofMaine.org)

Great Pond MIDAS # 5274
Belgrade, Kennebec Co. - Delorme Page 20(E4) - 8509 acres

Water quality data have been collected by Maine DEP and Lake Stewards of Maine (formerly the Volunteer Lake Monitoring Program) in cooperation with the Belgrade Lakes Association since 1970 at the deep holes (Stations 1 through 4, Figure 20). This includes 49 years of data³² collection over the 49-year monitoring period. More recent, and more intensive monitoring has been completed by Colby including deployment of "Goldie" in 2014 - a research buoy that collects information about the physical and biological conditions in the lake. Great Pond's buoy is a node in an international observation network (GLEON) to assess lakes across the world. In addition, a three-year intensive water quality study (2015-2017) was conducted by Colby researchers which included weekly collection of dissolved oxygen/temperature/pH profiles, water clarity, nutrients, metals and phytoplankton, as well as sediment sampling. This intensive monitoring effort has continued through 2020, led by staff at 7 Lakes and Maine Lakes Resource Center in collaboration with Colby College interns.

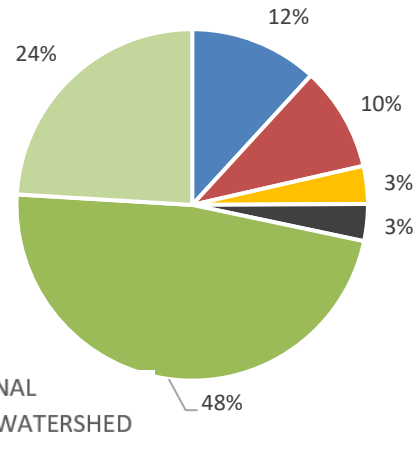
Figure 25. Percentage of total phosphorus loading (kg/yr) by source (atmospheric, internal loading, waterfowl, septic systems, watershed load) to Great Pond.

Great Pond Load Summary
(Pre-Development)

Great Pond Load Summary
(Current Conditions)

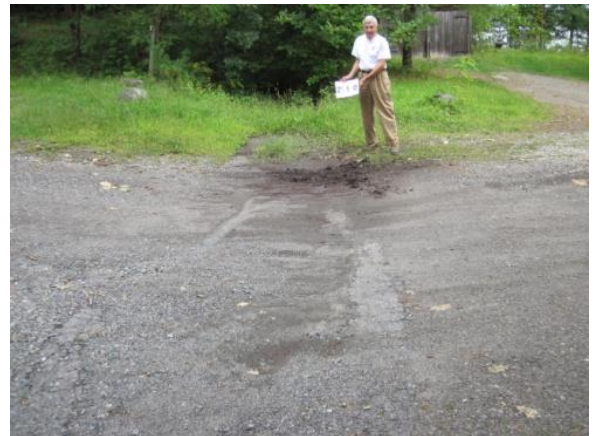
Improvements are needed at a commercial parking lot in Sector 20 to prevent sediment from getting into the lake.

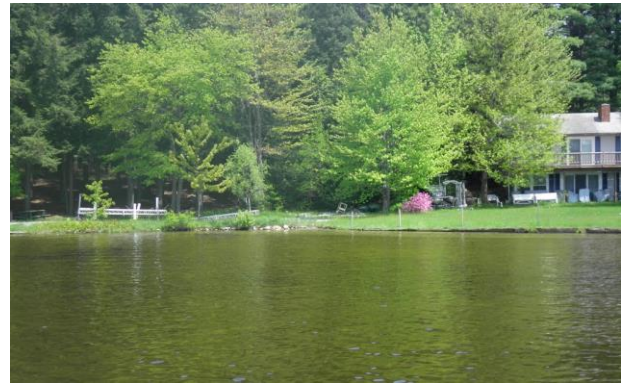
Shoreline survey photo on Great Pond (Zone F) taken in 2011 as part of the of the Belgrade Lakes Watershed Sustainability Project. (Source: Colby College)

In 2011, researchers at Colby College organized shoreline photographic surveys for all of the Belgrade Lakes. The shoreline of Great Pond was divided into nine sections, and georeferenced photographs were taken to document shoreline development and buffer conditions around the lake. The photos were provided to towns to help track changes in the shoreland zone. The surveys confirm that many properties on Great Pond have very limited to non-effective shoreline buffers.

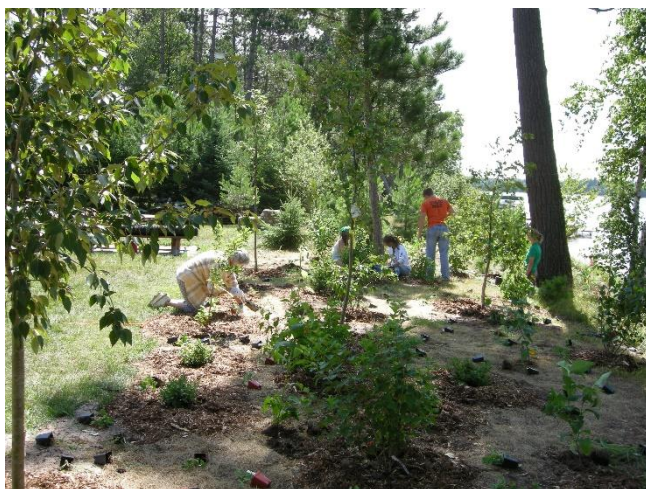
Shoreline buffer installation on a lake front property.

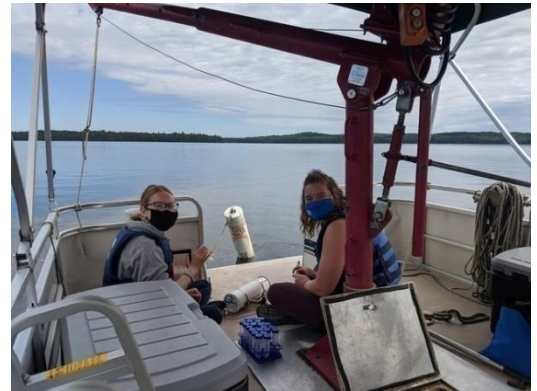
7 Lakes interns collecting data on Great Pond. (Photo: 7 Lakes)

- 1) **Water Clarity** measured biweekly April through October.
- 2) **Temperature, Dissolved Oxygen, pH, and Conductivity** profiles collected biweekly April through October and monthly during the winter.
- 3) **Phosphorus & Metals** collected from profile grab samples using a grab sampling device biweekly every 2 m from 0 – 20 m April through October and monthly during the winter.
- 4) **Phytoplankton** collected biweekly May through October at 2 m and analyzed using a FlowCam.
- 5) **Chlorophyll-*a*, DO, Temp, PAR** collected continuously from Goldie at Station 2 at 2m and 6m (Chl-*a*), at 4 depths for DO, at odd meters (temp), and above the surface and 2 m (PAR).
