## ATV PROGRAM

DEPARTMENT OF AGRICULTURE,  
CONSERVATION & FORESTRY

# ATV Inspections

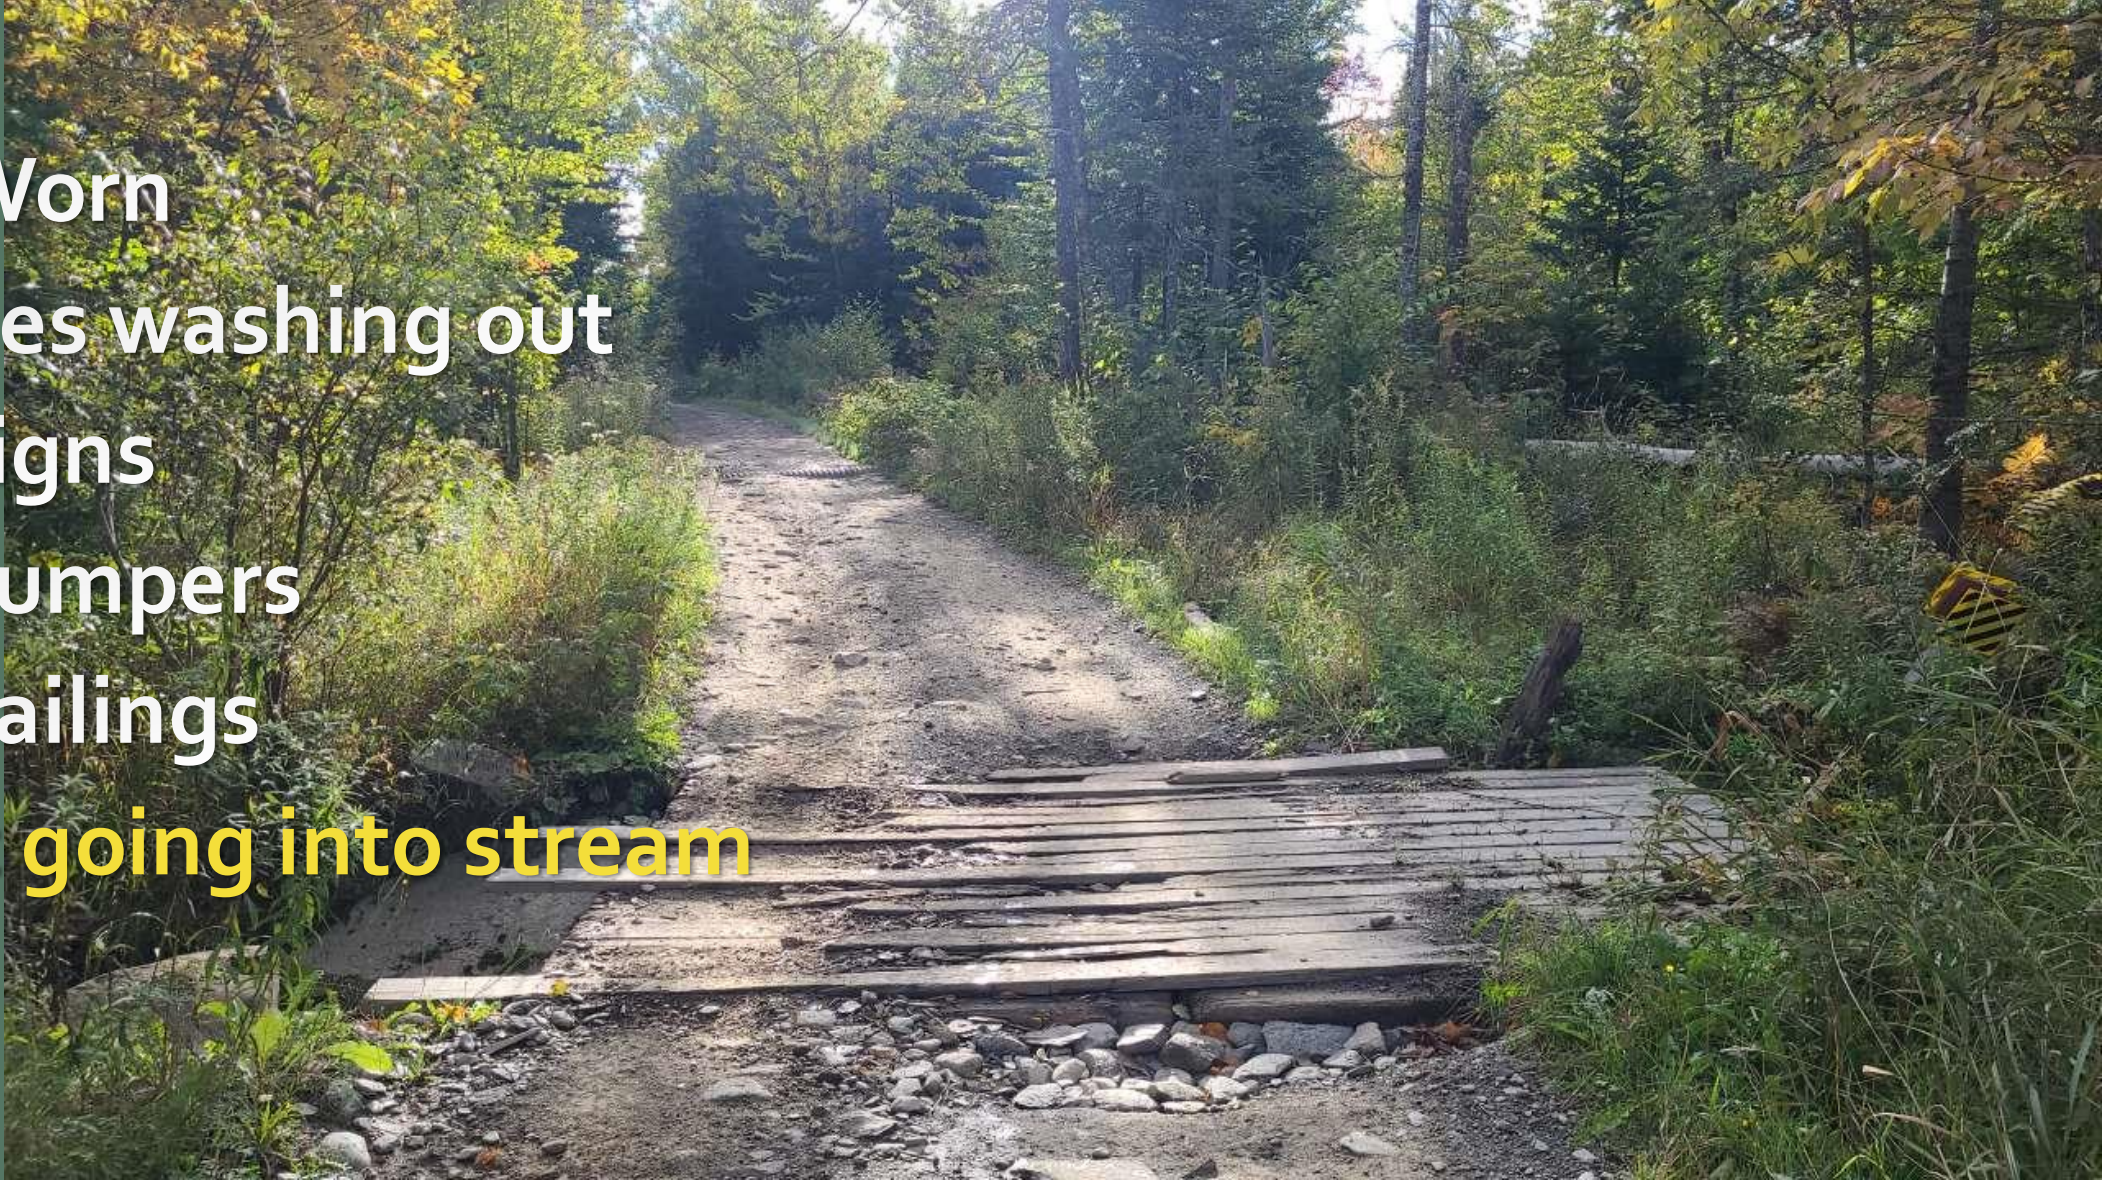
# BMP ISSUE

## Issues:

Decking Worn

Approaches washing out

Missing Signs

Missing Bumpers

Missing Railings

Sediment going into stream

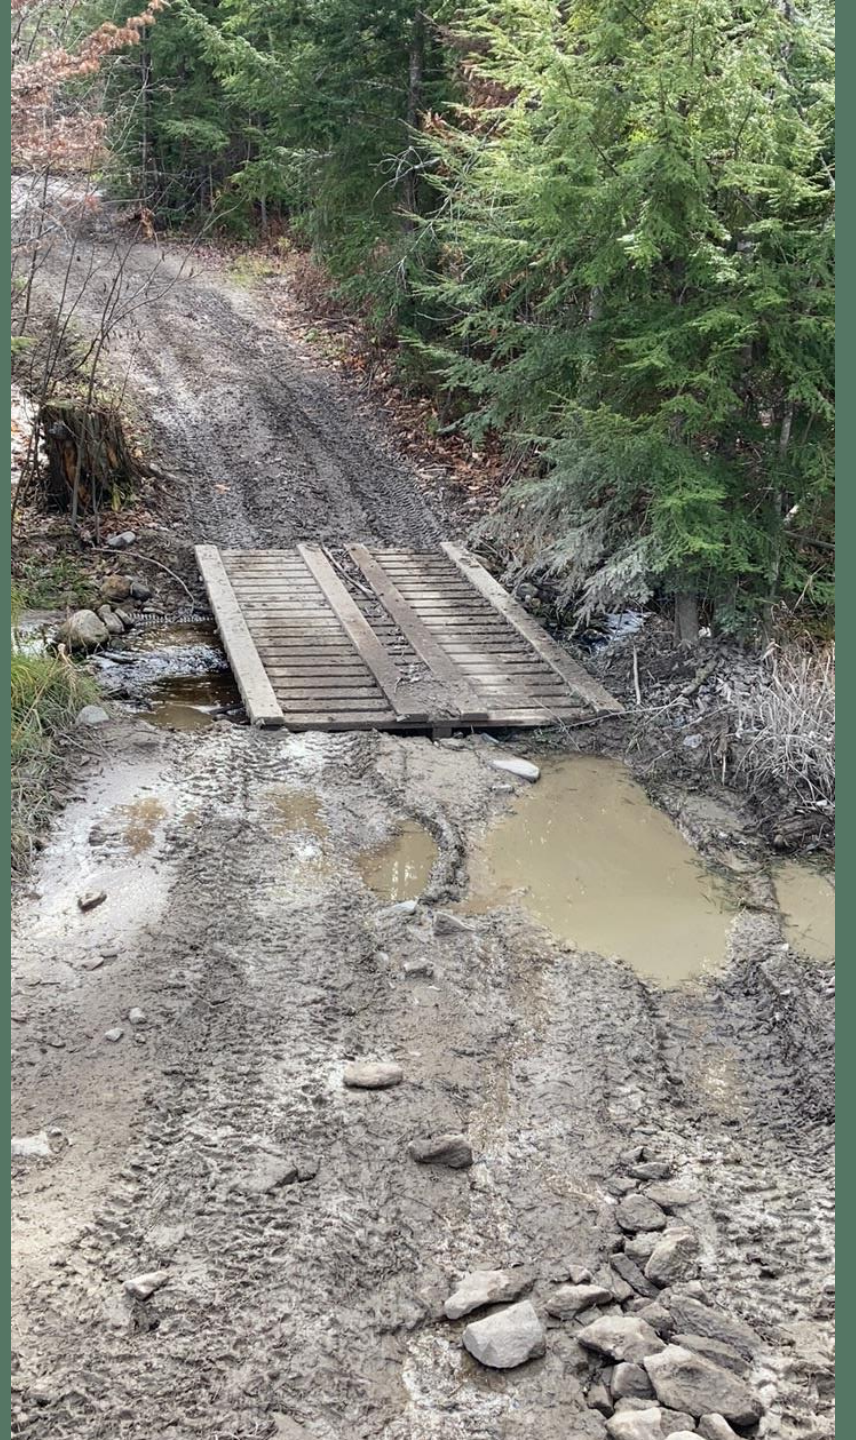
Issues:

Open Decking

Too narrow (must be  $>65''$ )

Missing Signs

**Sediment going into stream**

Inadequate Bridge Approaches

**BMP ISSUE**

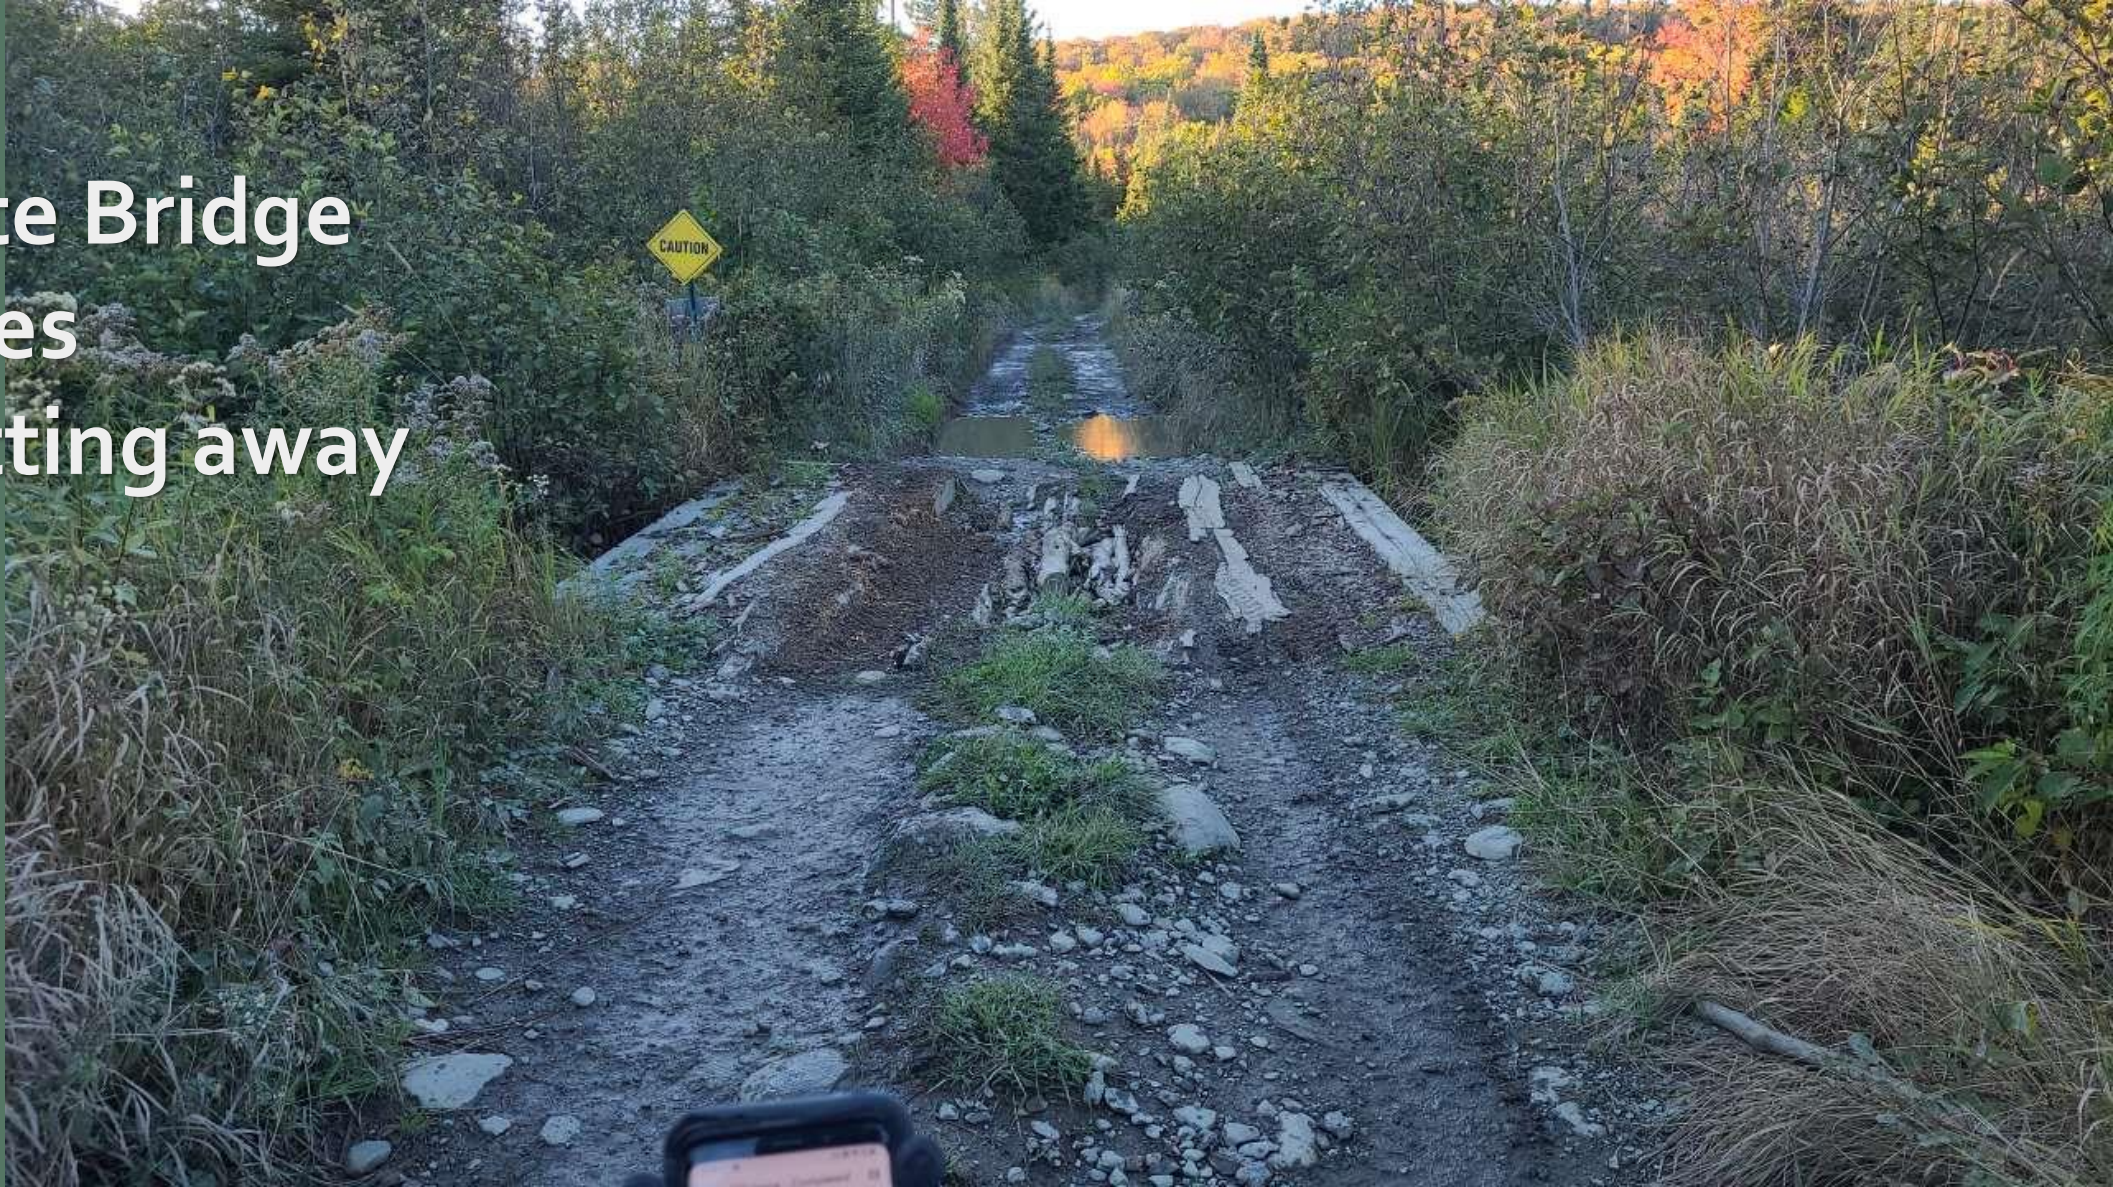
Issues:  
Inadequate Bridge  
Approaches  
Bridge rotting away

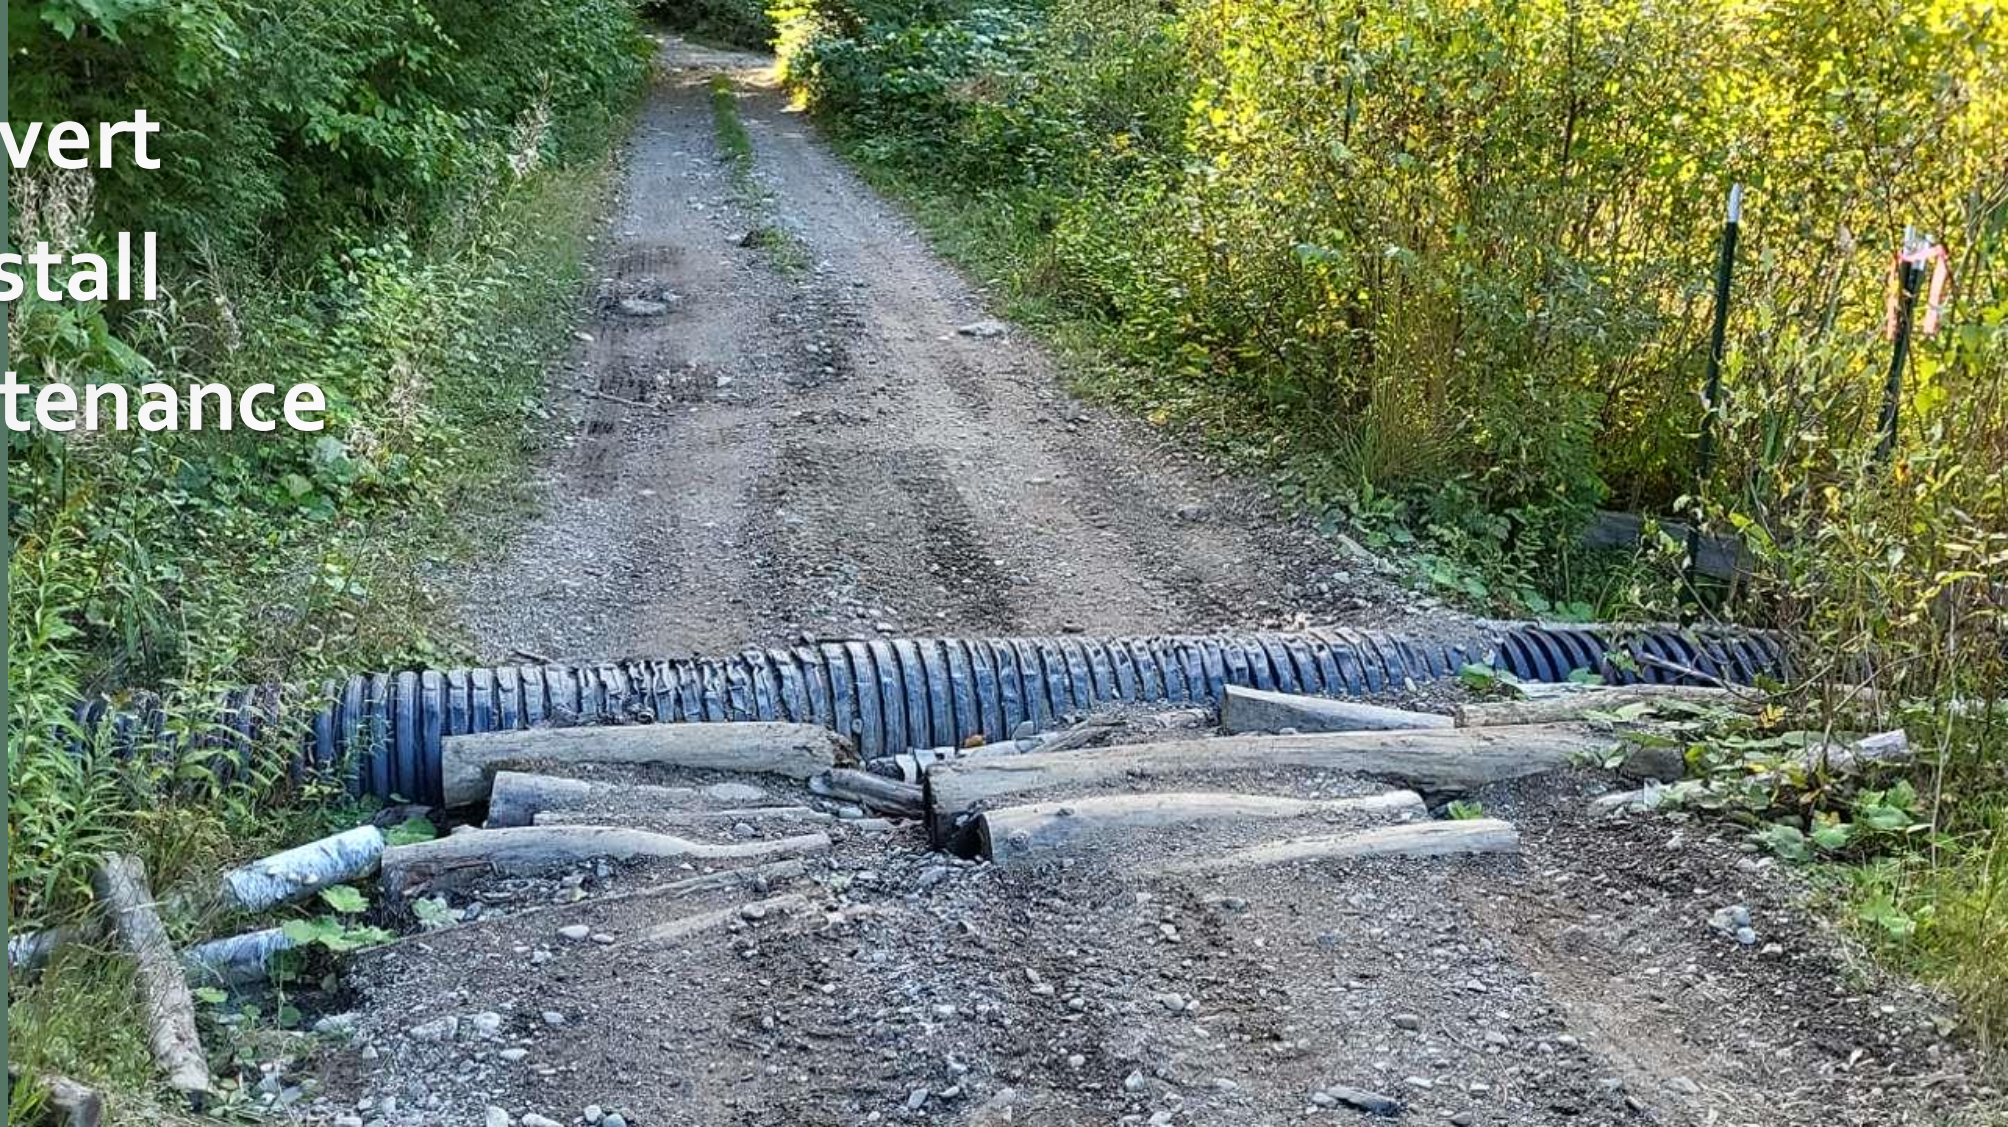
Issues:

Exposed culvert

Improper Install

Needs maintenance

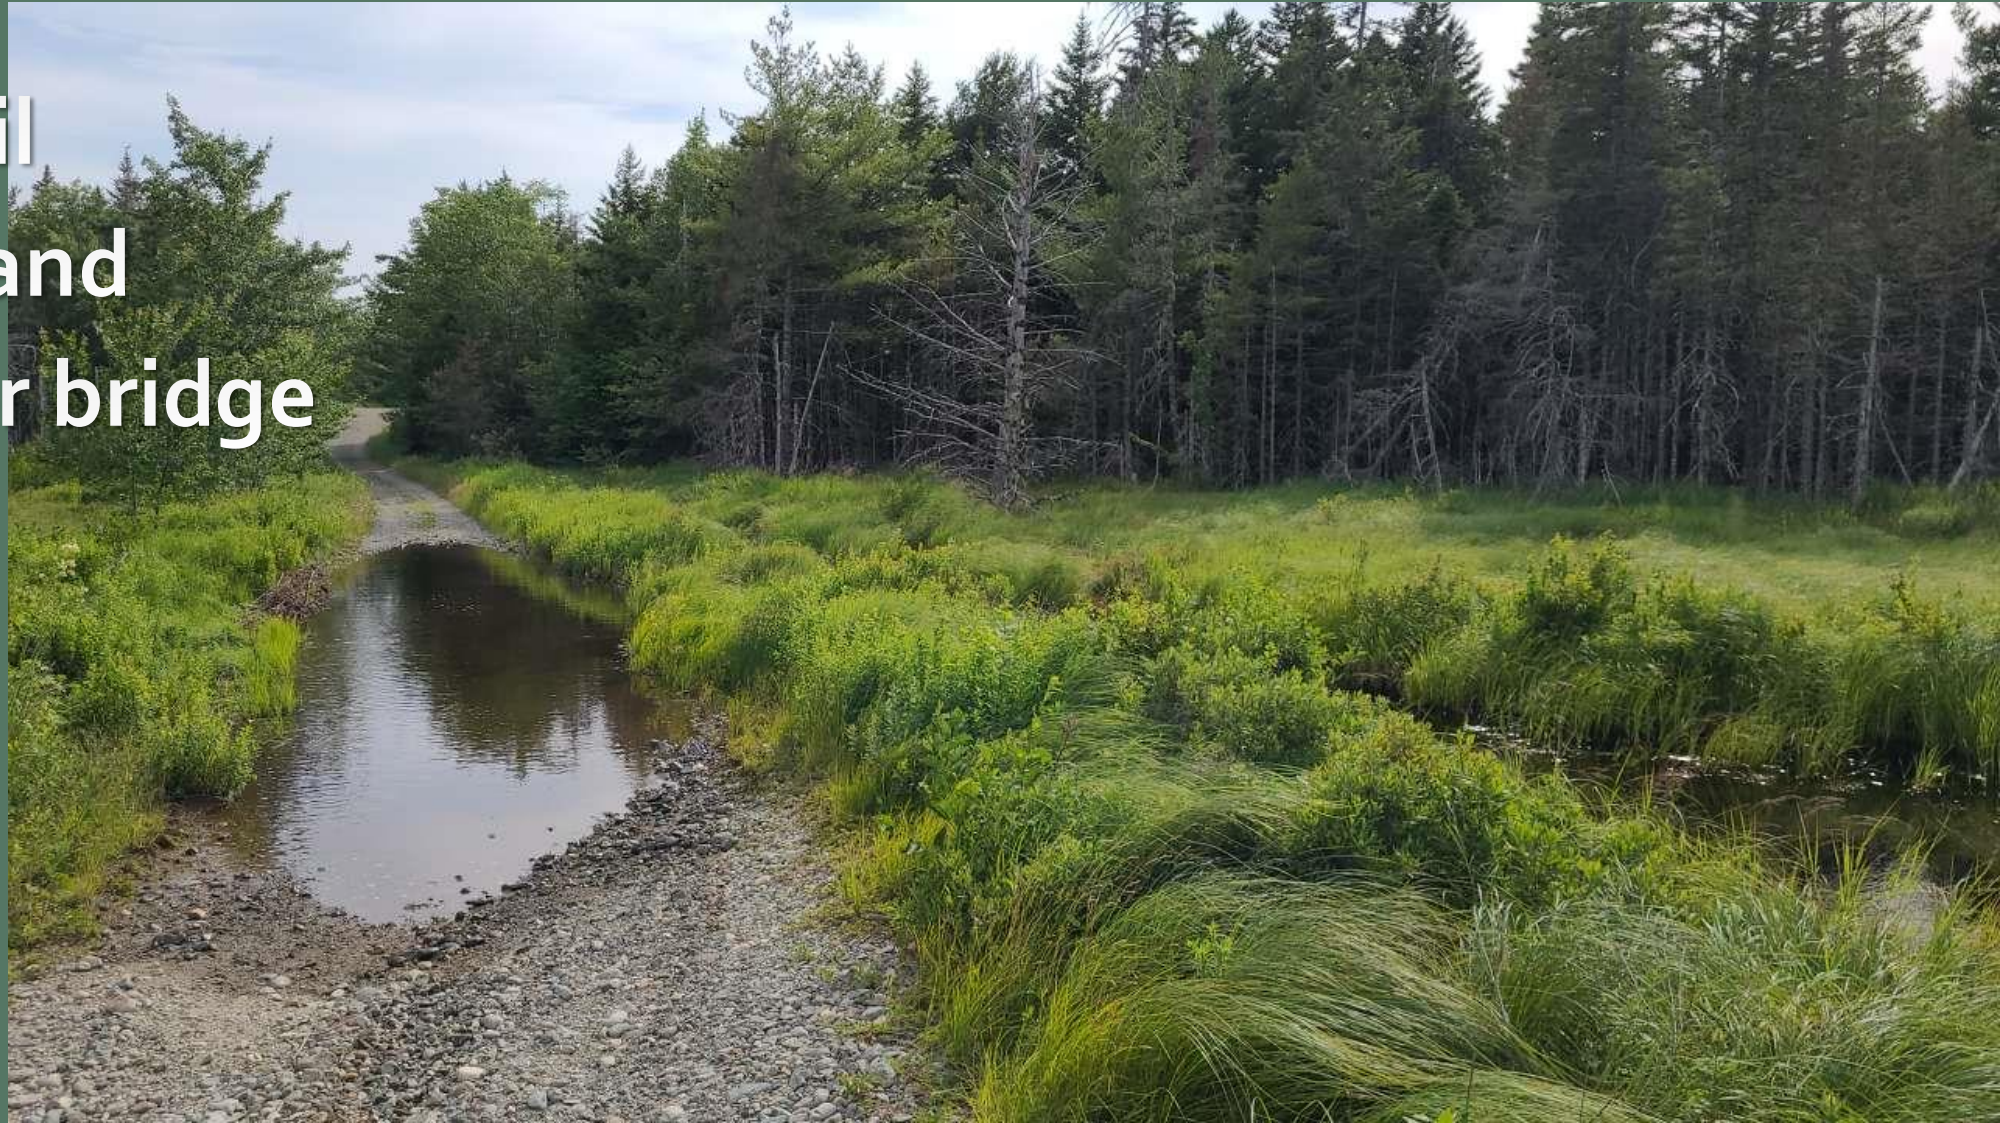
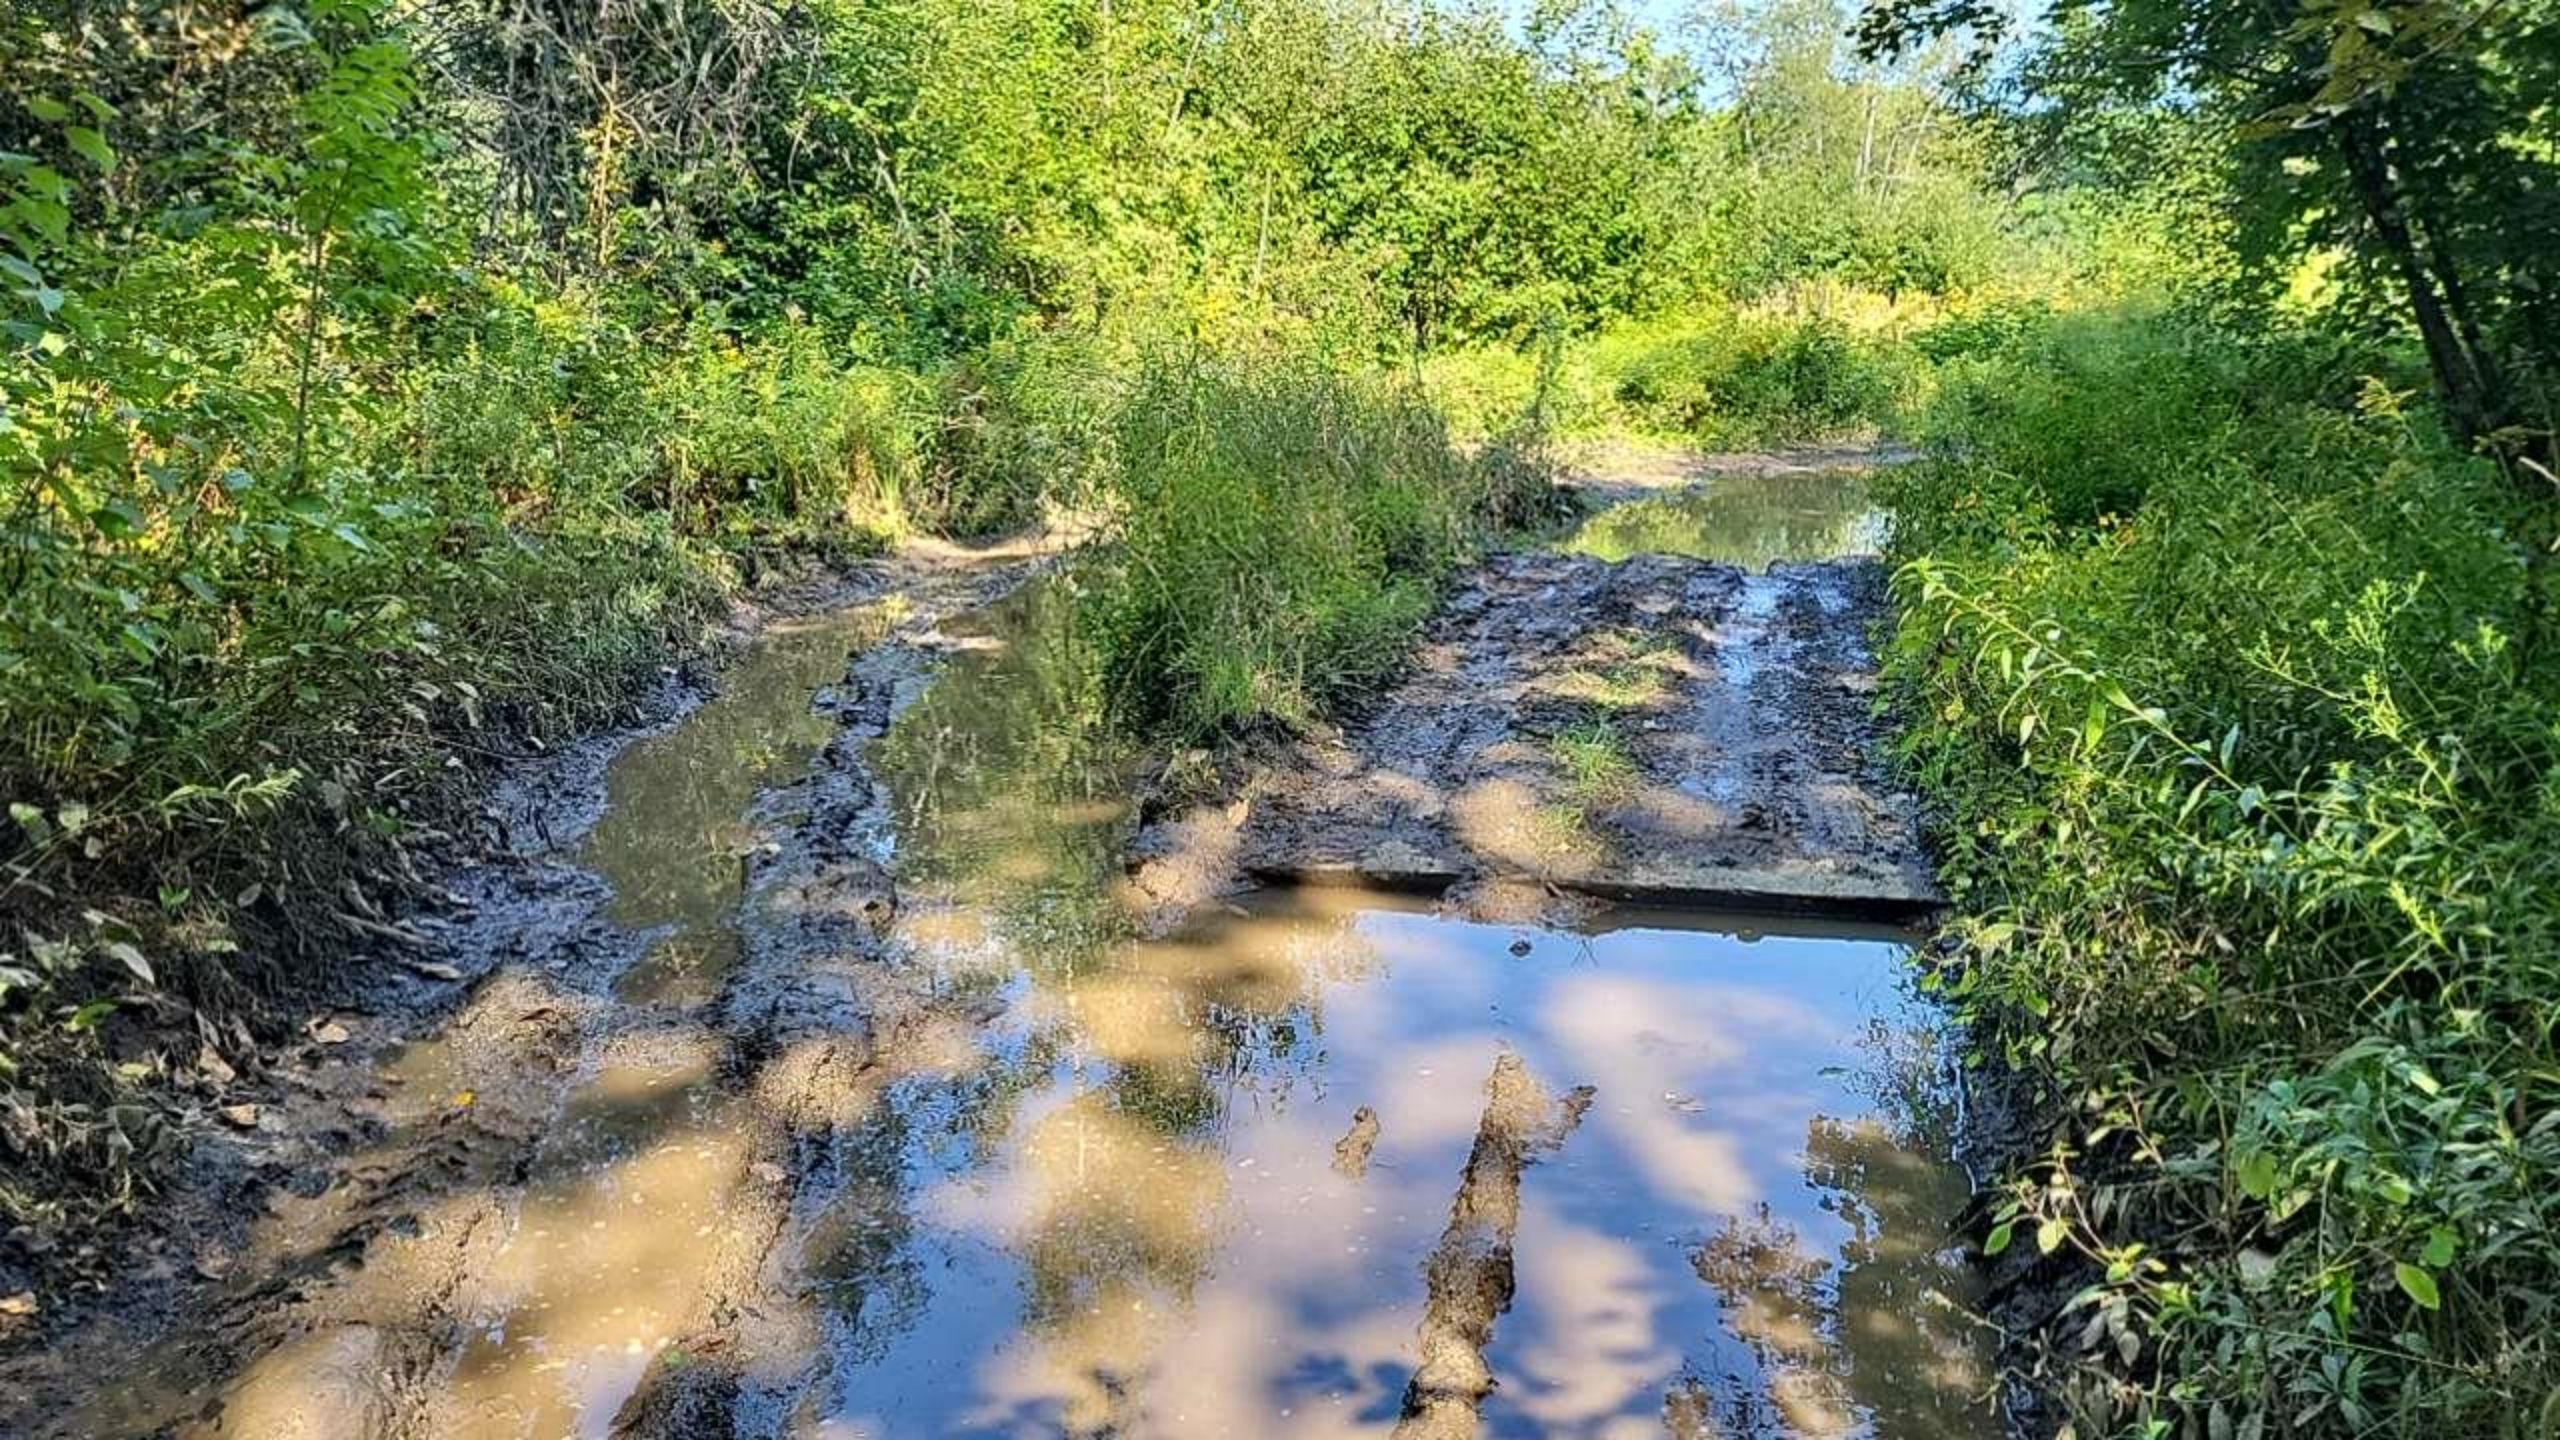
Issues:

Water in trail

Trail in wetland

No culvert or bridge

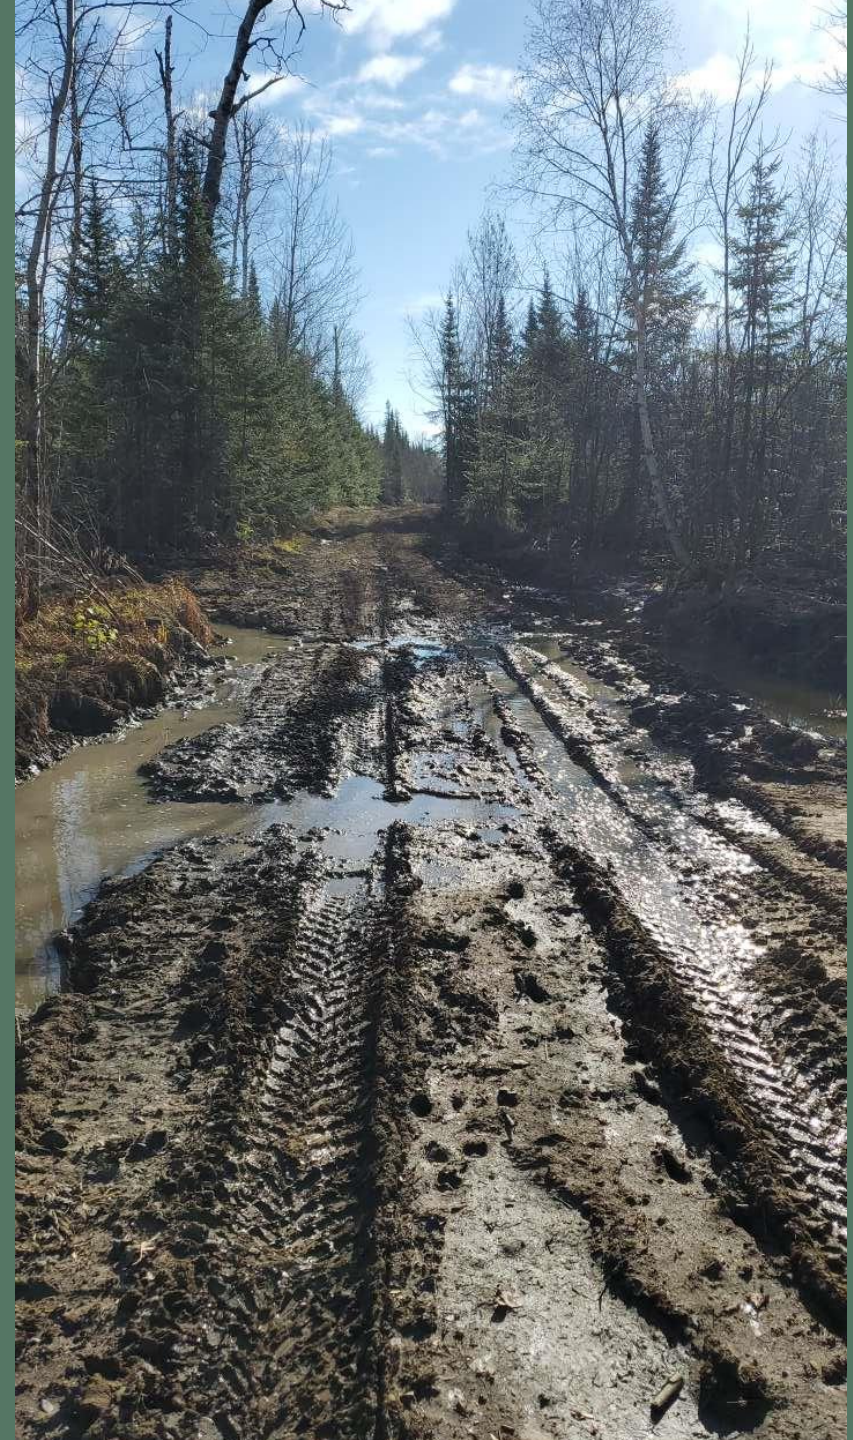
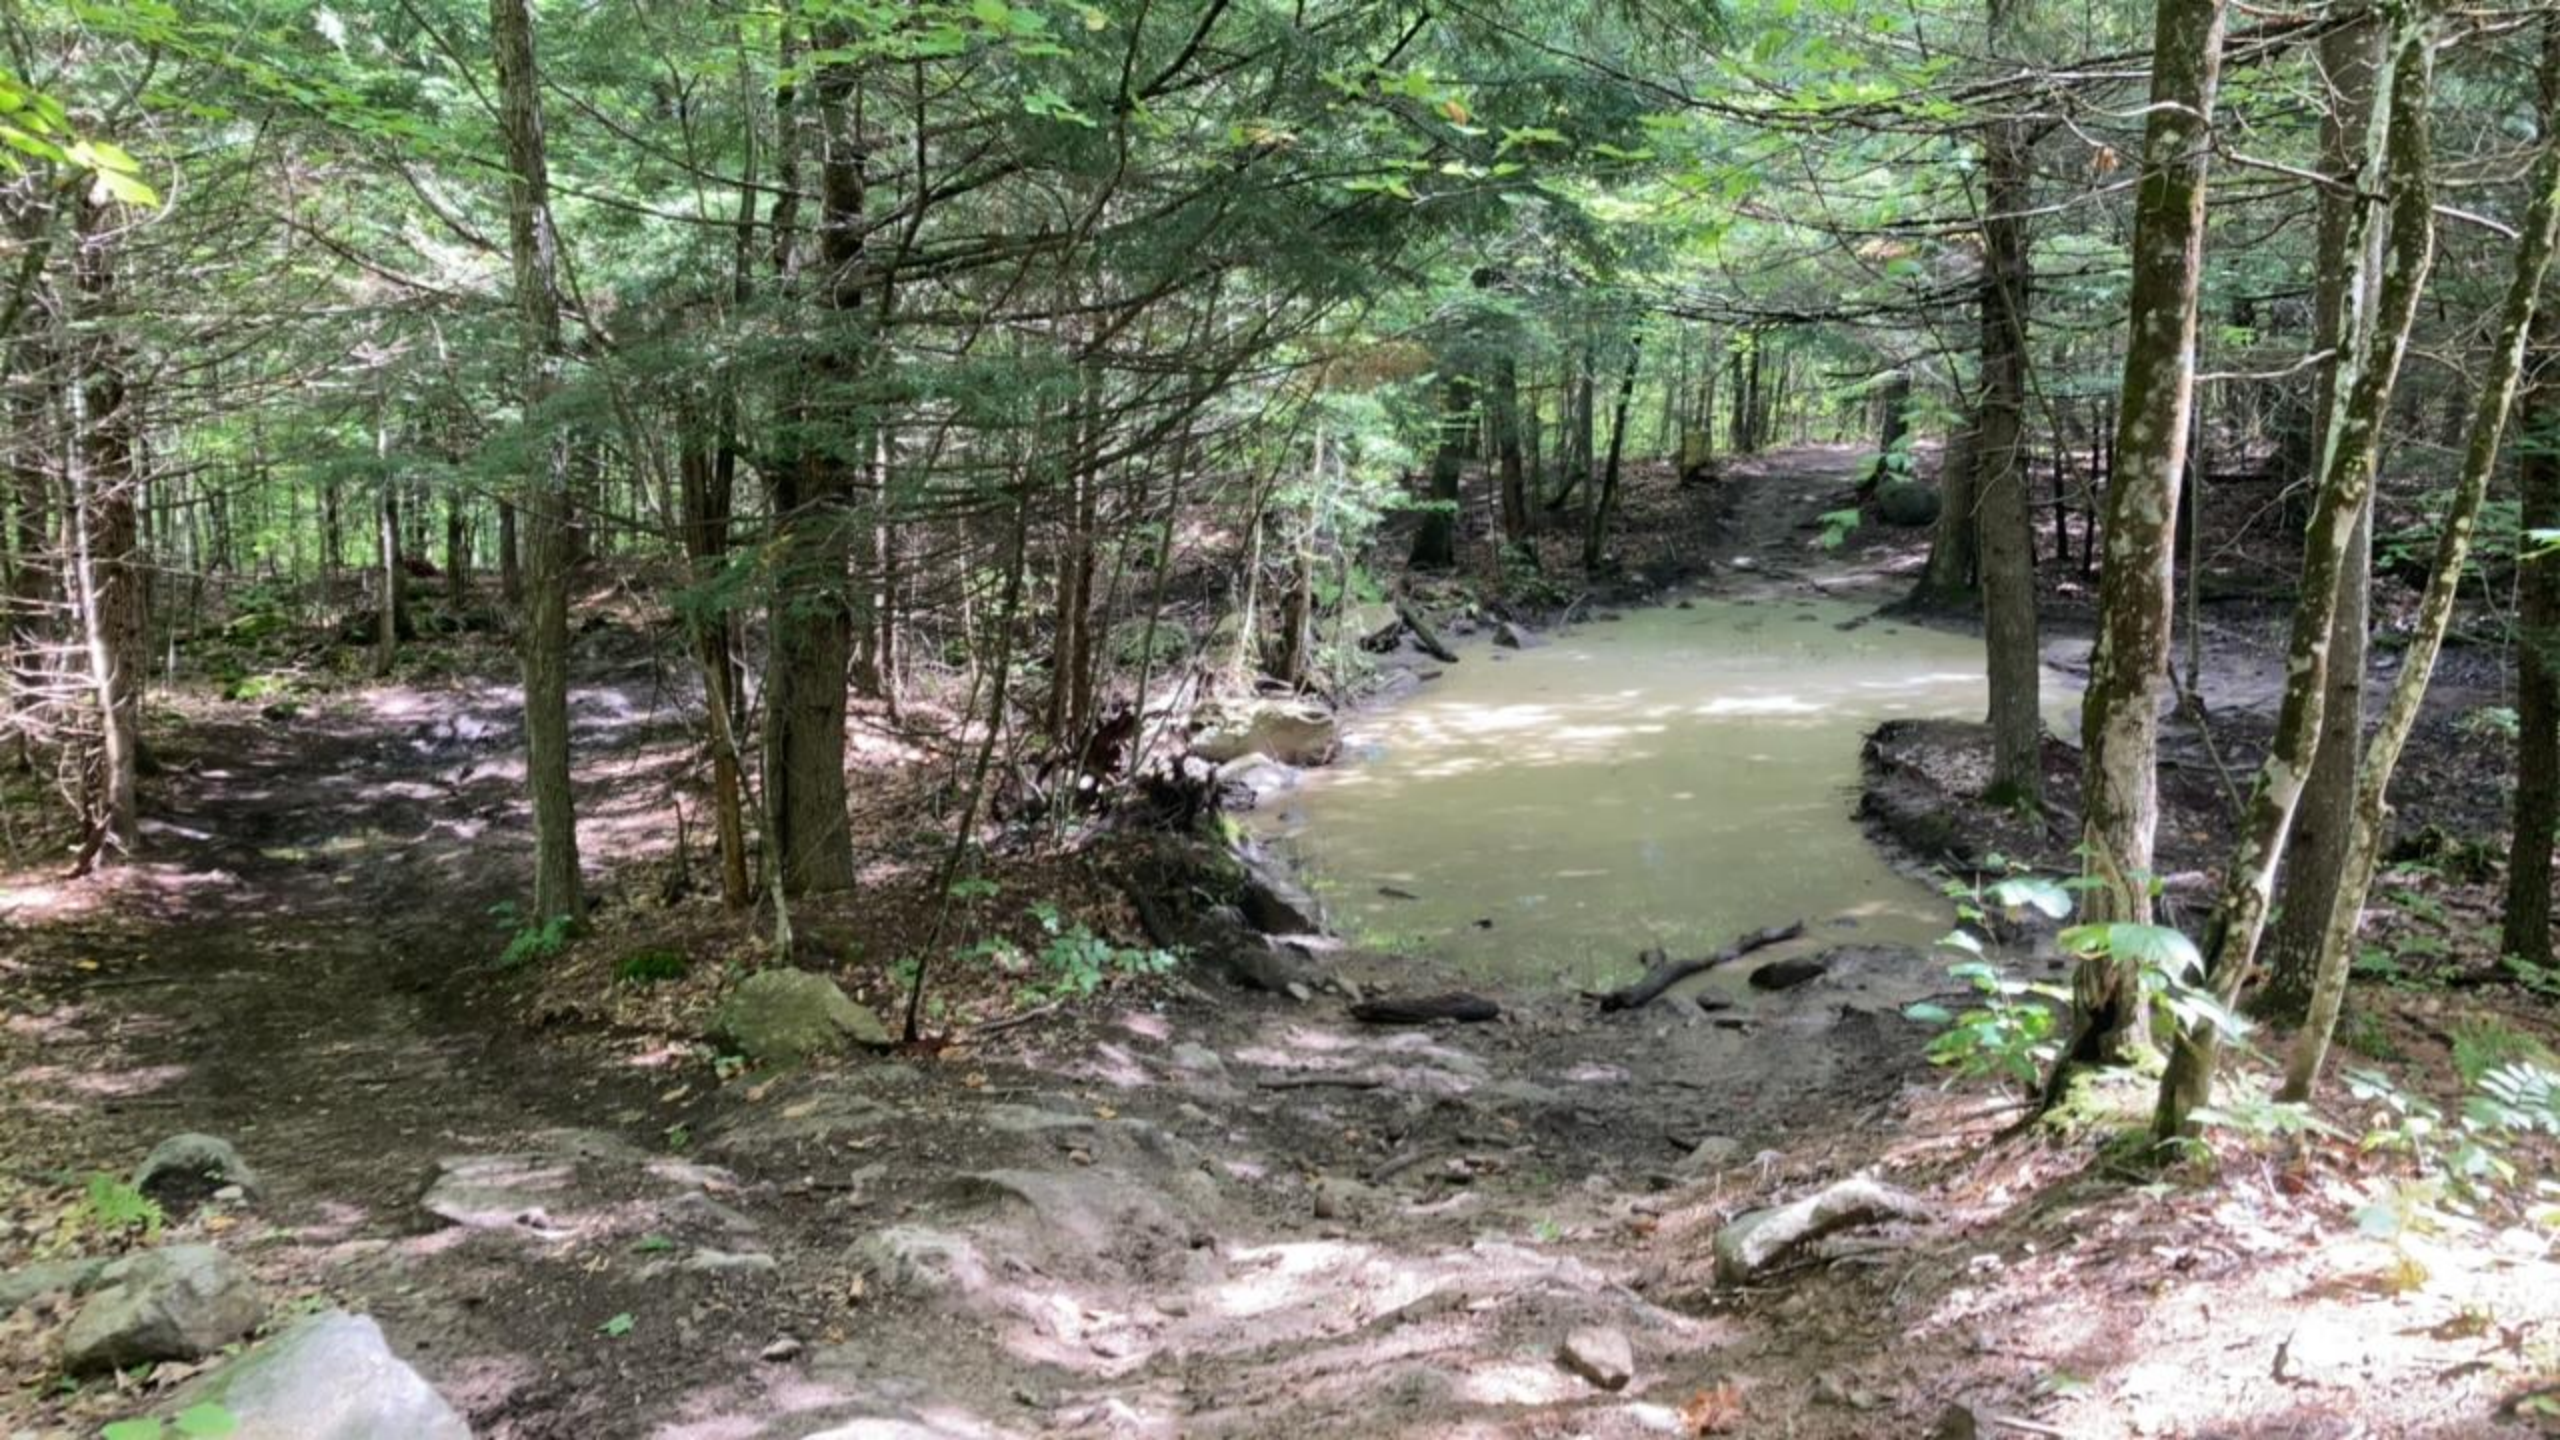
Issues:

Water in trail

Crushed culvert

Poor drainage

Erosion

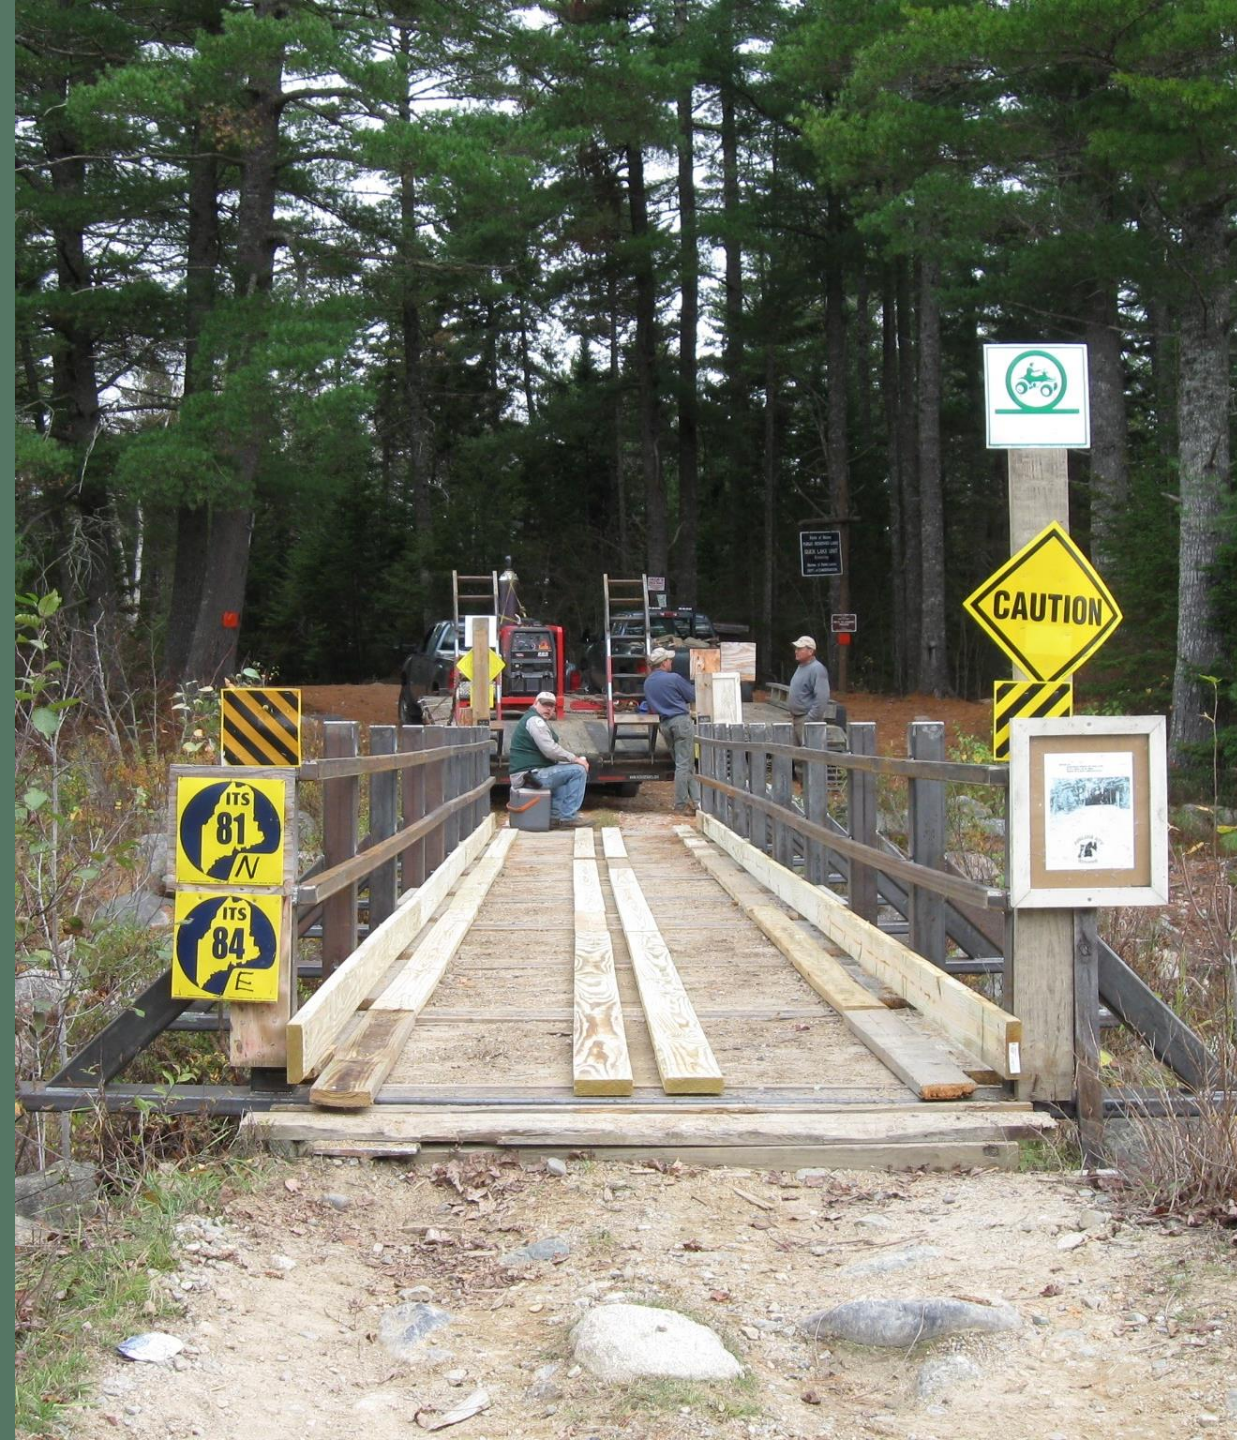
- ✓ Good railings
- ✓ Straight Approaches
- ✓ Good Signage
