## ATV PROGRAM

DEPARTMENT OF AGRICULTURE,  
CONSERVATION & FORESTRY

# ATV Inspections

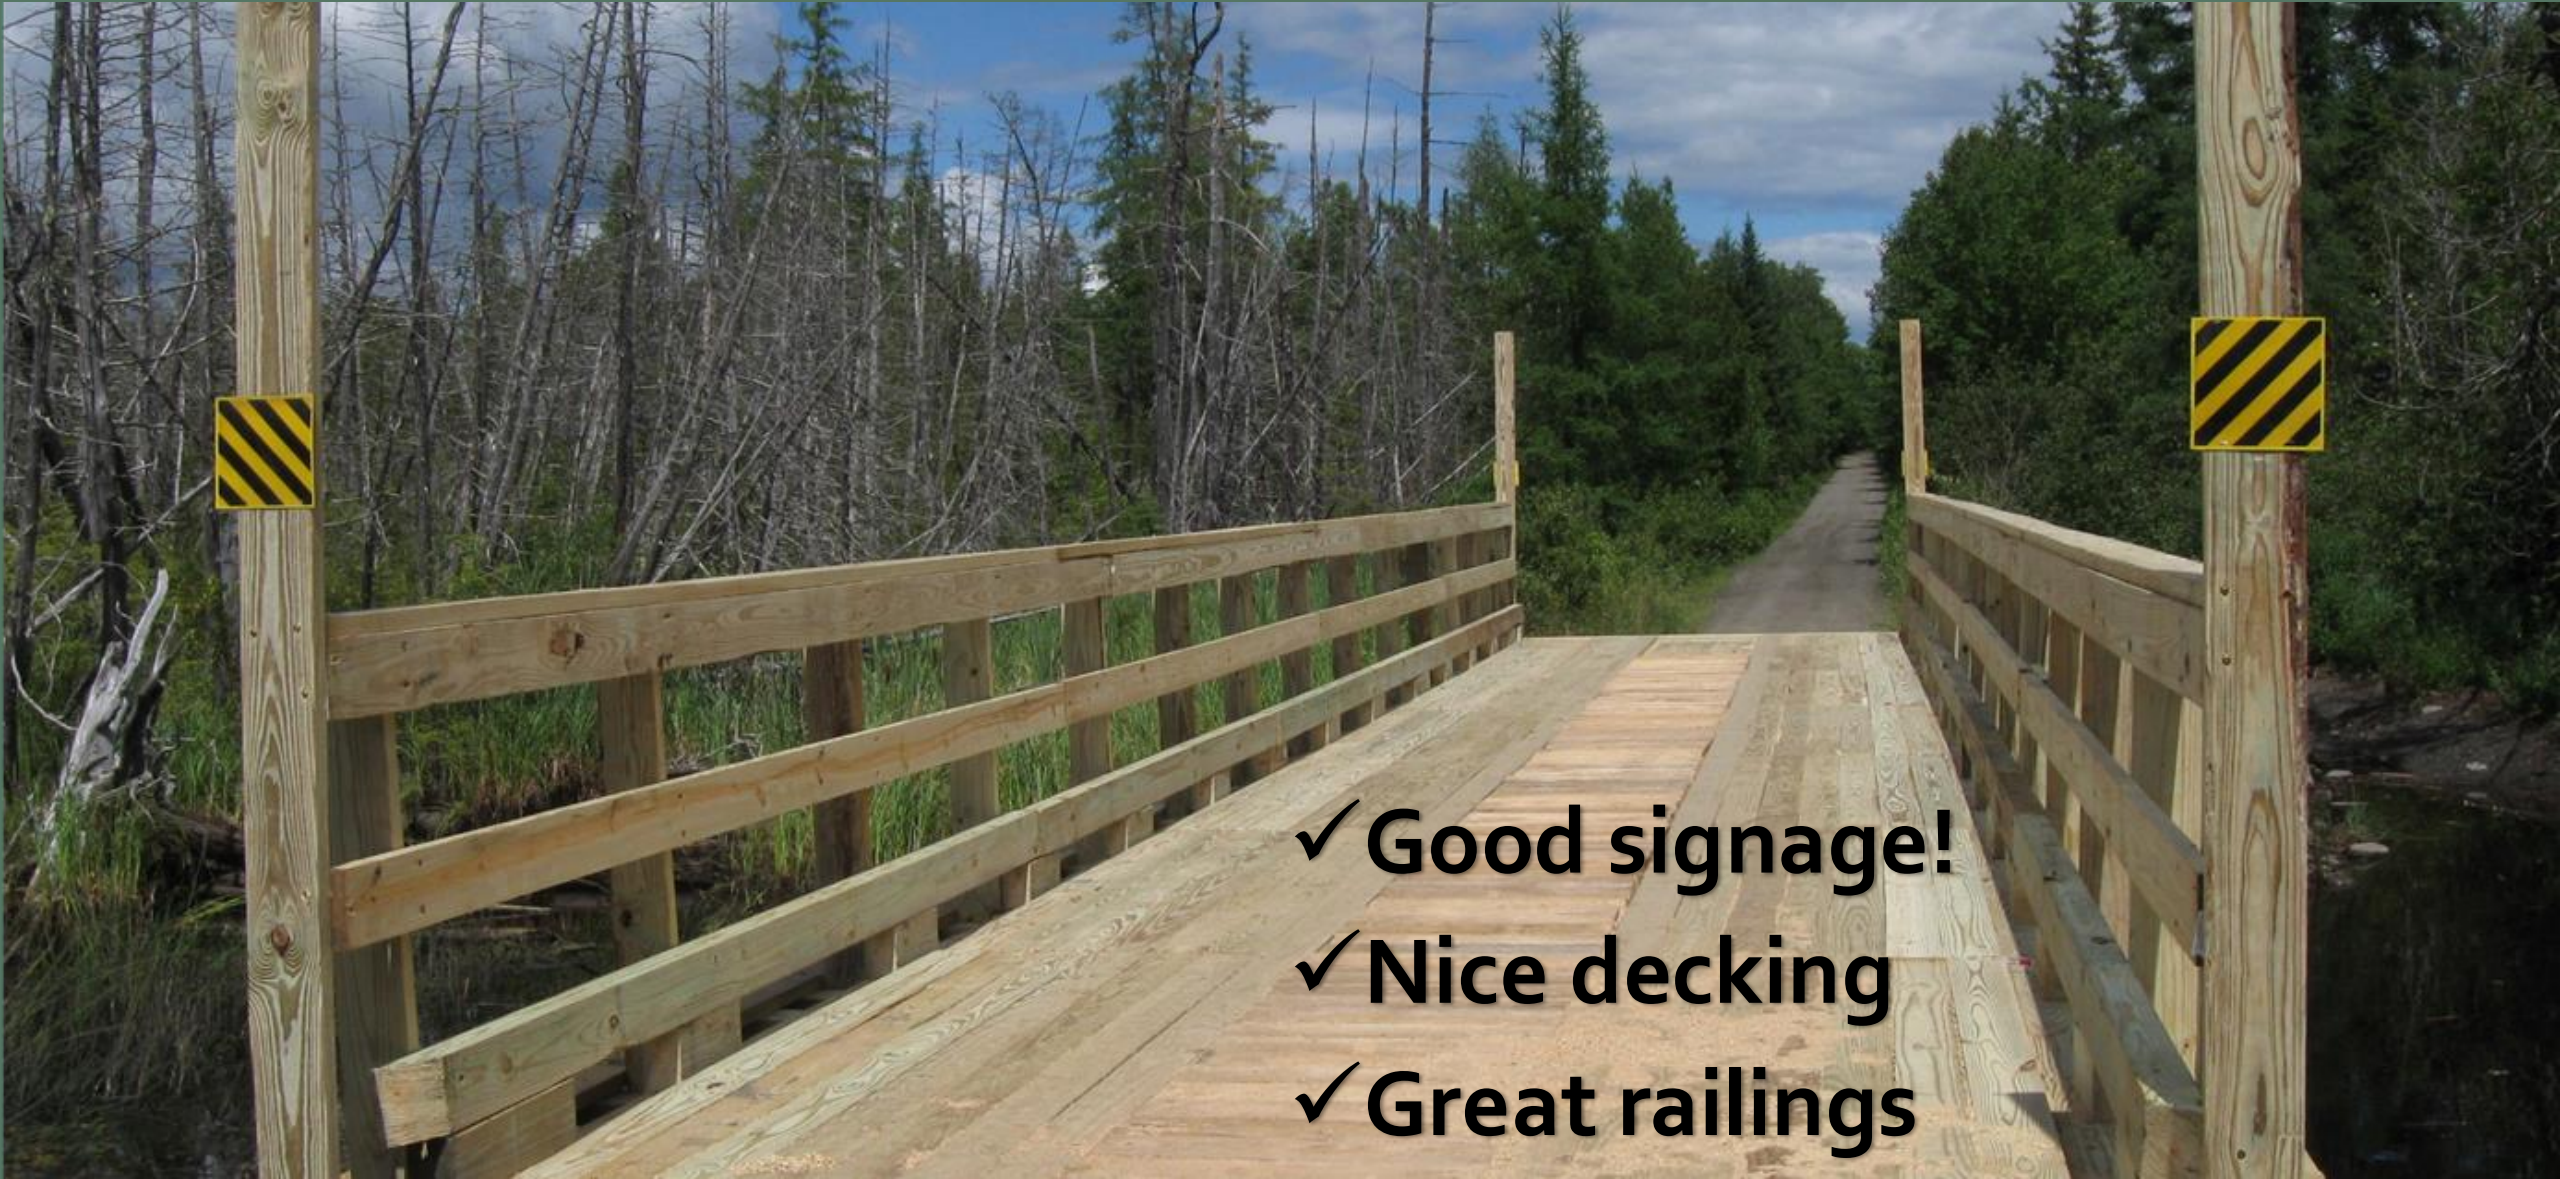
- ✓ Good signage!
- ✓ Nice decking
- ✓ Great railings

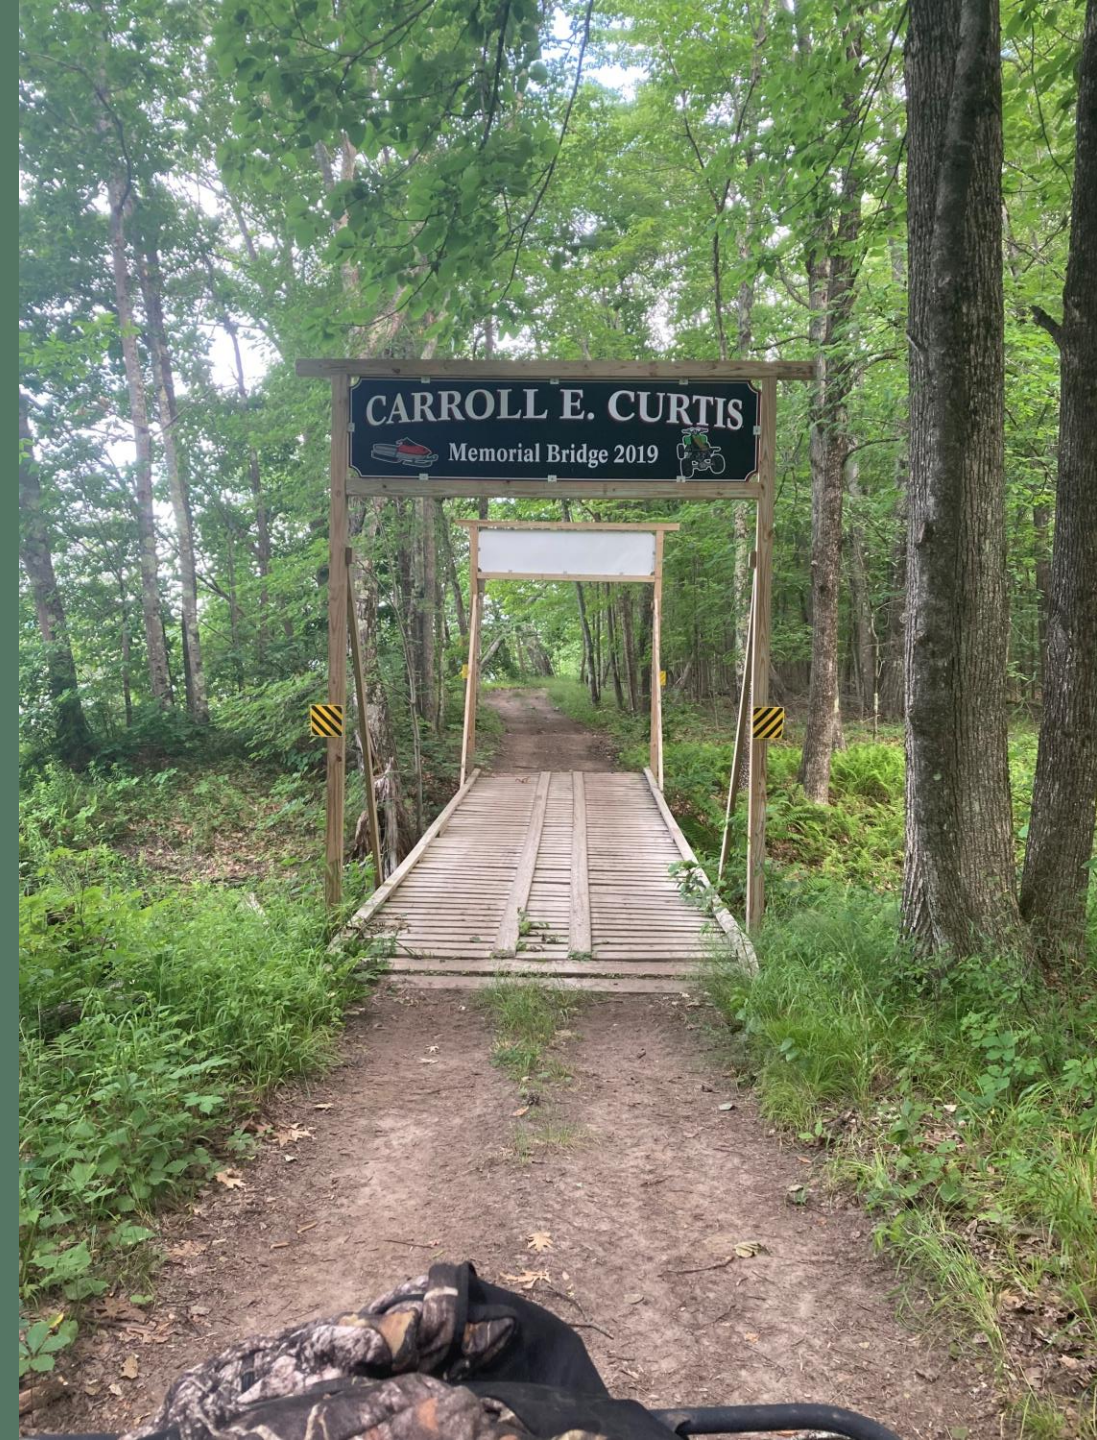
✓ Good signage!

✓ Nice approach on bridge

× Open decking = sediment in stream

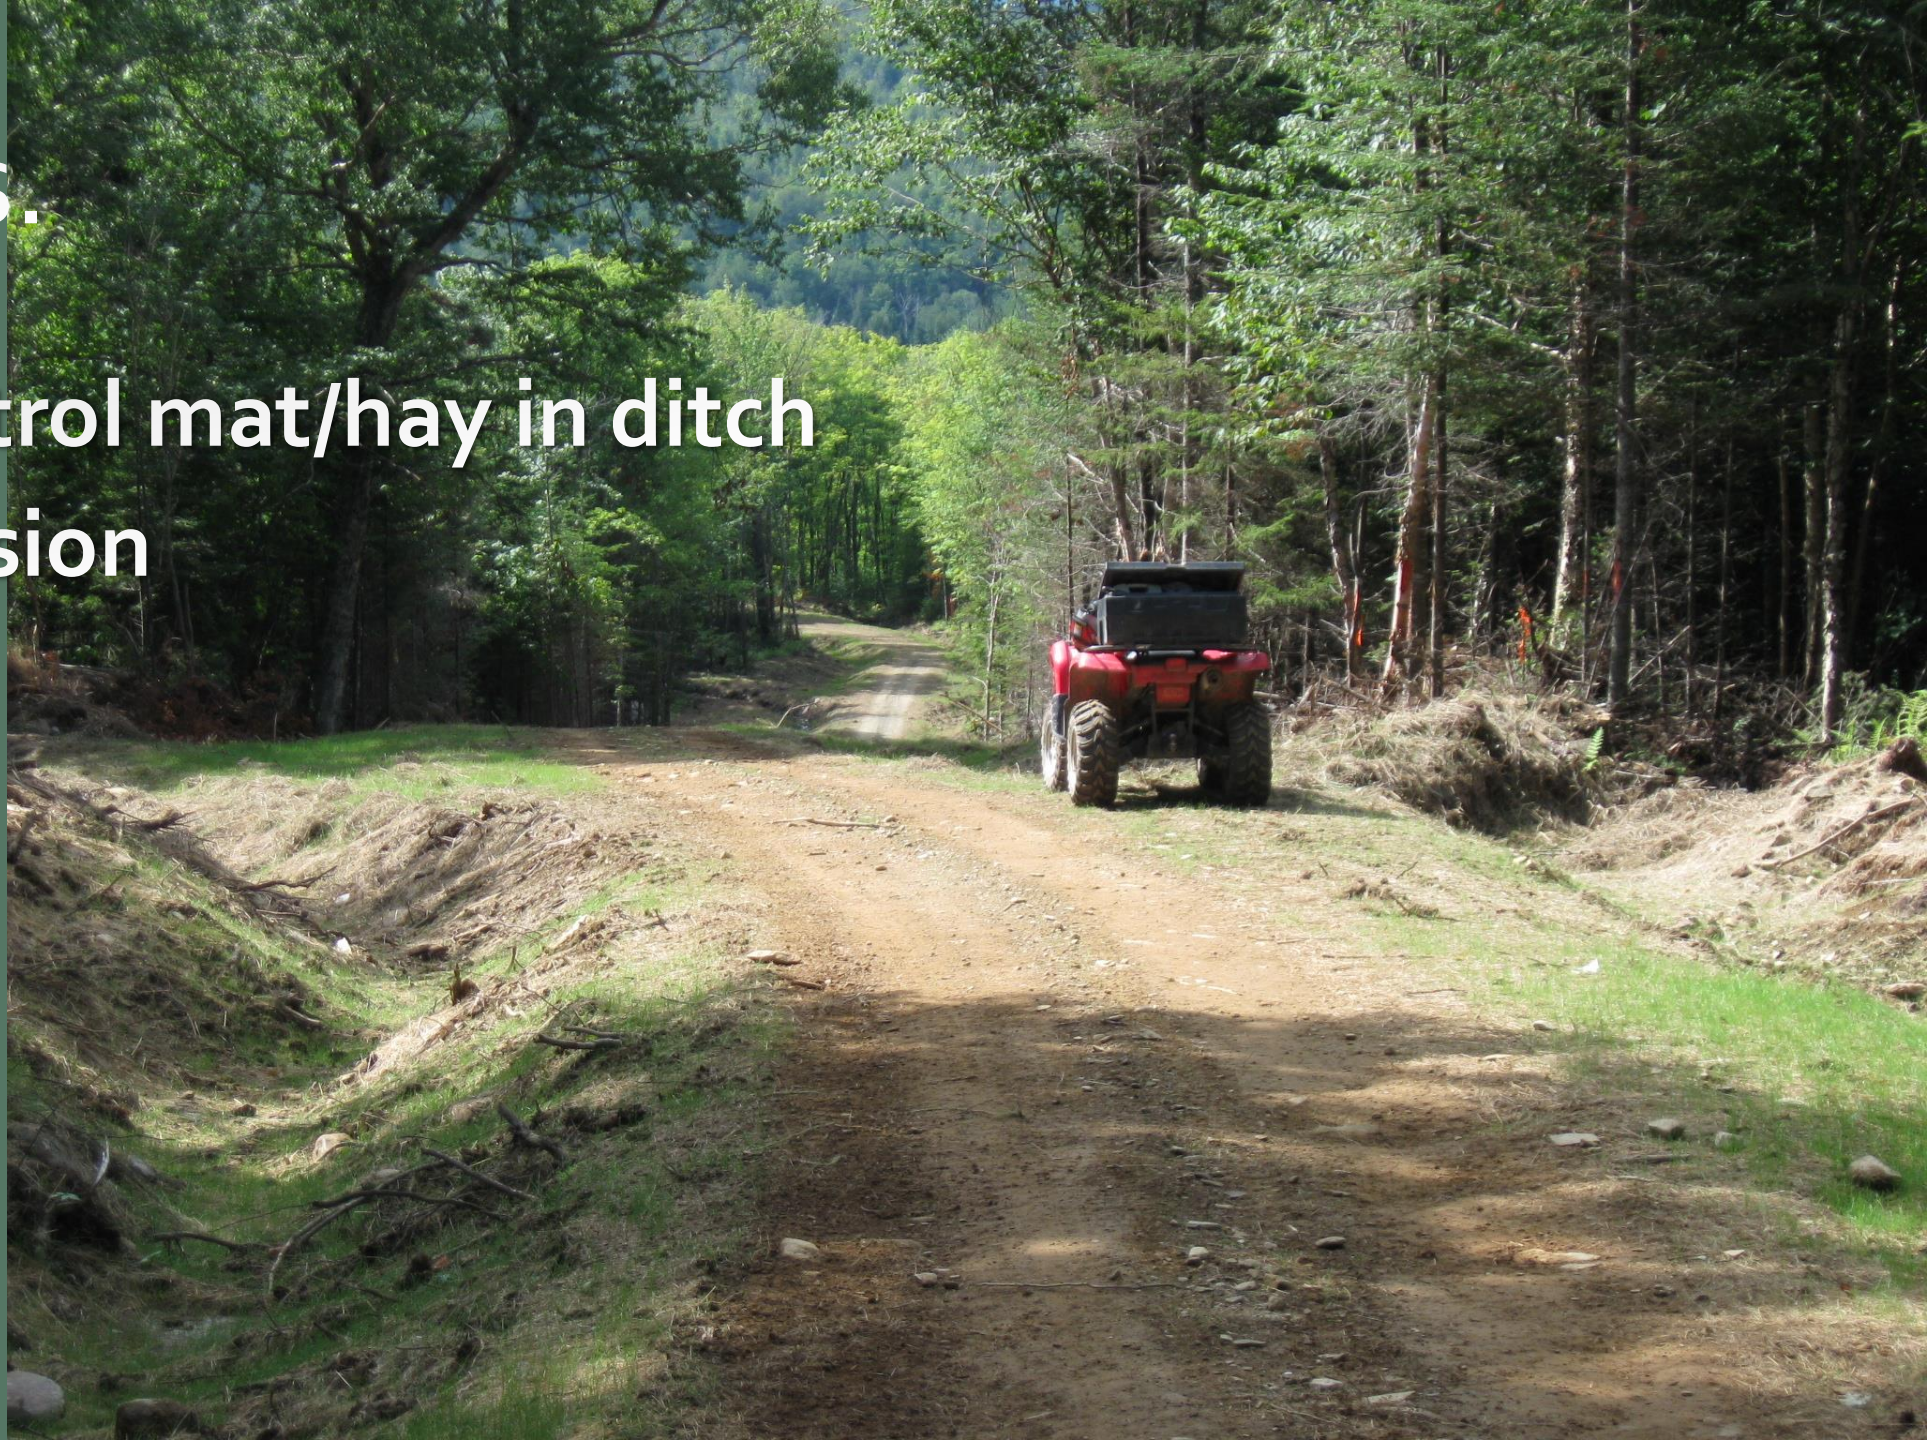
- ✓ Erosion control mat/hay in ditch
- ✓ Water diversion
- ✓ Ditching
- ✓ Grading

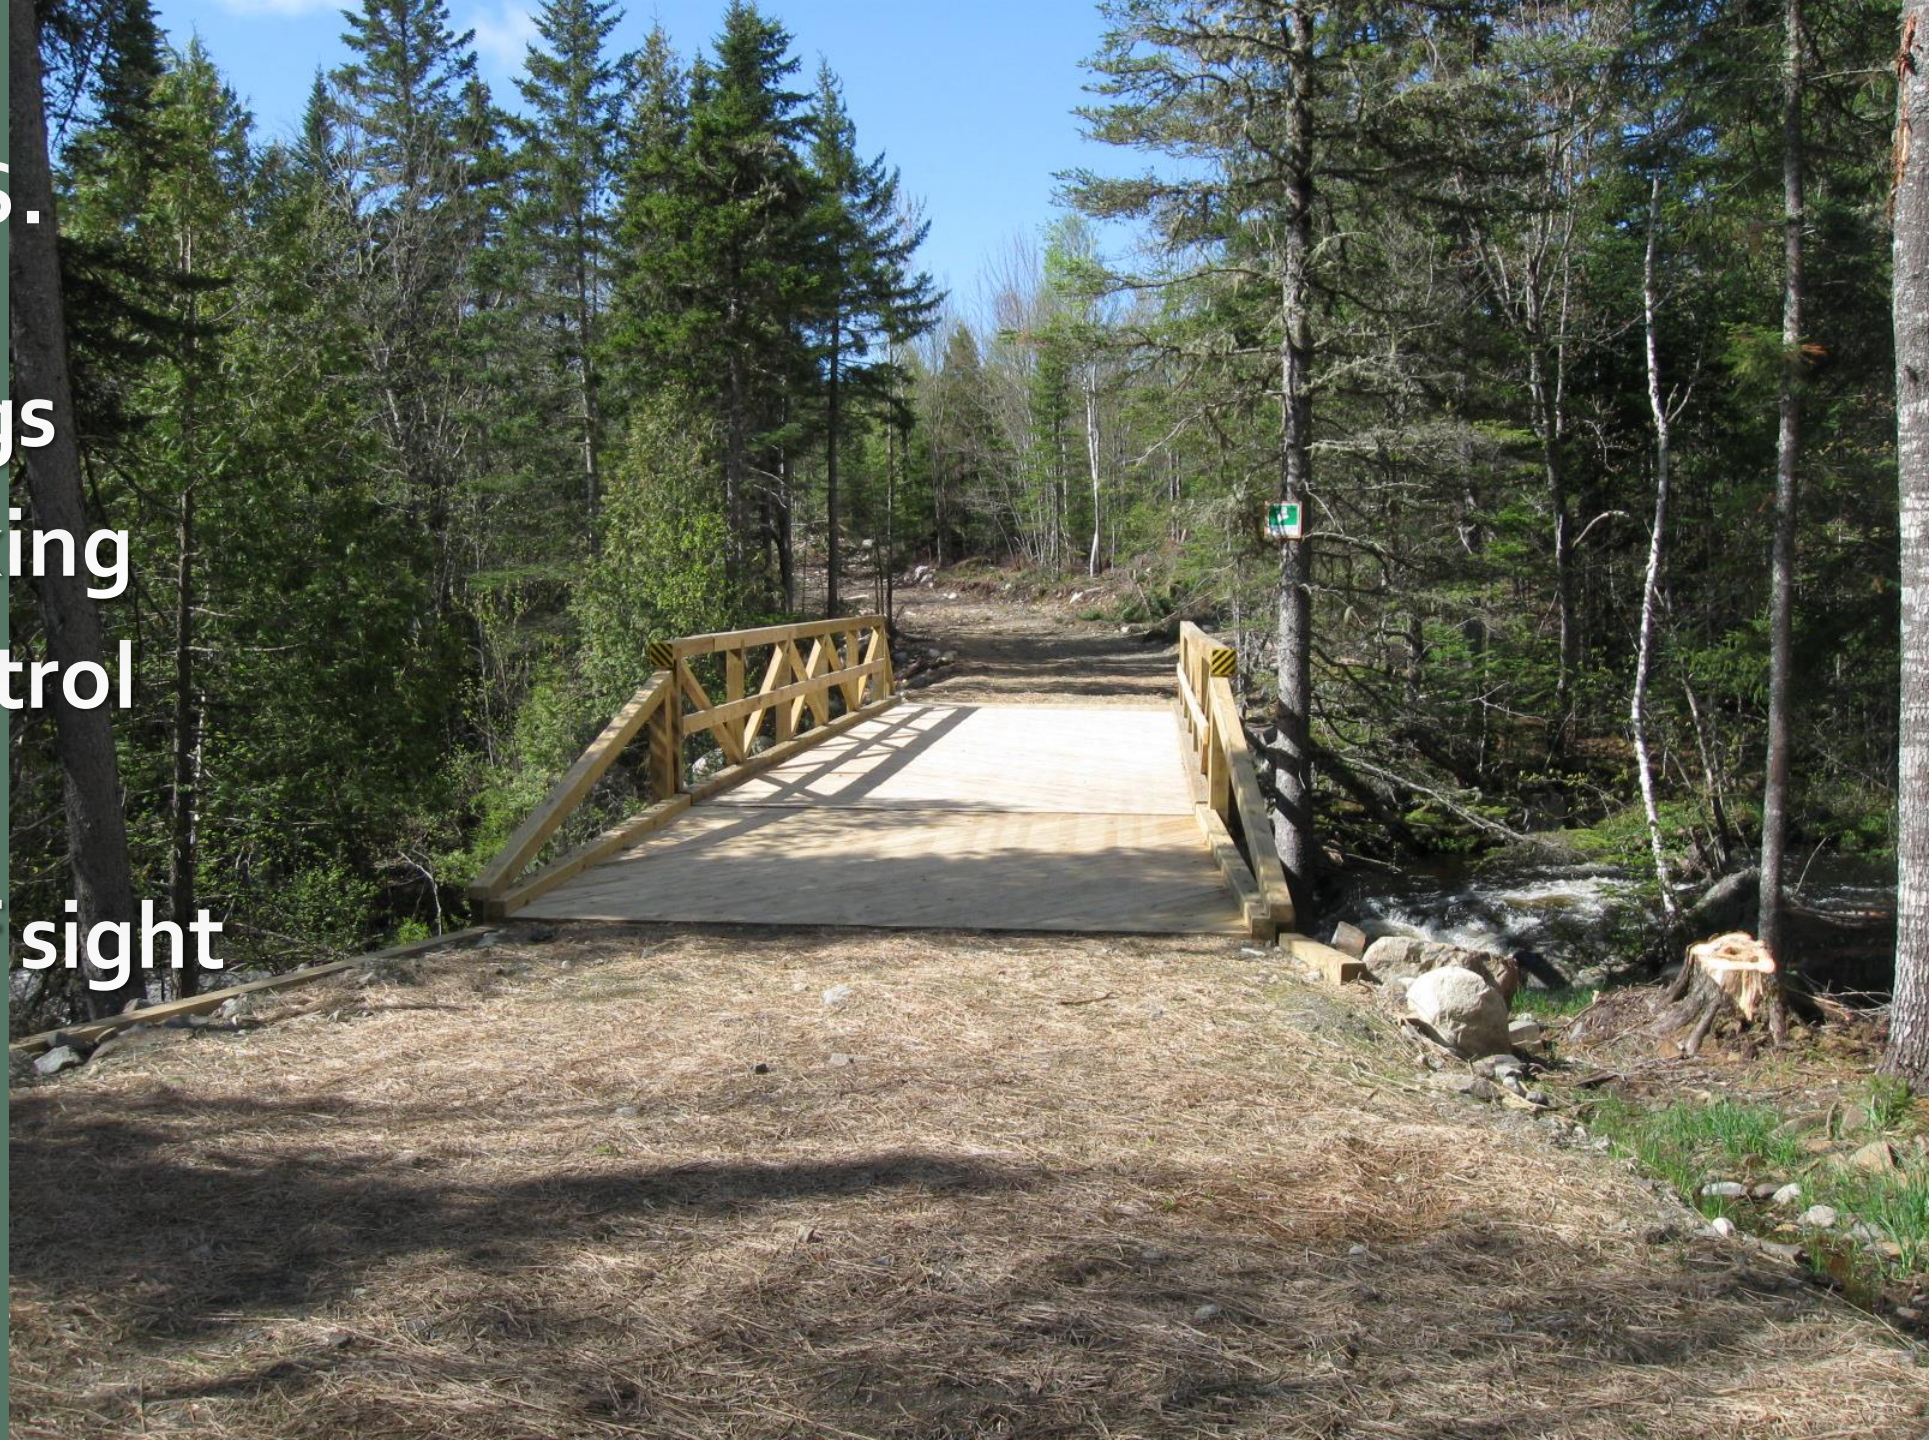
- ✓ Solid Railings
- ✓ Closed Decking
- ✓ Erosion Control
- ✓ Signs
- ✓ Good line of sight

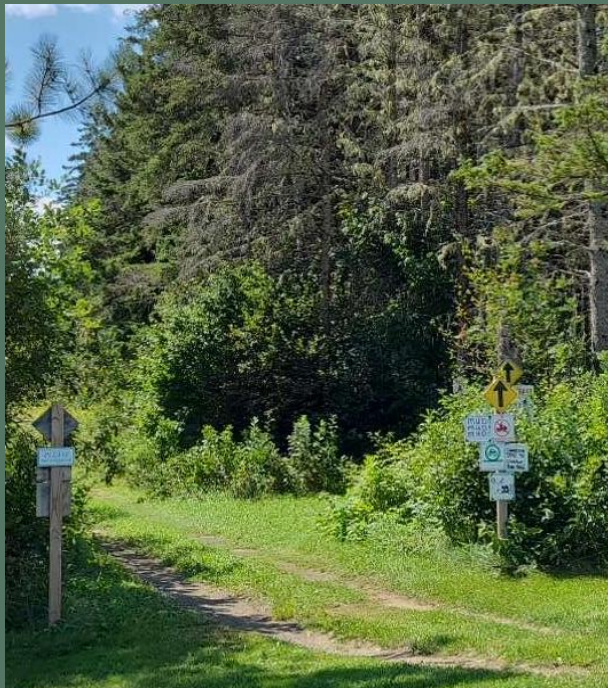
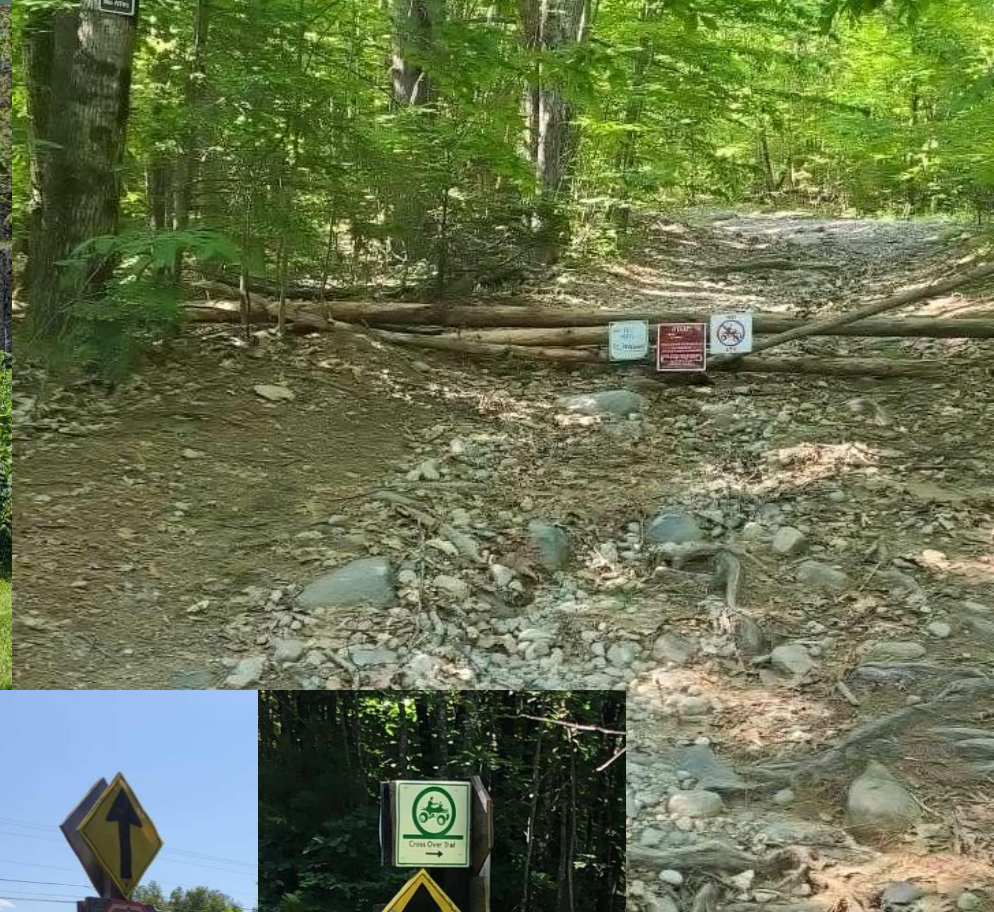
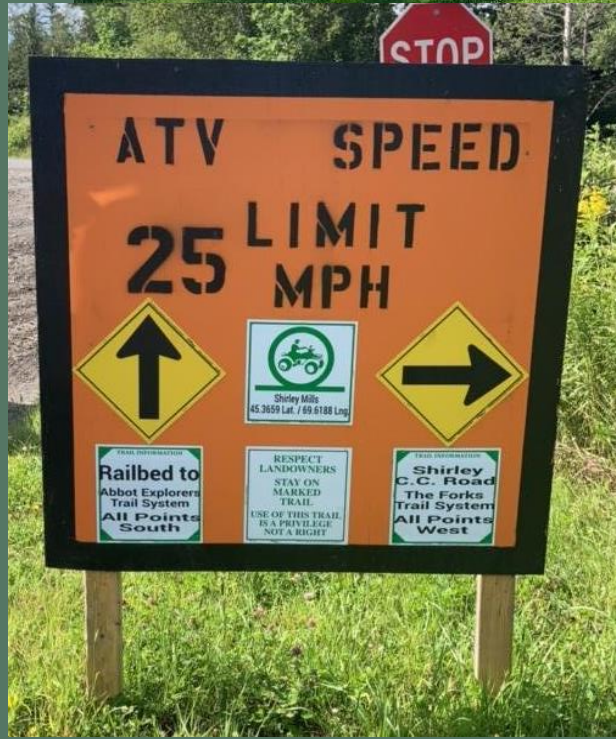
- ✓ Consolidated Signs
- ✓ Closed Trail Blocked
- ✓ Stop Sign with Cross Road
- ✓ Club Sign
- ✗ Writing on arrows

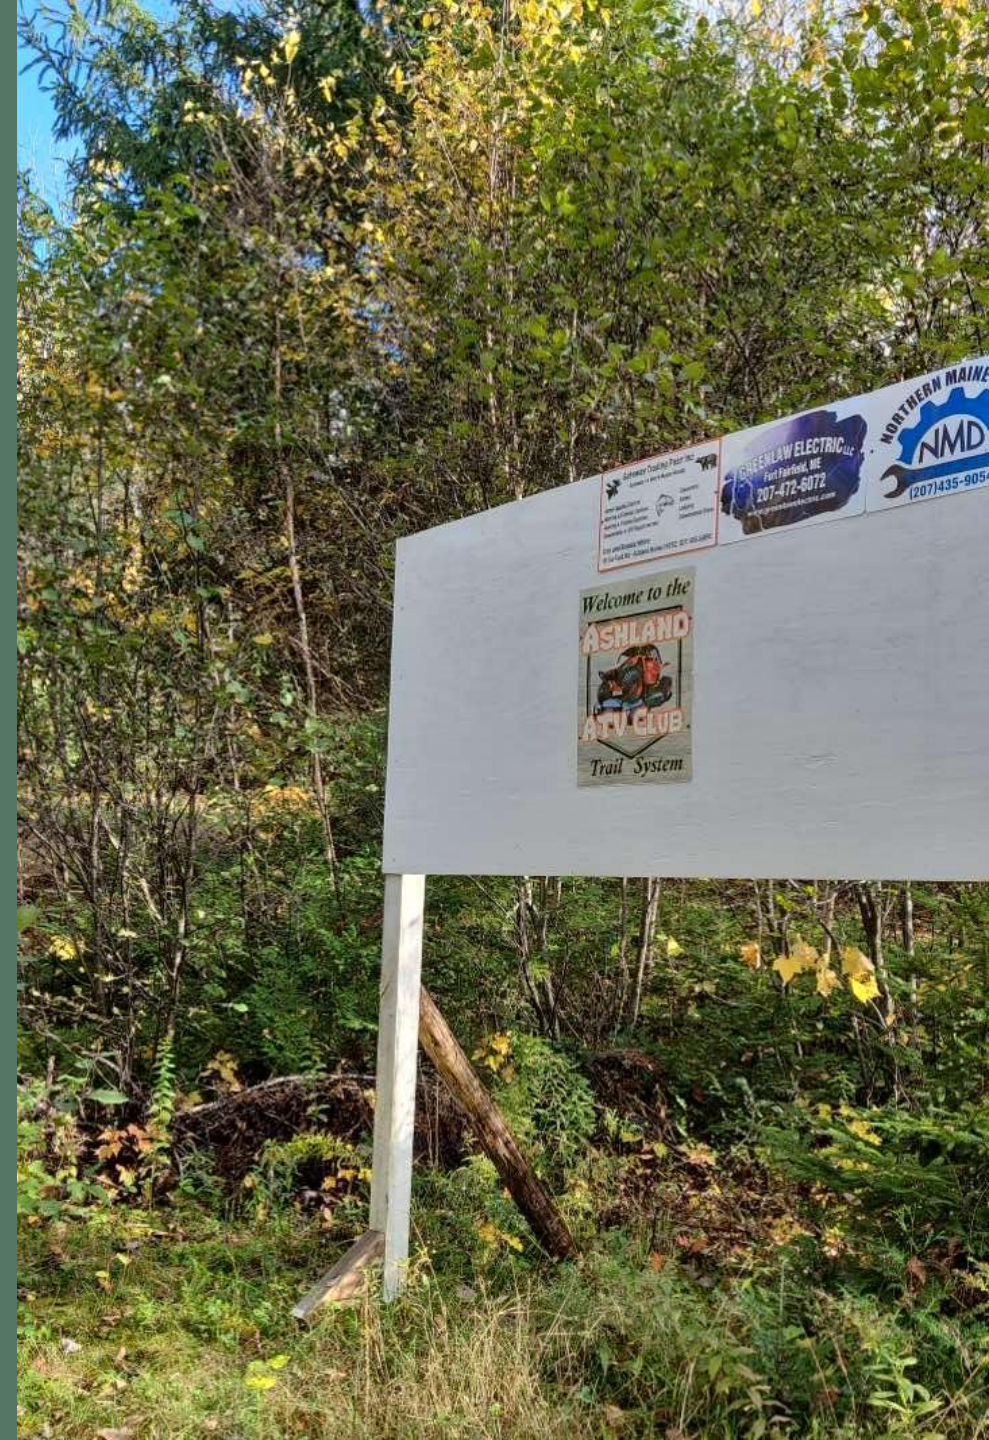
✓ Consolidated Signs

✓ Club Sign

× No Information

**\*\*Landowner must approve any signs not provided by ATV Program\*\***

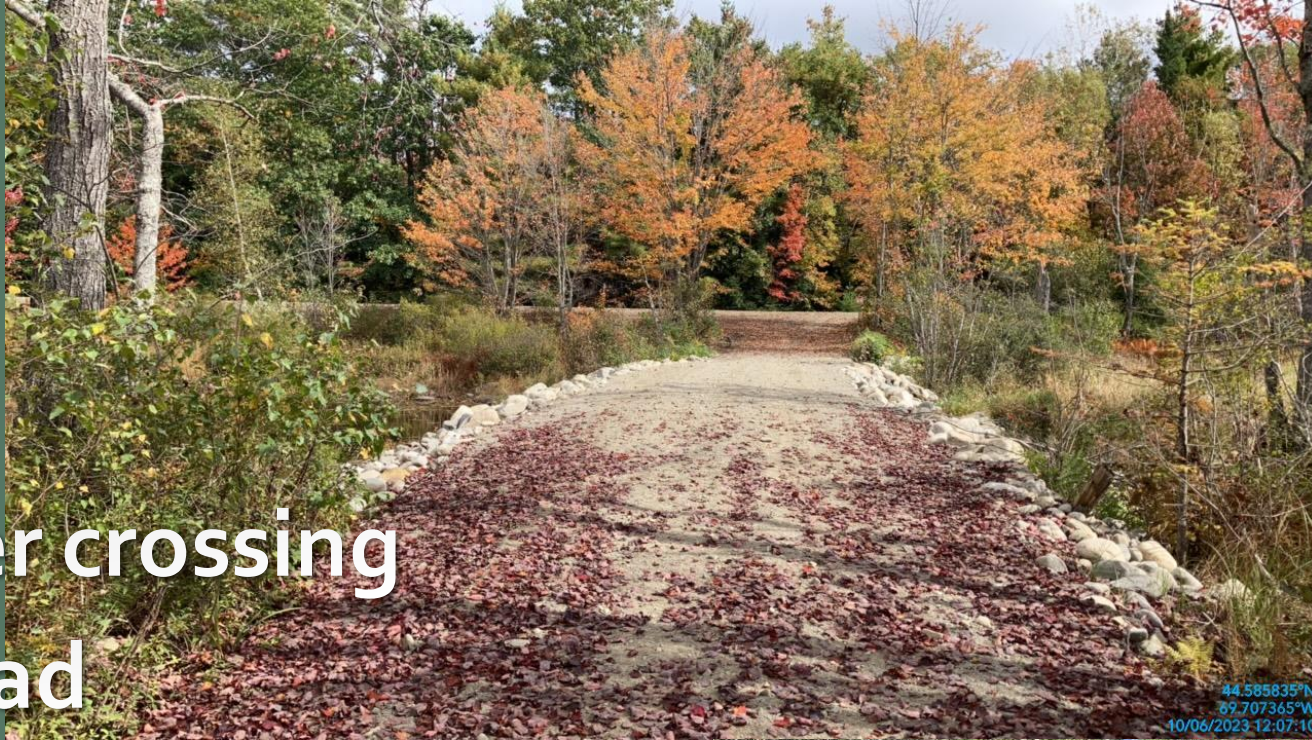
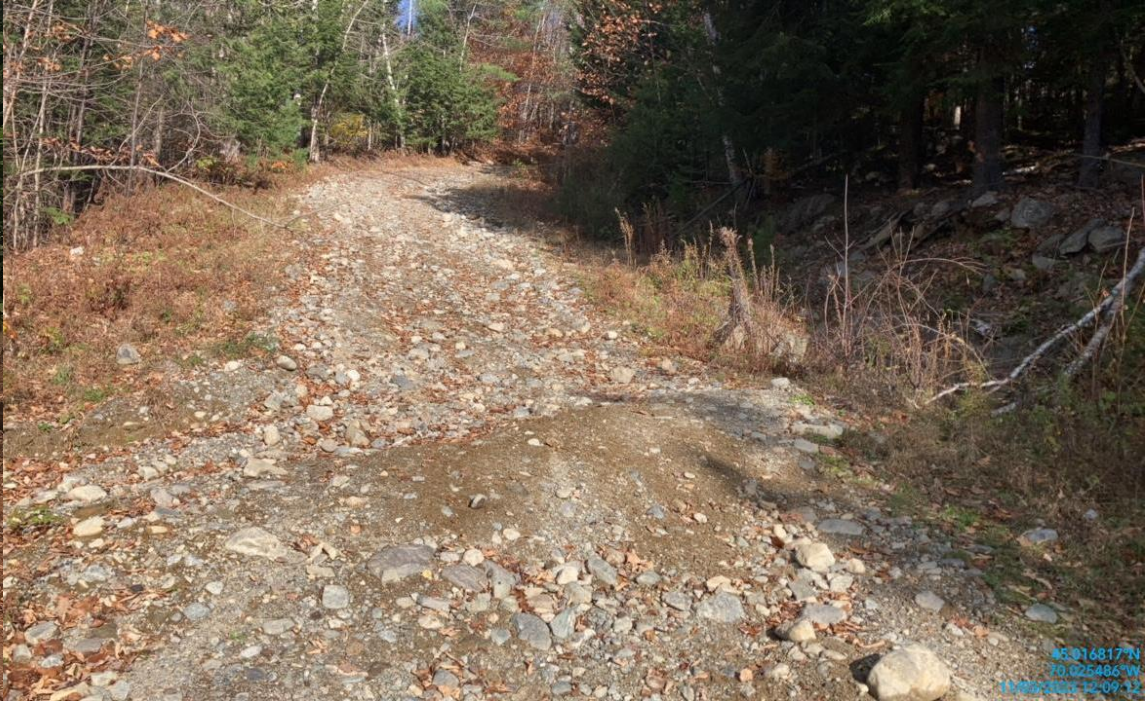
- ✓ Ditching
- ✓ Riprap'd water crossing
- ✓ Hardened tread
- ✓ Good line of sight
- ✓ Drive through waterbar
