FSMA Produce Safety Rule Pre-Harvest Agricultural Water Inspection & Assessment How-To

6. Let's Inspect Lindsay's Well with pictures:

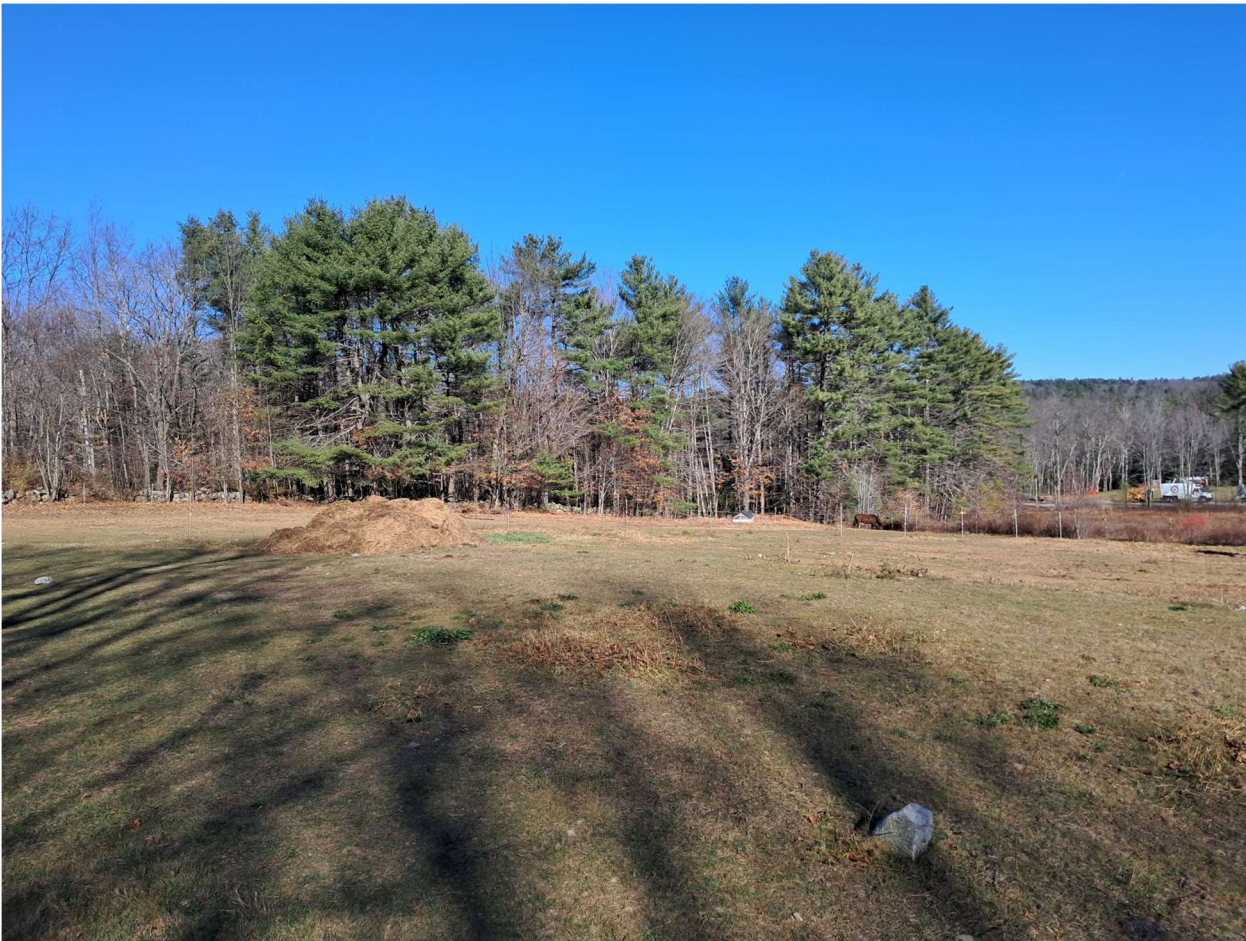
- a. *Use the DACF cheat sheet for evaluating the degree of protection and other considerations when conducting an inspection.
- b. 1st photo is standing in the horse pasture on the edge of the leach field marked with rocks. Manure pile with sloping land down to the dug well behind the little white house.

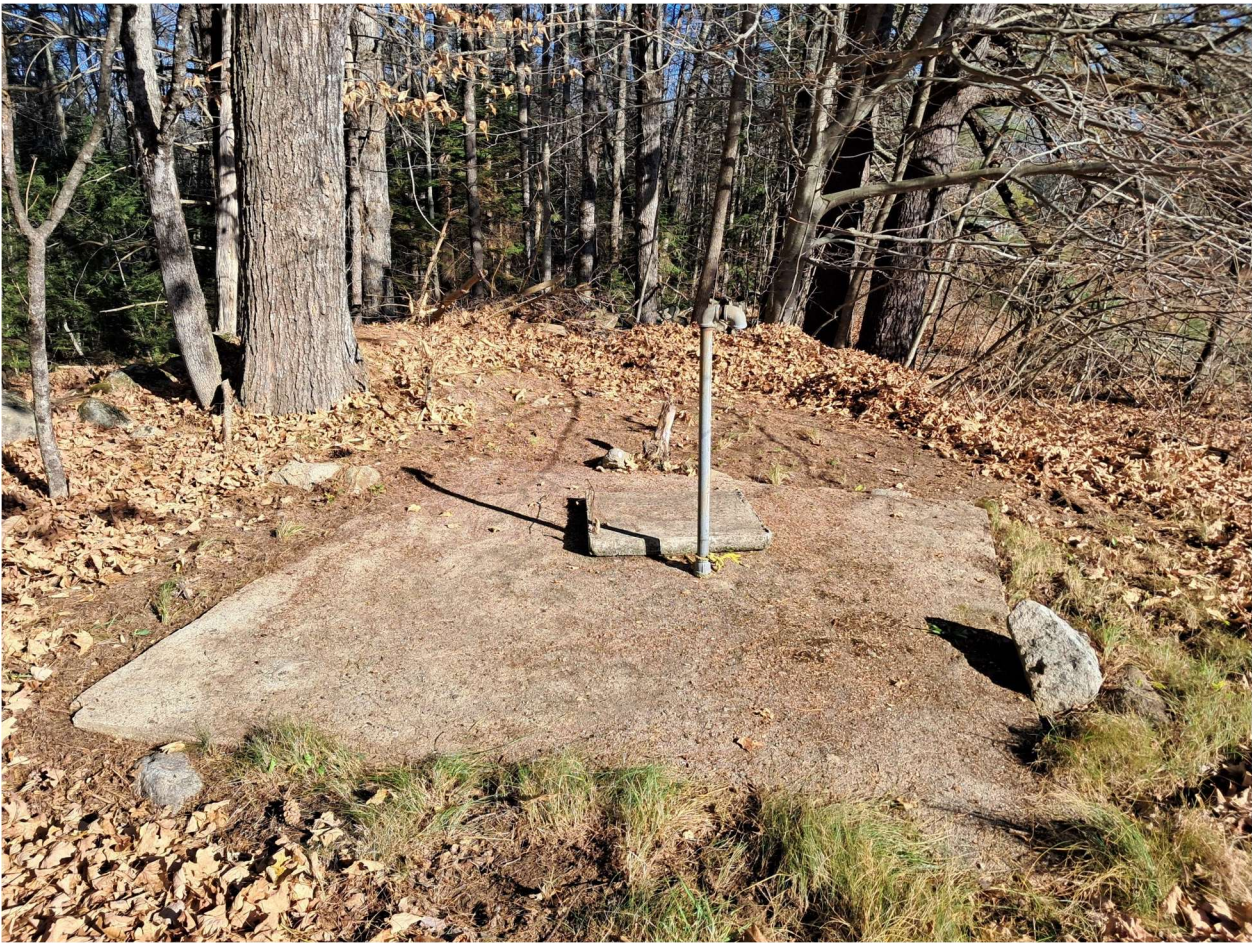
- c. 2nd photo is the well cap. Pictures taken when raking leaves away. Out of sight to the left is the old windmill. This well used to supply the old school.

Annual rake leaves away from well

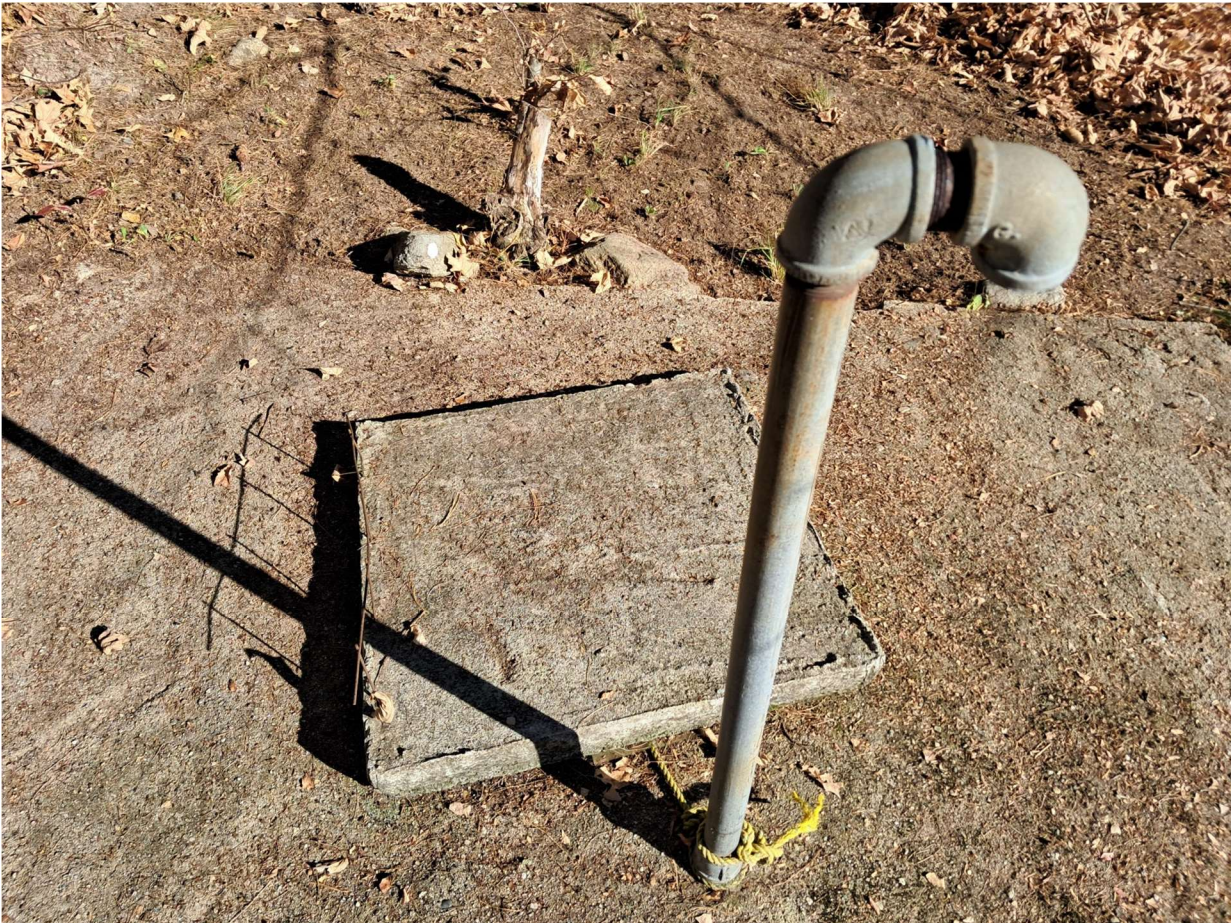
- d. 3rd photo a closeup of the well cover. Made a cement cover to replace the wood one that was rotted. Submersible pump suspended by the rope tied to the pipe that serves no other function. No seal between the cement cover and pad but no large open gap either.

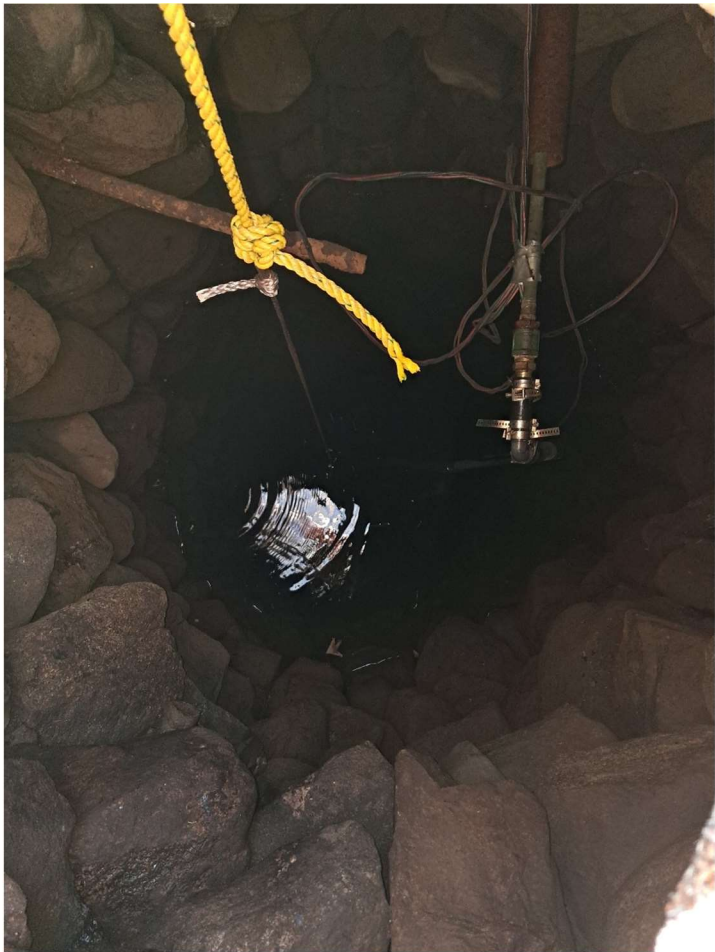
- f. 5th photo is the stone-lined inside of the well.
- g. 6th photo is the grass not grazed by the horse due to them being well fed enough not to eat grass contaminated with manure runoff. Runoff pattern from the side.

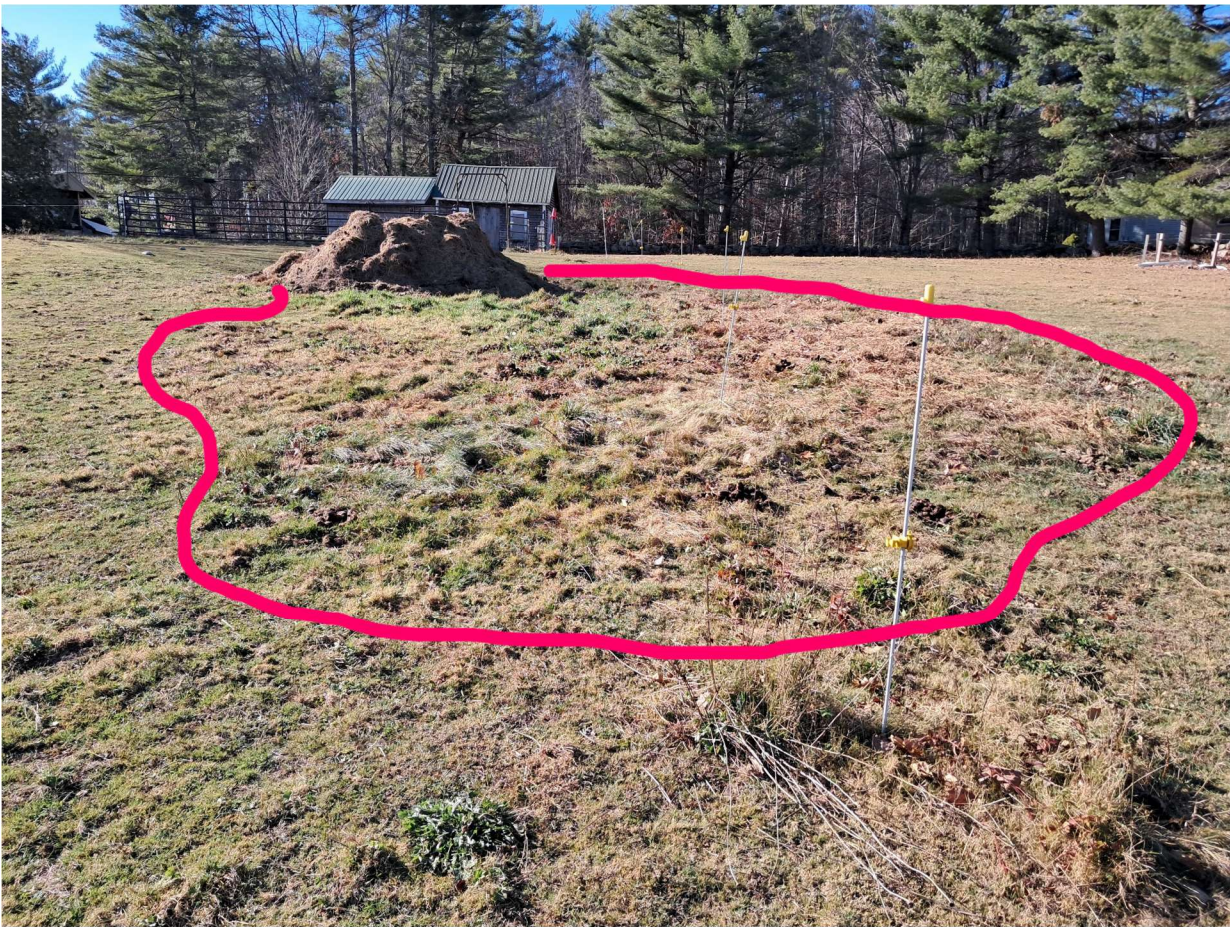
- h. 7th Photo shows the runoff pattern from below. About 33-36 feet between the bottom edge of runoff and the manure pile. Manure pile hauled off every spring.
