C-02-1

Meduncook River / Back River Friendship / Cushing, ME

C-02-1 Meduncook River / Back River

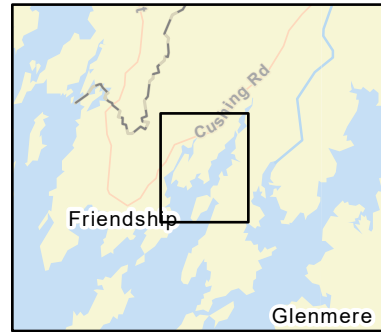
Strategy Purpose	To exclude oil from Back and Meduncook Rivers
Staging Areas	Wadsworth Point boat ramp, Wadsworth Point Road, Friendship
Site Access	Wadsworth Point Road, Friendship
Nearest Boat Ramp	Wadsworth Point boat ramp, Wadsworth Point Road, Friendship
Collection Points	Primary exclusion. If necessary, collect from north side of bridge on Route 97.
Special Instructions	
Work Assignment	Deploy 550' and 450' lengths of boom from both sides at entrance to Meduncook River in chevron formation. Deploy 500 feet of boom at entrance to Back River. Deploy 250 of boom at the salt marsh located east of Route 97'.

Length of Boom (feet)	1750	Type of Boom	12" to 18" containment boom
Recommended Equipment (Minimum)	1 - anchor systems: 35 lb. Danforth or equivalent and line for 3:1 scope plus tag line with buoy 6 - shoreside connections 2 - workboats with minimum 90 hp 2 - boat operators 4- laborers 1 - skimmer and storage if needed

Unless otherwise indicated, the boom length given is the distance measured on the chart. Actual length required may vary with conditions.
