# Interim 2021 Memo Report: Seafloor Mapping and Field Sampling in Casco Bay, Maine

Maine Coastal Mapping Initiative, September 2021

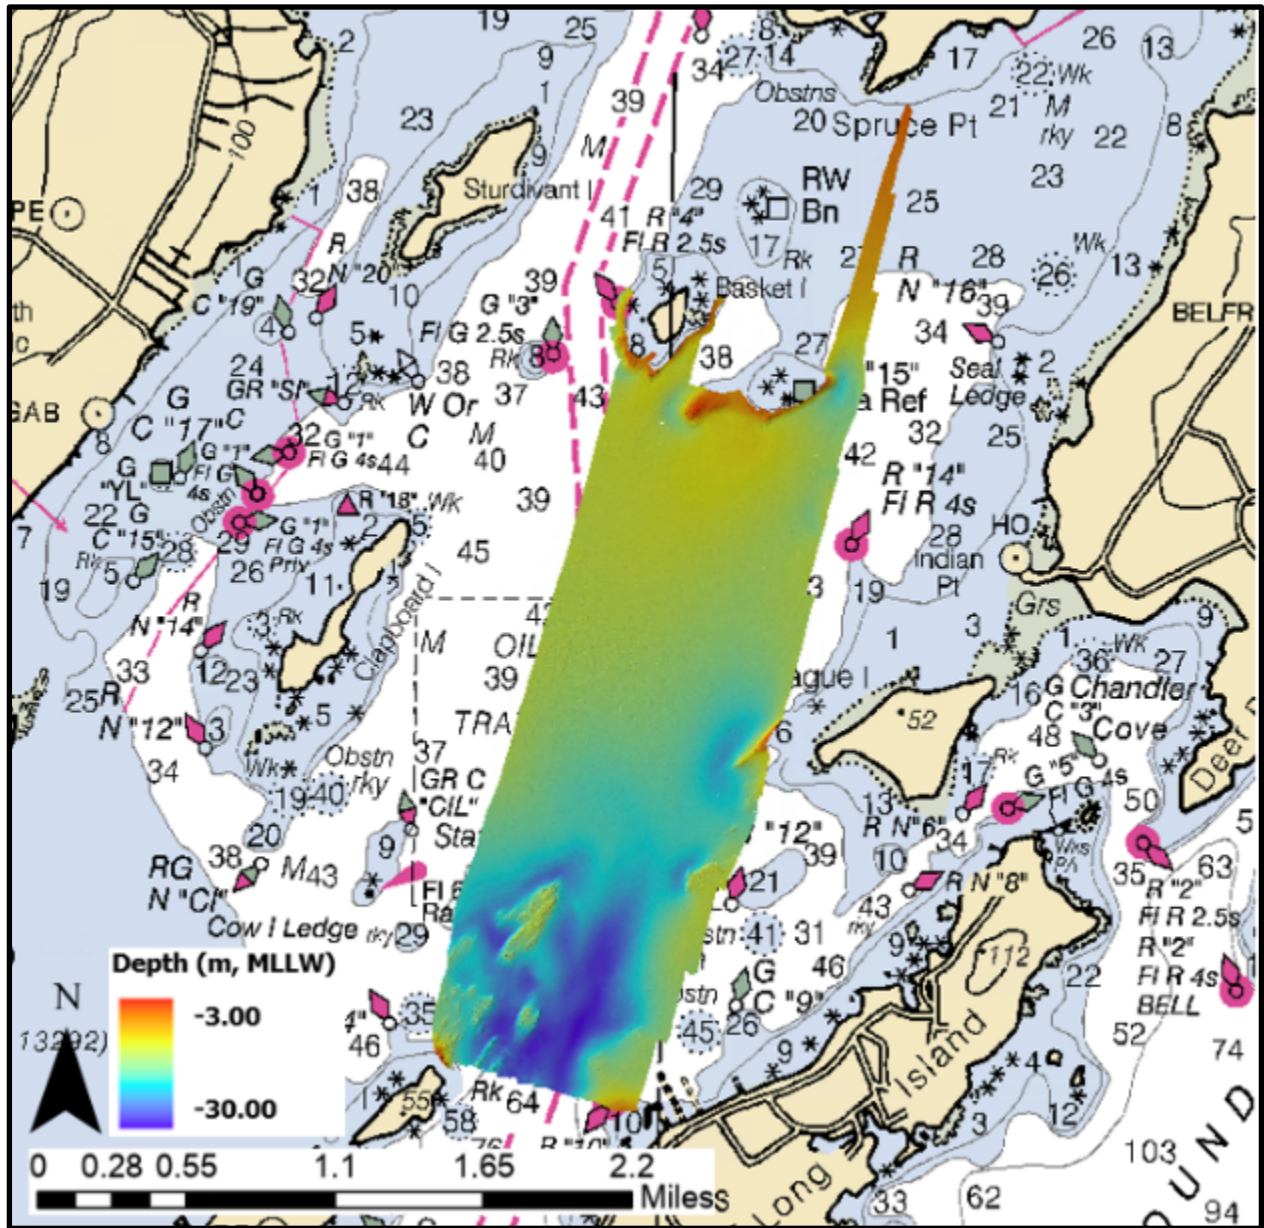
Figure 2 – Shaded relief image of 2021 inshore bathymetry data off Long Island gridded at 50-centimeter resolution and colored by depth. More MBES coverage in this area adjoining the northern, western, and southern extents is planned for the remainder of the 2021 season and the 2022 season.

Depths in the area off Long Island ranged from 3 to 30 meters (roughly 10 to 98 feet; referenced to mean lower-low water). The morphology of the seafloor in this area is characterized mainly by a muddy flat bottom which slopes gently upward toward hard-bottom outcroppings of adjacent islands. In the southwestern quarter of the dataset, there is as assumed flat sandy deposit interspersed with small hard-bottom ledges, but this region has not yet been ground-truthed for confirmation of backscatter returns.

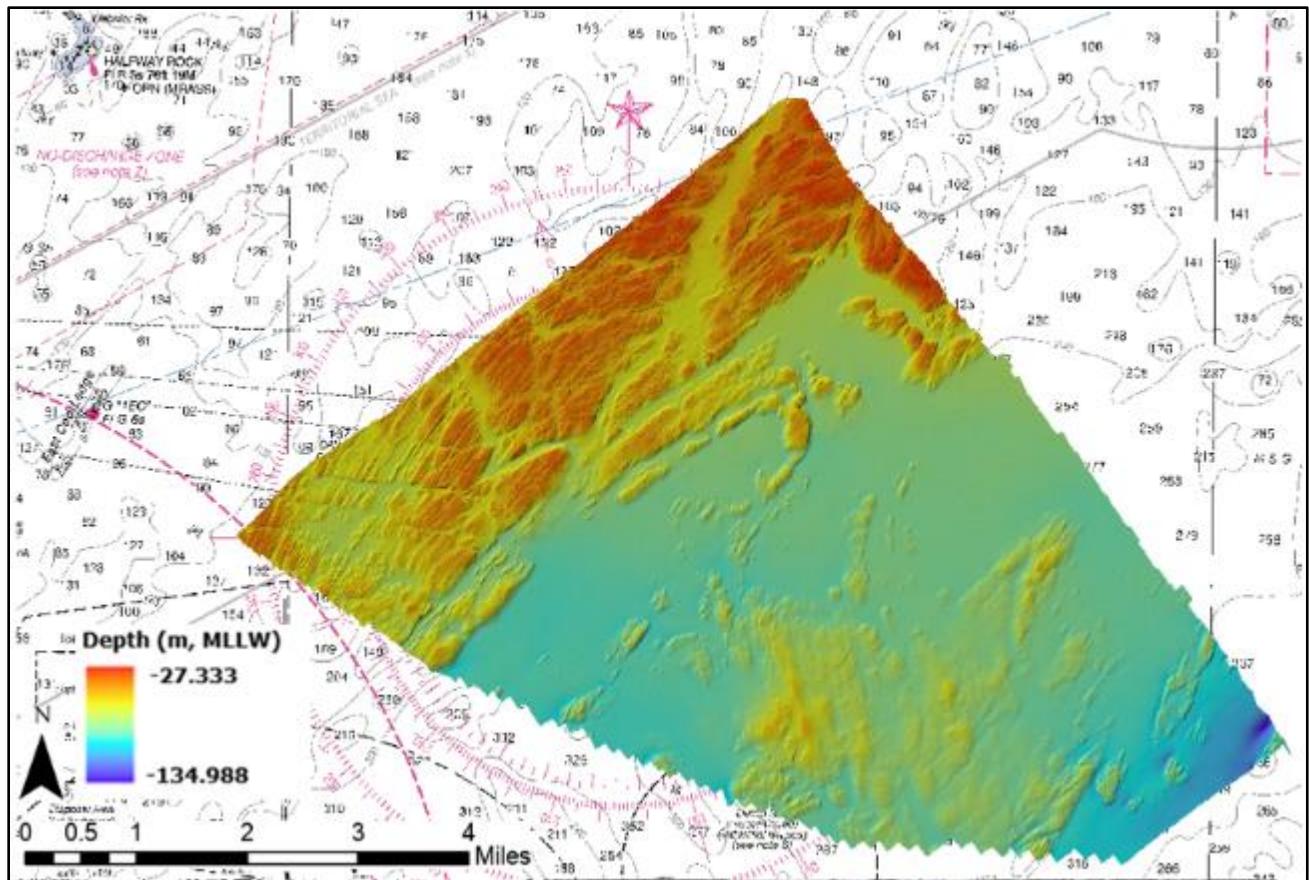
Figure 3 – Shaded relief image of 2021 mainscheme bathymetry data off Halfway Rock gridded at 4-meter resolution and colored by depth. More MBES coverage in this area adjoining the northwestern extent is planned for the remainder of the 2021 season and the 2022 season.

Depths in the area off Halfway Rock ranged from 27 to 135 meters (approximately 85 to 443 feet; referenced to mean lower-low water). The morphology of the seafloor in this area is characterized by a mix of feature types. In the southeastern two-thirds of the dataset the region is characterized by muddy flats which are intermixed with gently sloping hard-bottom ledges, generally oriented in a northeast to southwest configuration. To the northwest of this region, the dataset is characterized predominantly by more dramatically rising hard-bottom, bedrock ledges, in some places covered by surficial gravel, which are split by semi-connected ravines composed of muddy gravel, trending generally in the same configuration of northeast to southwest.

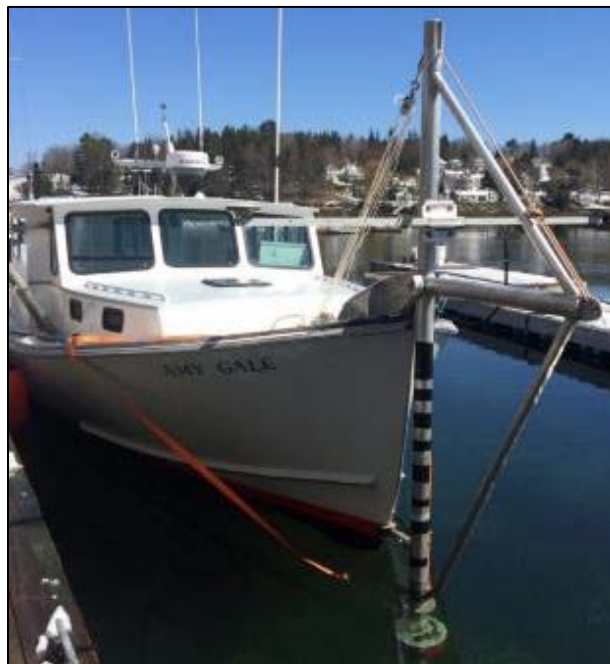
Figure 4 – R/V Amy Gale shown with pole-mounted dual GPS antennas, Kongsberg EM2040C multibeam sonar, MRU (not visible), and surface sound speed probe (not visible) in acquisition mode

All data were collected aboard the Research Vessel (R/V) Amy Gale (length = 10.7 m, width = 3.81 m, draft = 0.93 m) (Figure 4), a former lobster boat converted to a survey vessel and contracted to the MCMI. The vessel was captained by Caleb Hodgdon of Hodgdon Vessel Services based out of Boothbay Harbor, Maine. The EM2040C transducer, motion reference unit (MRU), AML MicroX surface sound speed probe, and dual GNSS antennas were pole-mounted to the bow; pole raised (for transit) and lowered (for survey) via a pivot point at the edge of the bow. The main cabin of the vessel served as the data collection center and was outfitted with four display monitors for real time visualization of data during acquisition.

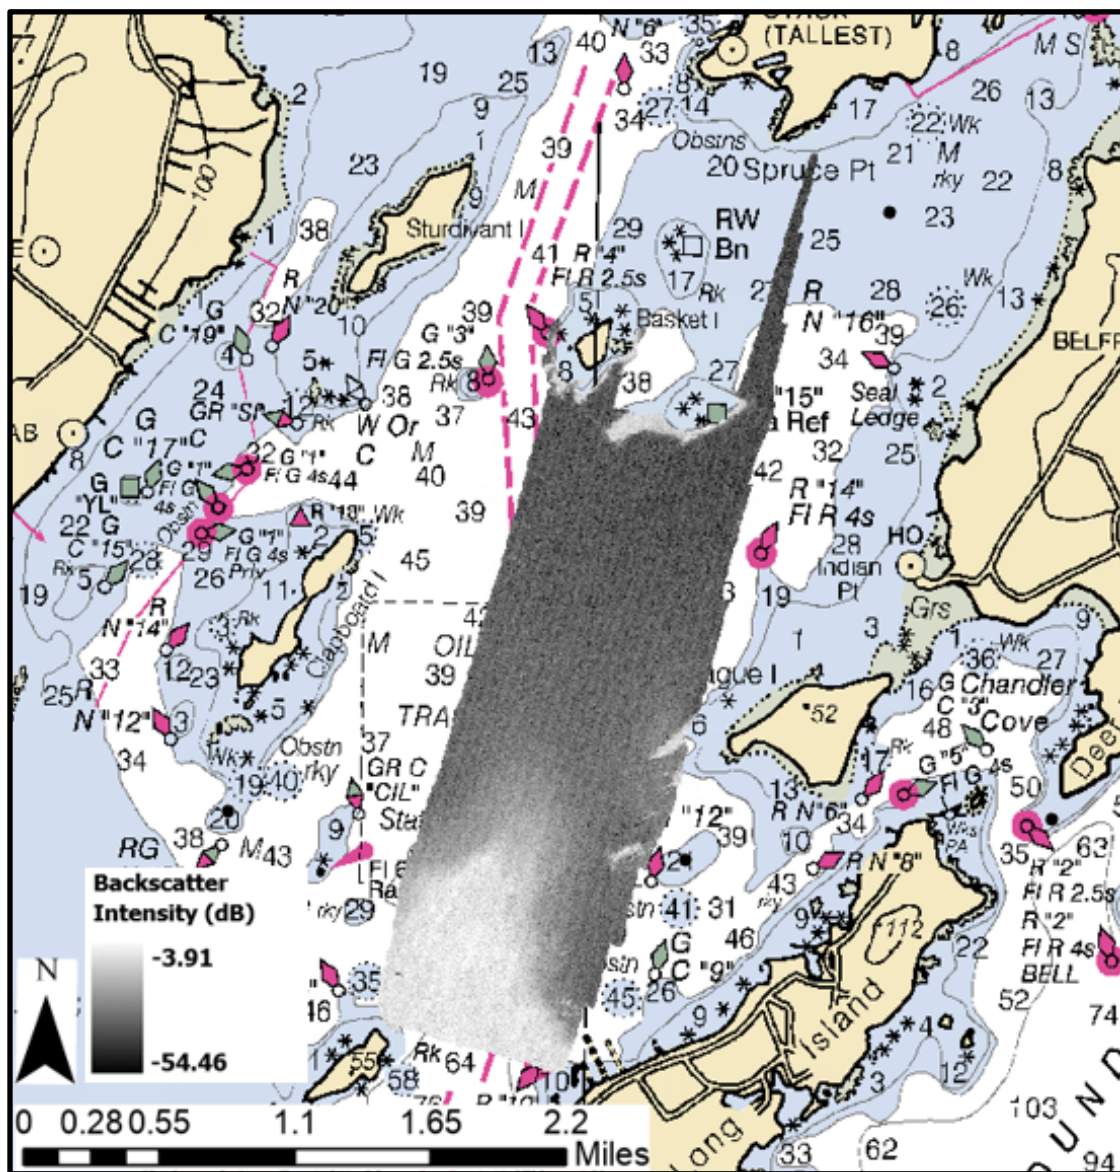
Figure 5 – Backscatter mosaic (50-centimeter pixel size) of 2021 survey off Long Island, in the vicinity of Casco Bay.

Backscatter was logged in the raw .db files. The .db files also hold the navigation record and bottom detections for all lines of surveys. Processed sonar files containing multibeam backscatter data (snippets and beam-average) were exported from Qimera v.2.4.0 in .GSF format. QPS Fledermaus Geocoder Toolbox (FMGT; v.7.9.4, 64-bit edition) was used to import, process, and mosaic time-series backscatter data. Default backscatter processing settings were used to create the mosaic, except for the Angle Varied Gain (AVG) filter and AVG window size, which were set to ‘Adaptive’ and ‘100’, respectively. Backscatter mosaics of the data were gridded at 2-meter and 4-meter resolution for the Halfway Rock dataset and at 25-centimeter and 50-centimeter resolution for the Long Island dataset. Mosaics were exported in greyscale and floating-point GeoTIFF format. The mosaics are shown in Table 6 and Figures 5 and 6.

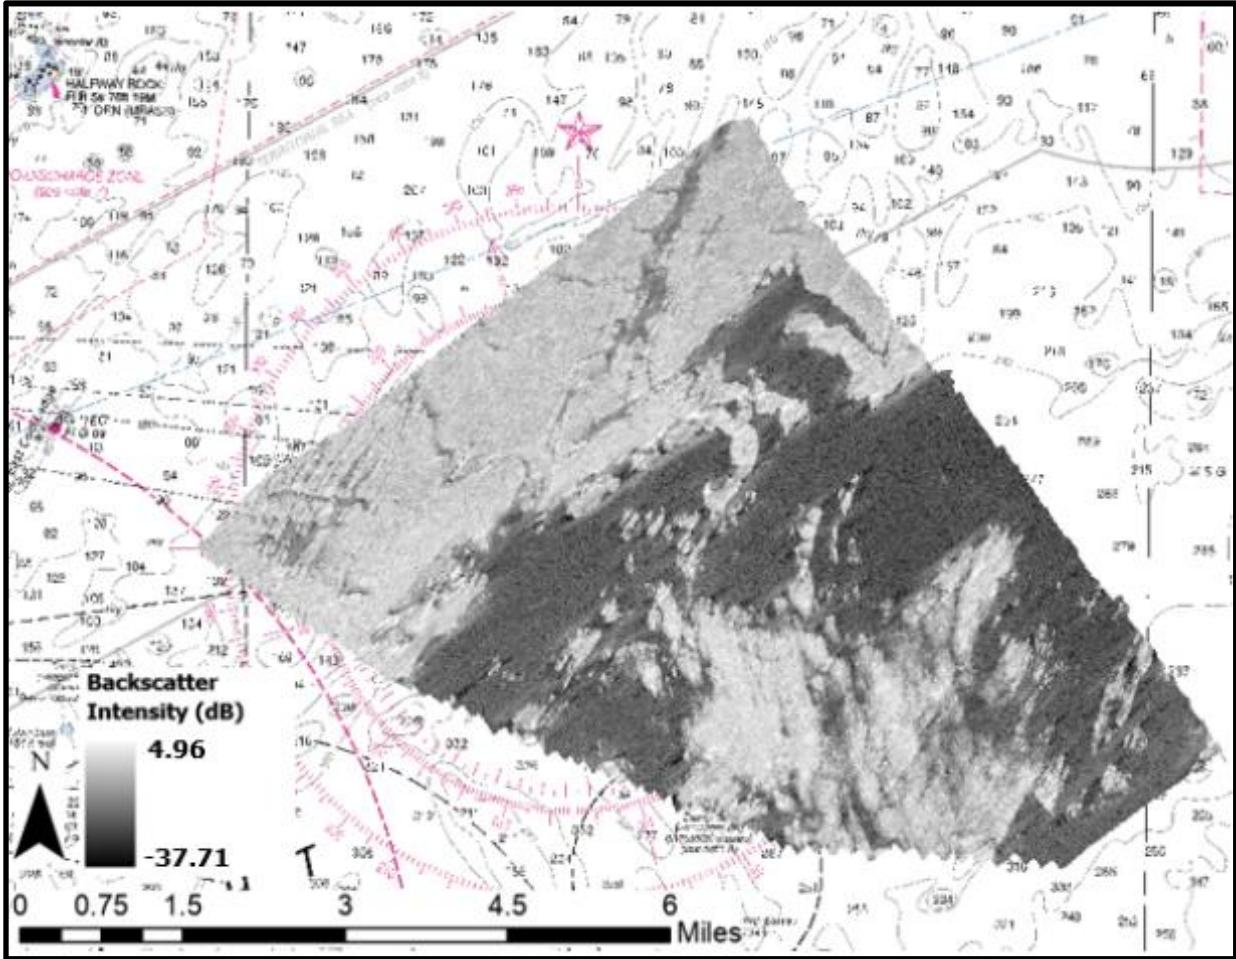
Figure 6 – Backscatter mosaic (4-meter pixel size) of 2021 survey off Halfway Rock, in the vicinity of Casco Bay.

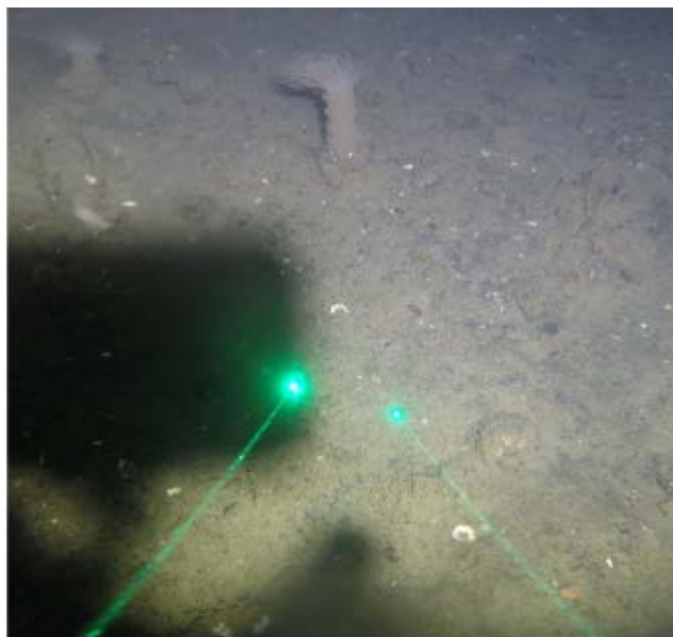
Sample ID:	CBO60-2
Date/Time (EST):	07/14/21 08:33
Depth (real-time, m):	80.0
Easting (WGS84 UTM Zone 19N, m):	429751.5
Northing (WGS84 UTM Zone 19N, m):	4823172

Laser spacing = 10 cm

**Substrate Type: muddy gravel**

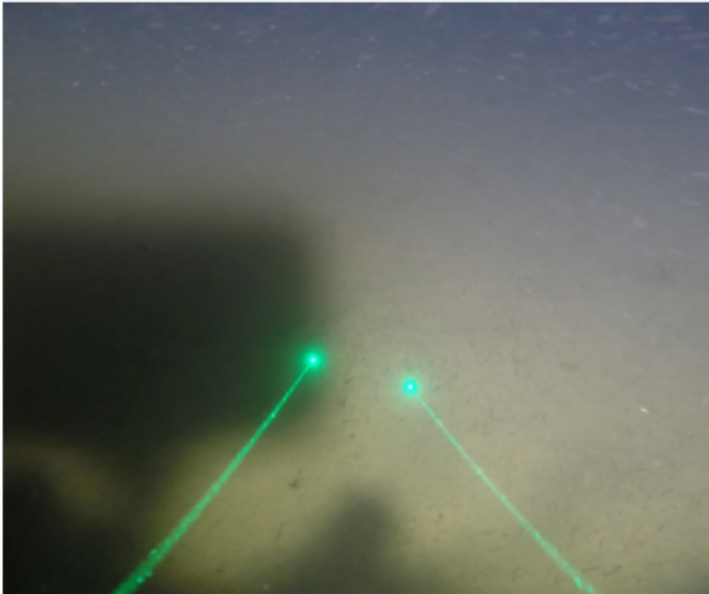
Sample ID:	CBO60-4
Date/Time (EST):	07/14/21 09:44
Depth (real-time, m):	66.2
Easting (WGS84 UTM Zone 19N, m):	428937.8
Northing (WGS84 UTM Zone 19N, m):	4824813

Laser spacing = 10 cm

**Substrate Type:** mud with shell hash

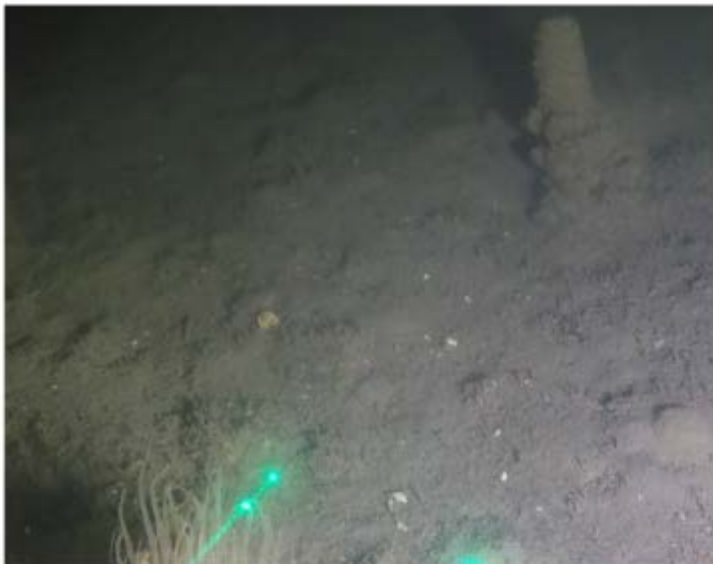
Sample ID:	CBO60-9
Date/Time (EST):	07/27/21 09:24
Depth (real-time, m):	105.0
Easting (WGS84 UTM Zone 19N, m):	421984.1
Northing (WGS84 UTM Zone 19N, m):	4821667

Laser spacing = 10 cm

**Substrate Type:** sandy gravel with mud assumed atop rock due to low yield

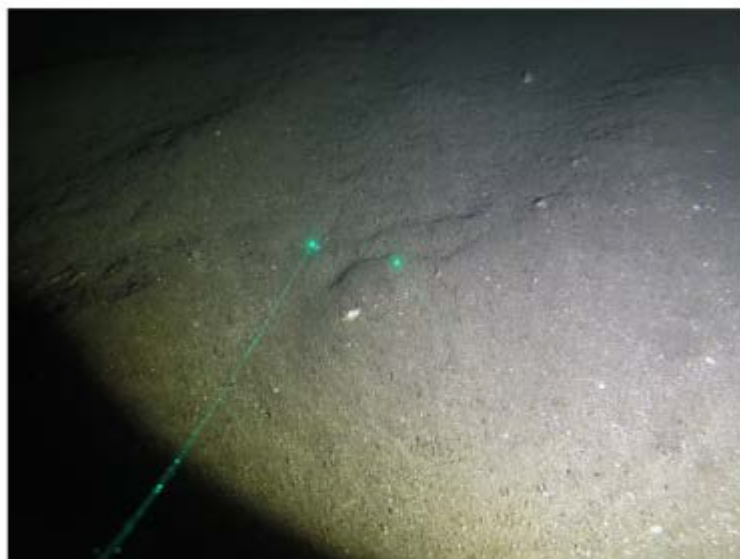
Laser spacing = 10 cm

**Substrate Type:** sand with shell hash and trace gravel

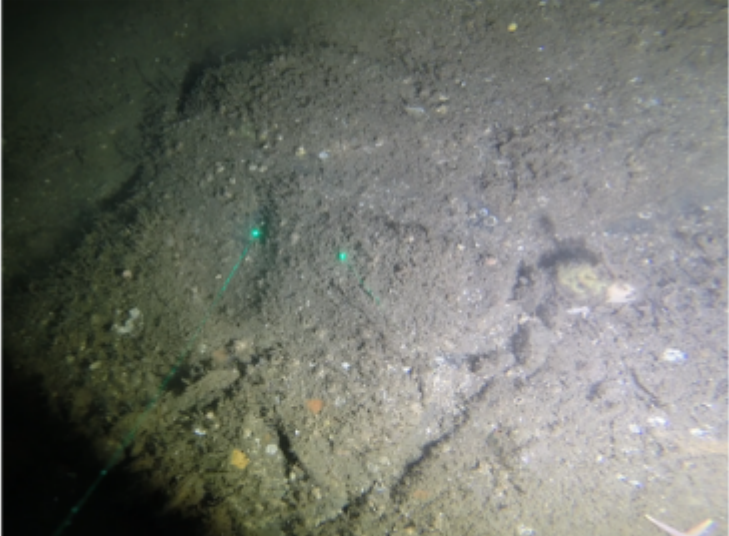
Sample ID:	CBO-18
Date/Time (EST):	08/10/21 07:34
Depth (real-time, m):	45.4
Easting (WGS84 UTM Zone 19N, m):	428264.5
Northing (WGS84 UTM Zone 19N, m):	4831279

<p data-bbox="814 987 982 1013">Laser spacing = 10 cm</p> <p data-bbox="453 1062 785 1101"><b>Substrate Type: rock</b></p>	<p data-bbox="1293 620 1562 704" style="text-align: center;"><b>NO SAMPLE RECOVERED</b></p>

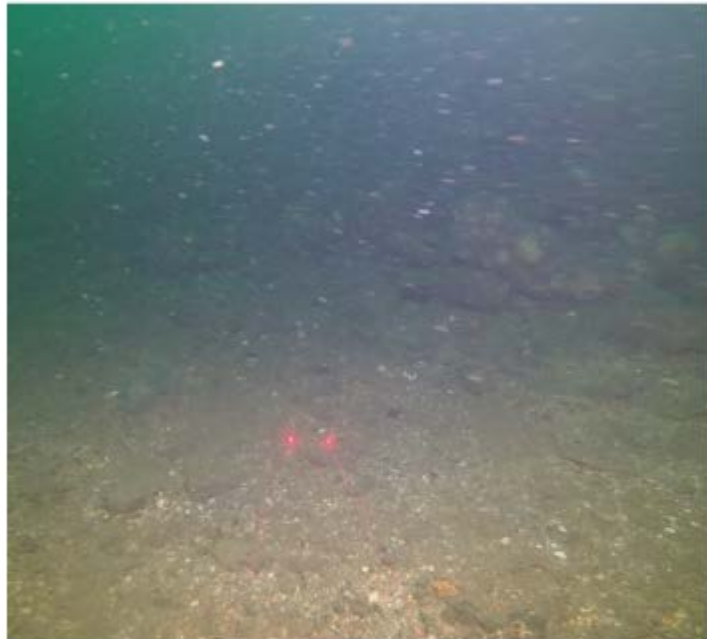
Sample ID:	CBO-31
Date/Time (EST):	09/14/21 10:33
Depth (real-time, m):	43.7
Easting (WGS84 UTM Zone 19N, m):	418945.6
Northing (WGS84 UTM Zone 19N, m):	4829533

Laser spacing = 10 cm

**Substrate Type:** muddy gravel with shell hash

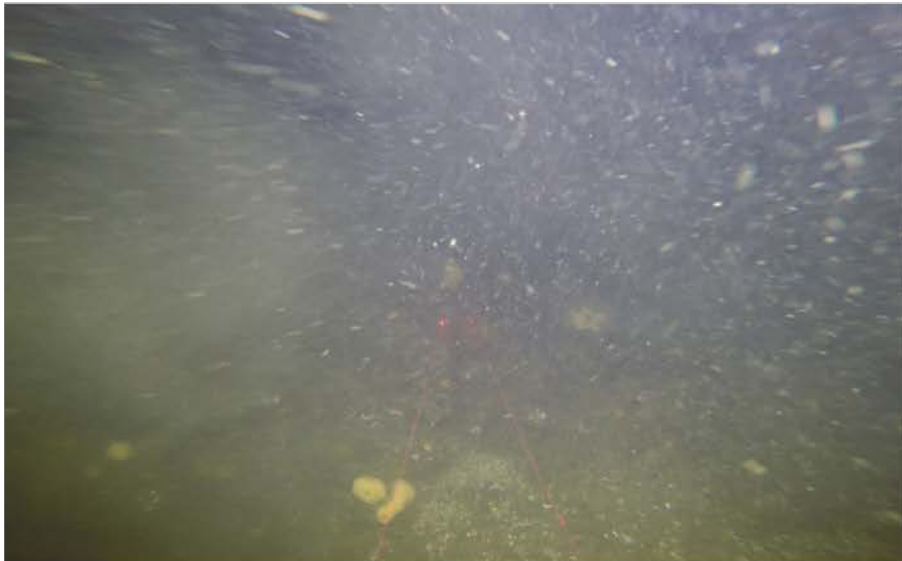
Sample ID:	CBO-39
Date/Time (EST):	09/21/21 12:18
Depth (real-time, m):	52.2
Easting (WGS84 UTM Zone 19N, m):	418544.4
Northing (WGS84 UTM Zone 19N, m):	4835270

<p data-bbox="877 1105 1079 1130">Laser spacing = 10 cm</p> <p data-bbox="464 1166 837 1206"><b>Substrate Type: rock</b></p>	<p data-bbox="1423 678 1730 776" style="text-align: center;"><b>NO SAMPLE RECOVERED</b></p>

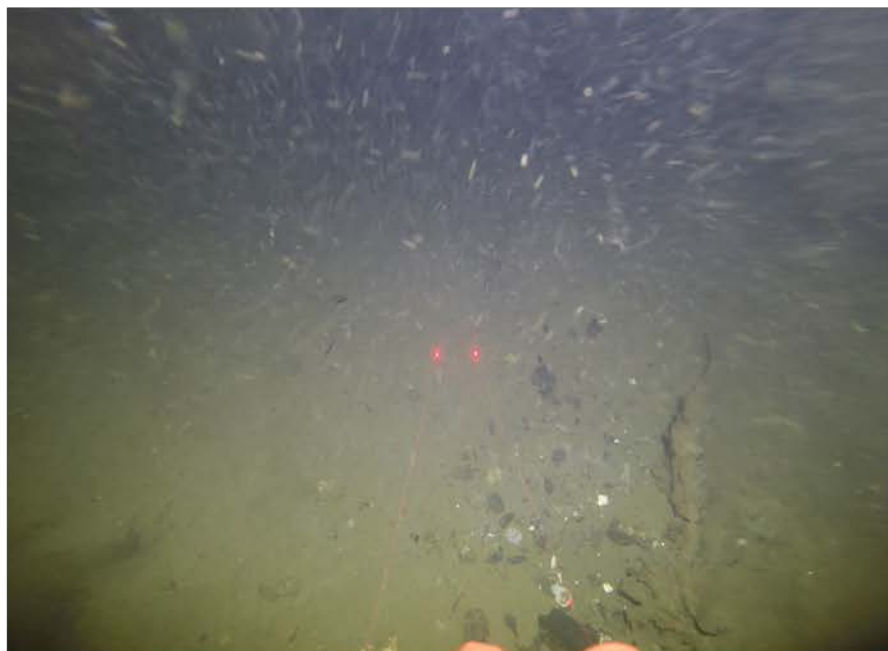
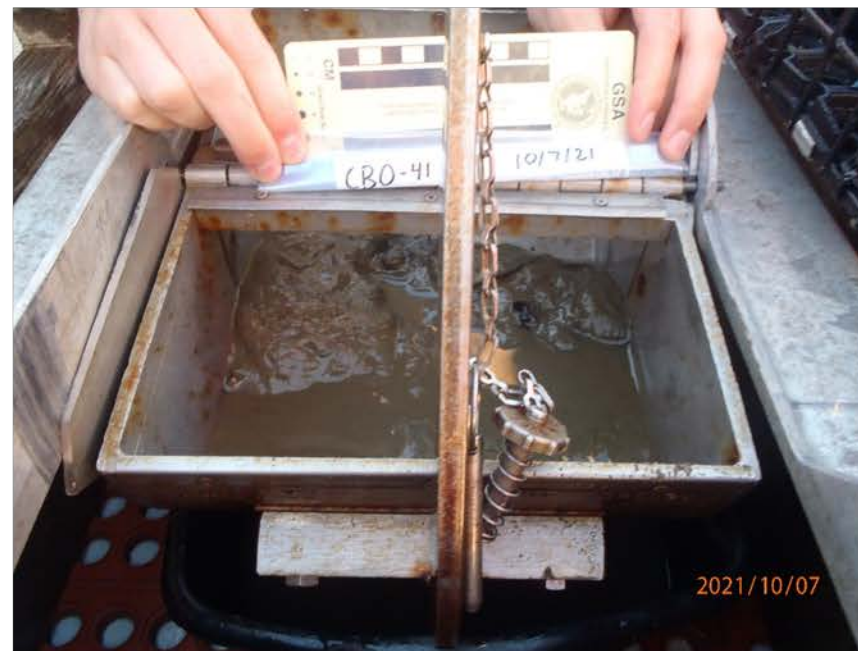
Sample ID:	CBO-40
Date/Time (EST):	10/07/21 07:03
Depth (real-time, m):	35.7
Easting (WGS84 UTM Zone 19N, m):	418587.0
Northing (WGS84 UTM Zone 19N, m):	4837371

Laser spacing = 10 cm

**Substrate Type: muddy gravel**

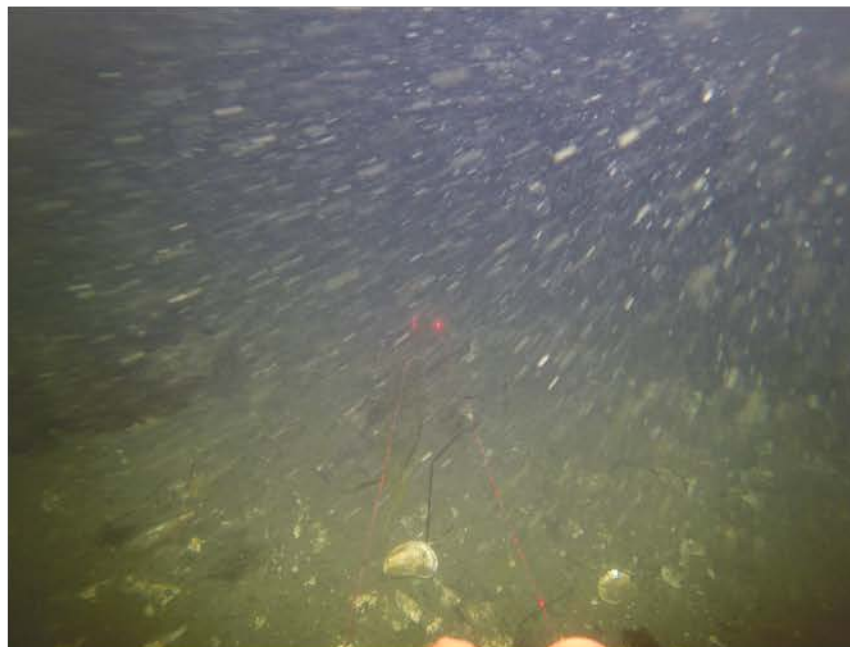
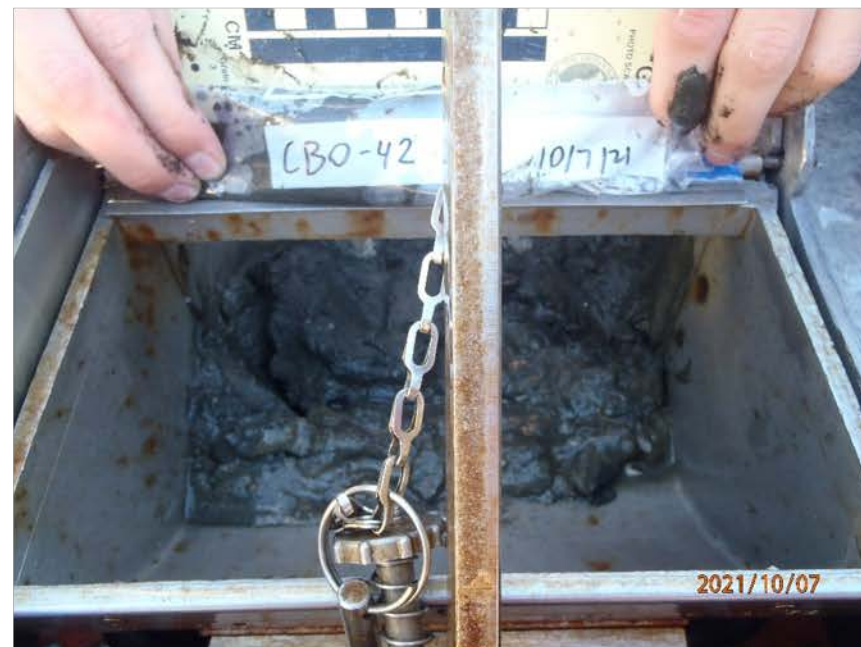
Sample ID:	CBO-41	
Date/Time (EST):	10/07/21 07:17	
Depth (real-time, m):	60.3	
Easting (WGS84 UTM Zone 19N, m):	415237.9	63
Northing (WGS84 UTM Zone 19N, m):	4837393

Laser spacing = 10 cm

**Substrate Type: muddy gravel**

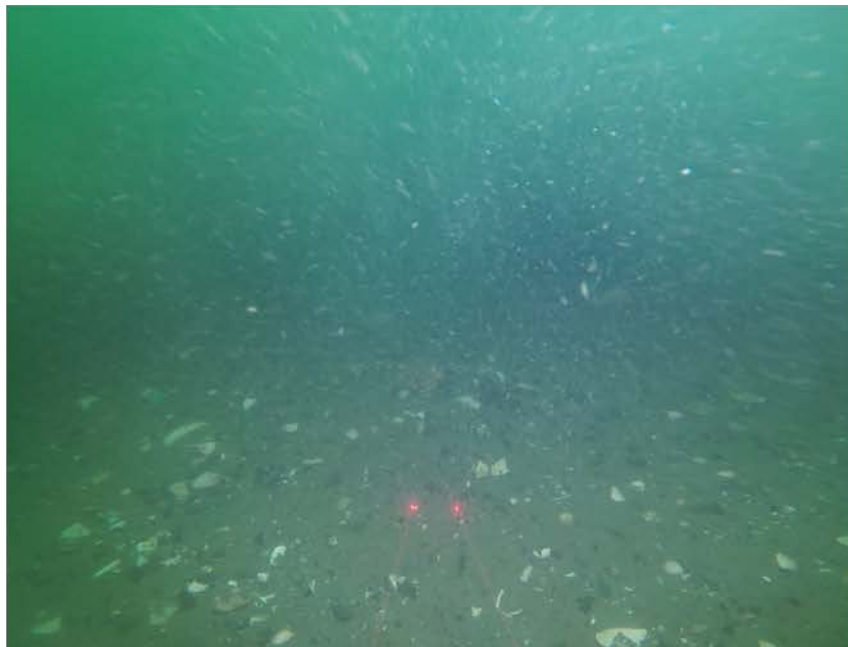
Sample ID:	CBO-42	
Date/Time (EST):	10/07/21 08:04	
Depth (real-time, m):	39.5	
Easting (WGS84 UTM Zone 19N, m):	413626.3	64
Northing (WGS84 UTM Zone 19N, m):	4839994

Laser spacing = 10 cm

**Substrate Type: gravelly sand**

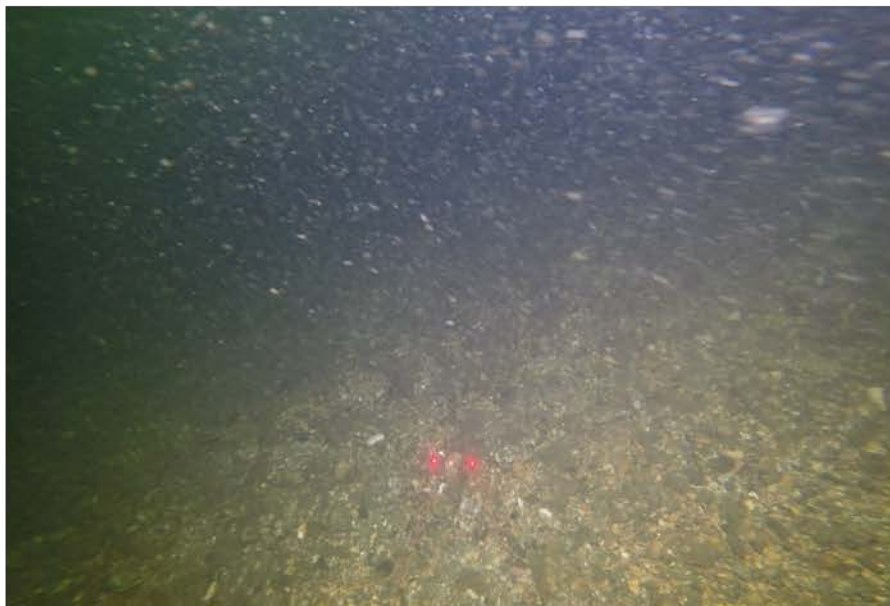
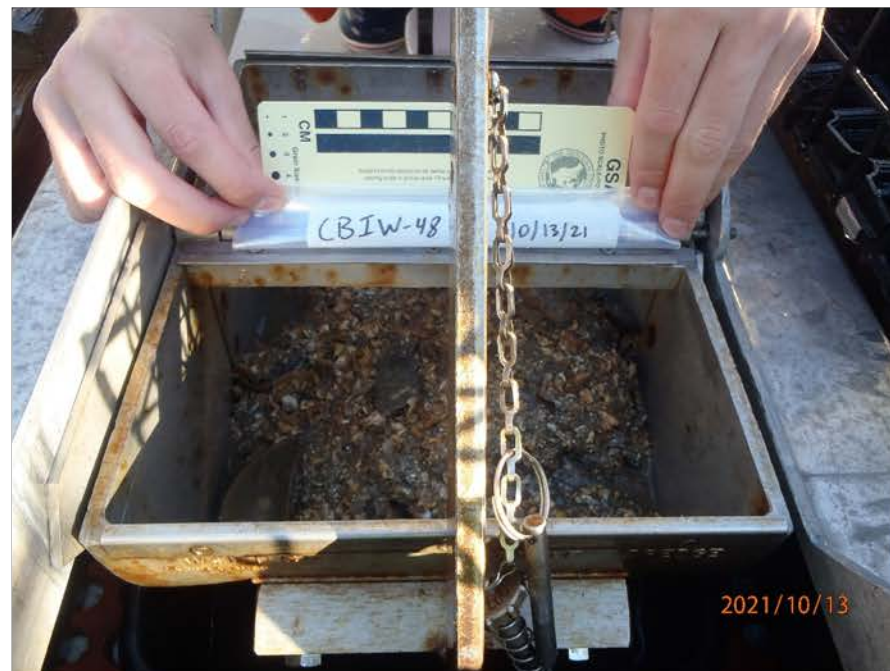
Sample ID:	CBIW-47	
Date/Time (EST):	10/13/21 09:49	
Depth (real-time, m):	25.7	
Easting (WGS84 UTM Zone 19N, m):	406184.8	68
Northing (WGS84 UTM Zone 19N, m):	4830910

Laser spacing = 10 cm

**Substrate Type:** muddy gravel (shell hash/pebble mix)

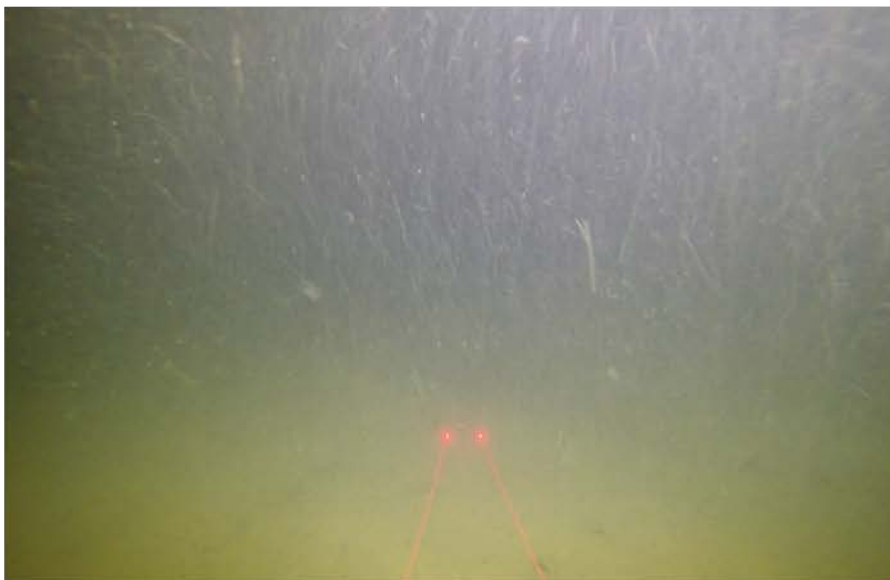
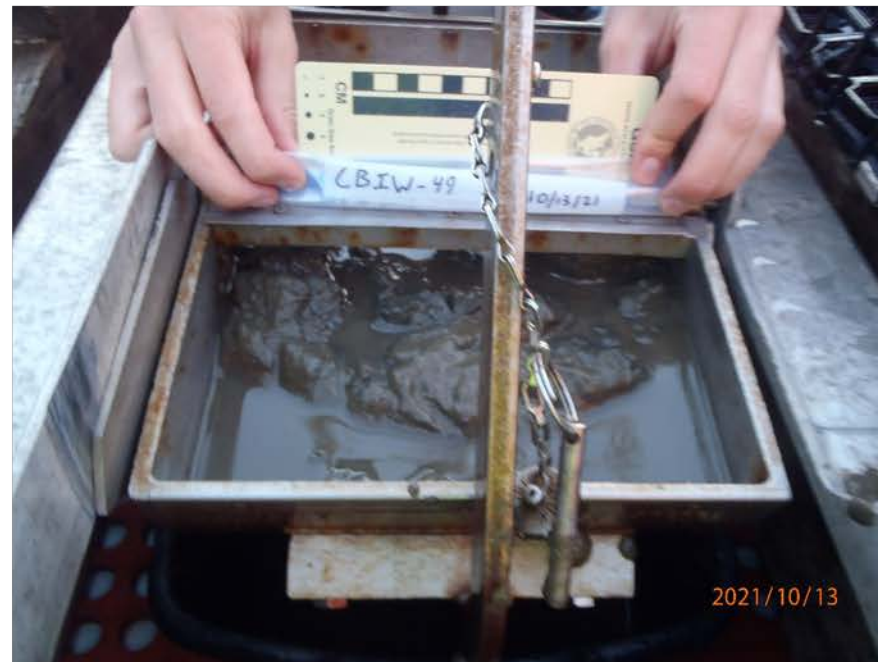
Sample ID:	CBIW-48	
Date/Time (EST):	10/13/21 08:19	
Depth (real-time, m):	19.8	
Easting (WGS84 UTM Zone 19N, m):	407768.4	69
Northing (WGS84 UTM Zone 19N, m):	4836015

Laser spacing = 10 cm

**Substrate Type:** clayey mud with trace sand

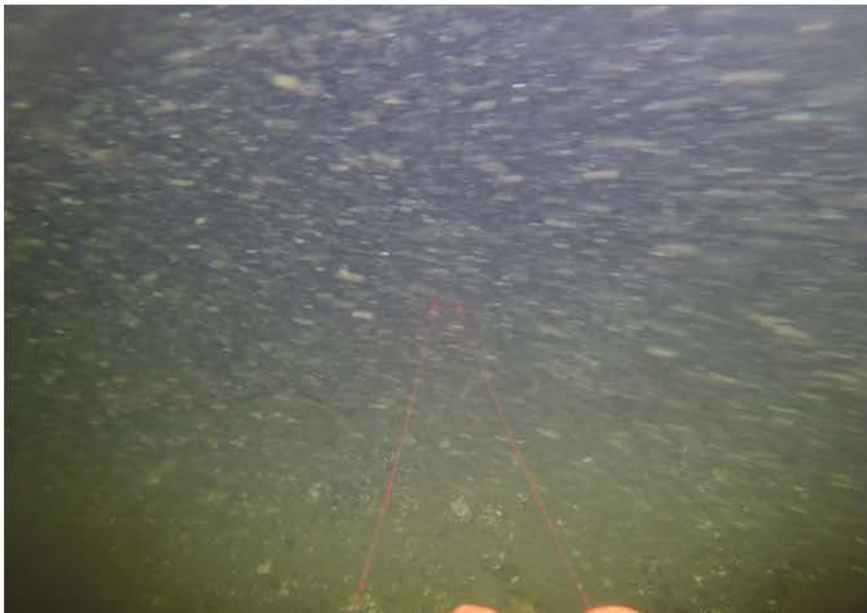
Sample ID:	CBIW-49
Date/Time (EST):	10/13/21 06:57
Depth (real-time, m):	30.8
Easting (WGS84 UTM Zone 19N, m):	408860.7 70
Northing (WGS84 UTM Zone 19N, m):	4836570

Laser spacing = 10 cm

**Substrate Type: gravel**

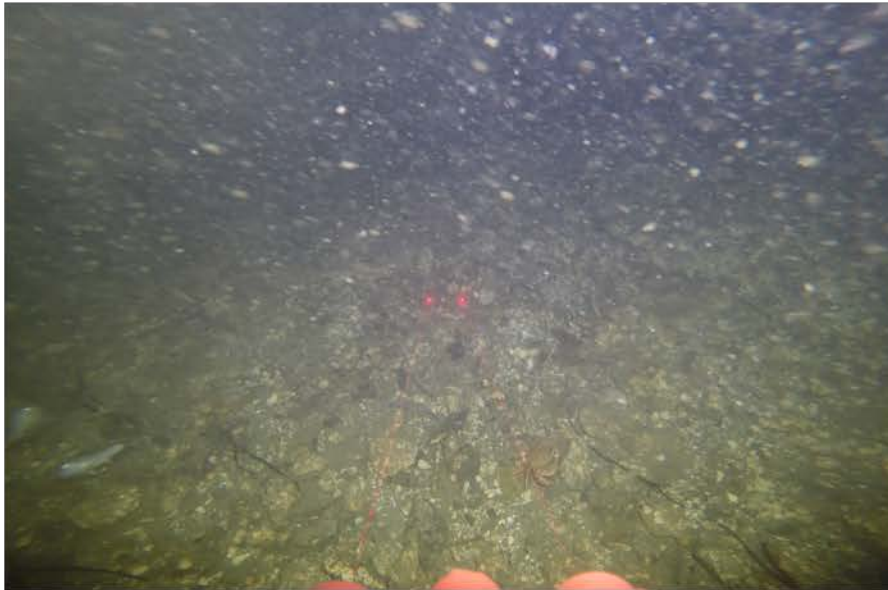
Sample ID:	CBIW-50
Date/Time (EST):	10/07/21 09:15
Depth (real-time, m):	27.7
Easting (WGS84 UTM Zone 19N, m):	415307.1
Northing (WGS84 UTM Zone 19N, m):	4841074

Laser spacing = 10 cm

**Substrate Type:** muddy gravel with shell hash,  
large cobbles present

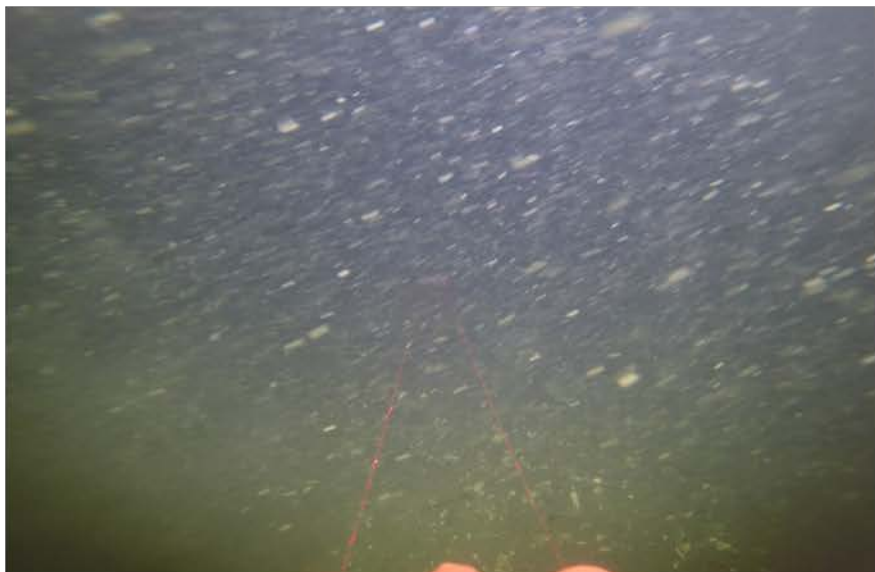
Sample ID:	CBIW-51	
Date/Time (EST):	10/07/21 10:34	
Depth (real-time, m):	29.9	
Easting (WGS84 UTM Zone 19N, m):	414976.4	72
Northing (WGS84 UTM Zone 19N, m):	4842441

Laser spacing = 10 cm

**Substrate Type:** medium/coarse grain sand with trace gravel

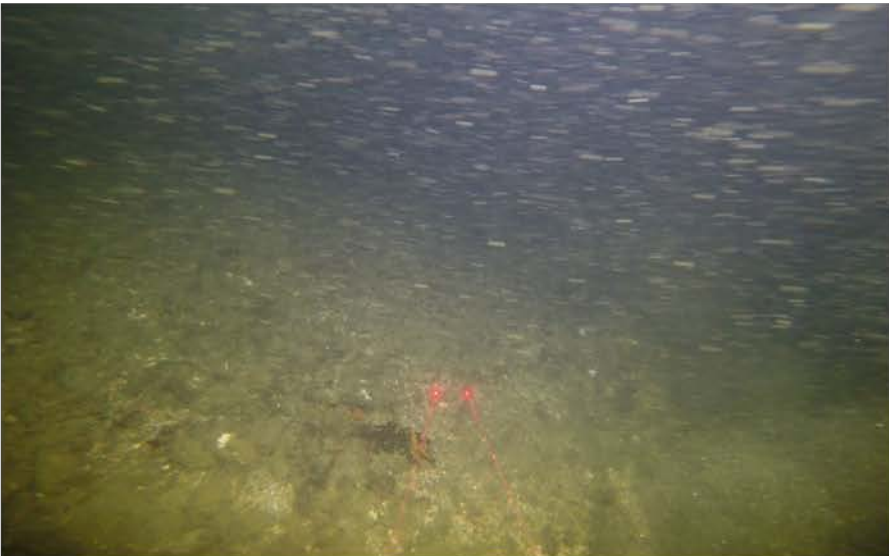
Sample ID:	CBIW-52	
Date/Time (EST):	10/07/21 12:11	
Depth (real-time, m):	29.0	
Easting (WGS84 UTM Zone 19N, m):	414068.9	73
Northing (WGS84 UTM Zone 19N, m):	4844495

<p data-bbox="879 1105 1079 1130">Laser spacing = 10 cm</p> <p data-bbox="464 1166 840 1206"><b>Substrate Type: rock</b></p>	<p data-bbox="1423 667 1732 764"><b>NO SAMPLE RECOVERED</b></p>

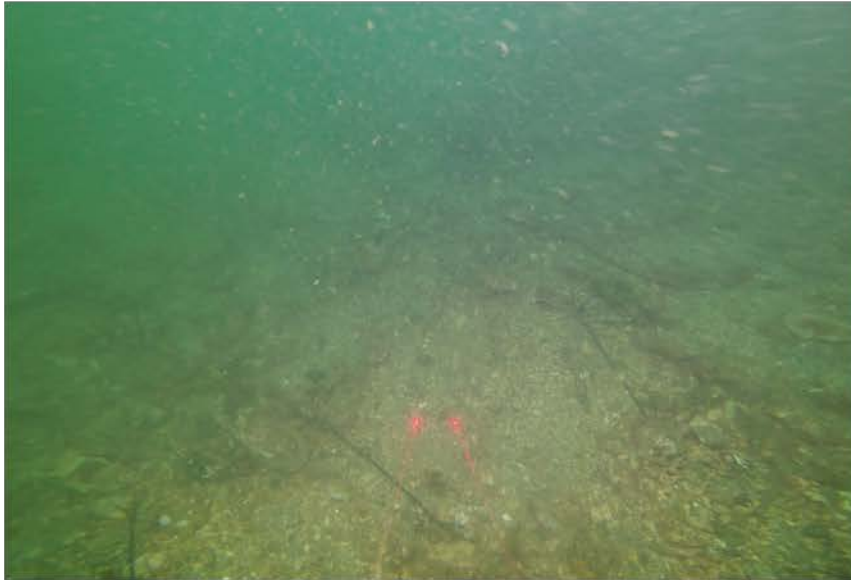
Sample ID:	CBIW-54
Date/Time (EST):	10/19/21 07:18
Depth (real-time, m):	22.6
Easting (WGS84 UTM Zone 19N, m):	410021.9 75
Northing (WGS84 UTM Zone 19N, m):	4839078

Laser spacing = 10 cm

**Substrate Type:** gravelly sand with shell hash

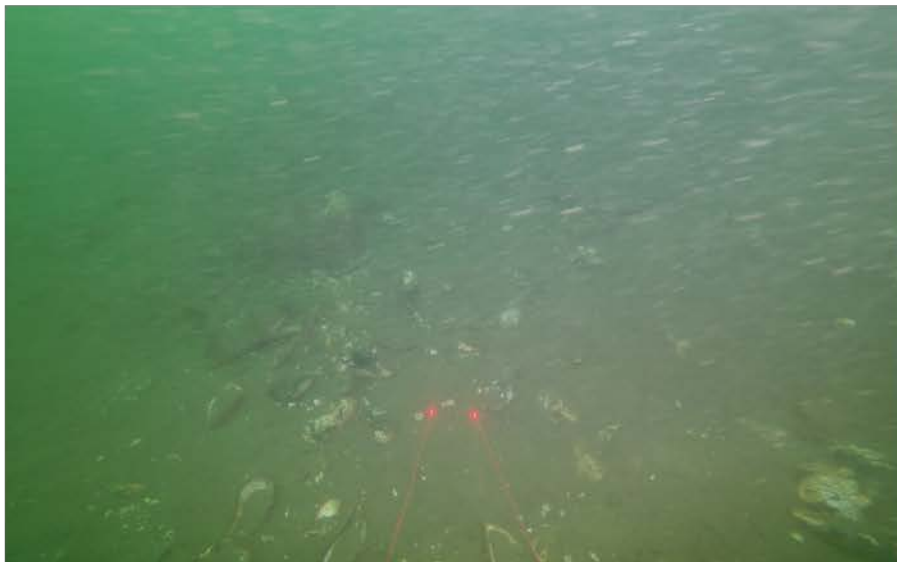
Sample ID:	CBIW-55	
Date/Time (EST):	10/19/21 08:19	
Depth (real-time, m):	10.3	
Easting (WGS84 UTM Zone 19N, m):	409034.8	76
Northing (WGS84 UTM Zone 19N, m):	4839944

Laser spacing = 10 cm

**Substrate Type: rock**

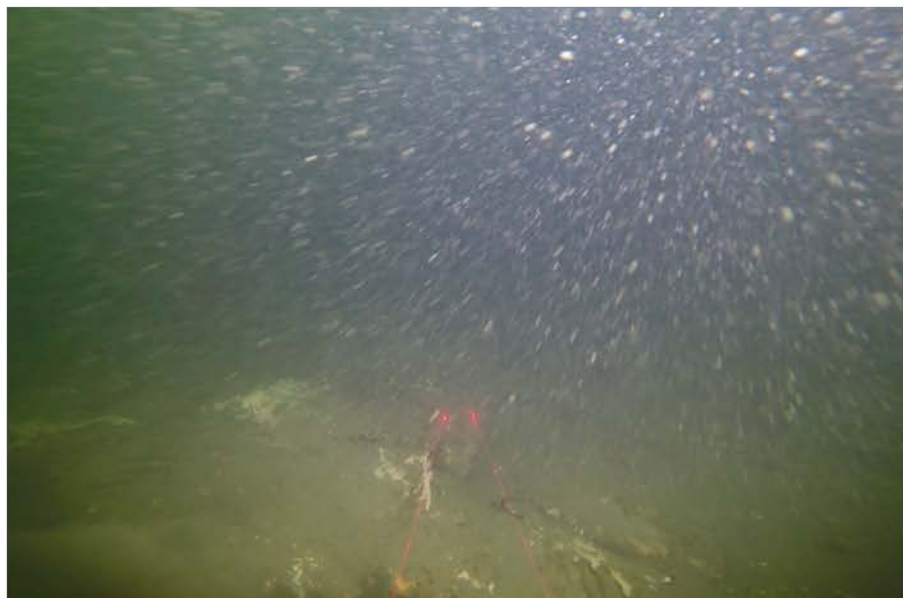
**Still Image from Video**

Laser spacing = 10 cm

**Substrate Type:** sandy mud with shell hash

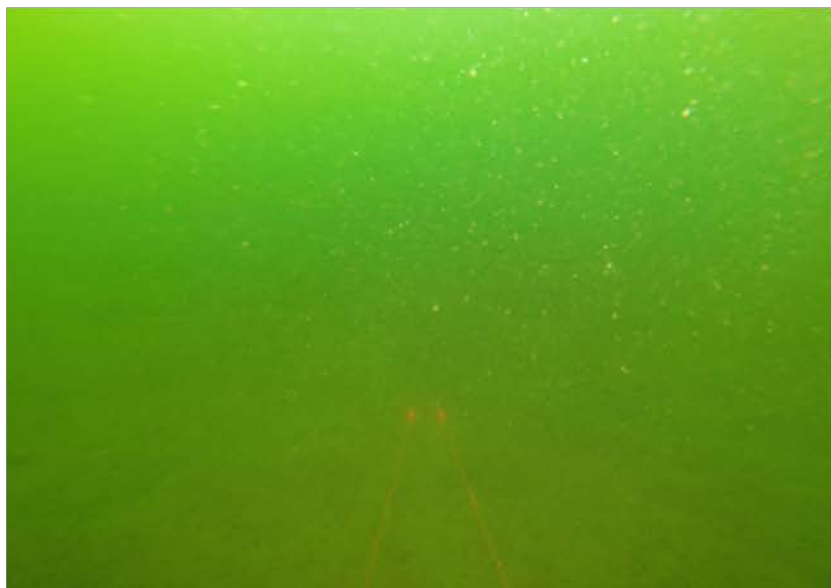
Sample ID:	CBIW-58	
Date/Time (EST):	10/19/21 10:00	
Depth (real-time, m):	19.1	
Easting (WGS84 UTM Zone 19N, m):	414011.4	78
Northing (WGS84 UTM Zone 19N, m):	4845542

Laser spacing = 10 cm

**Substrate Type:** silty mud with trace sand

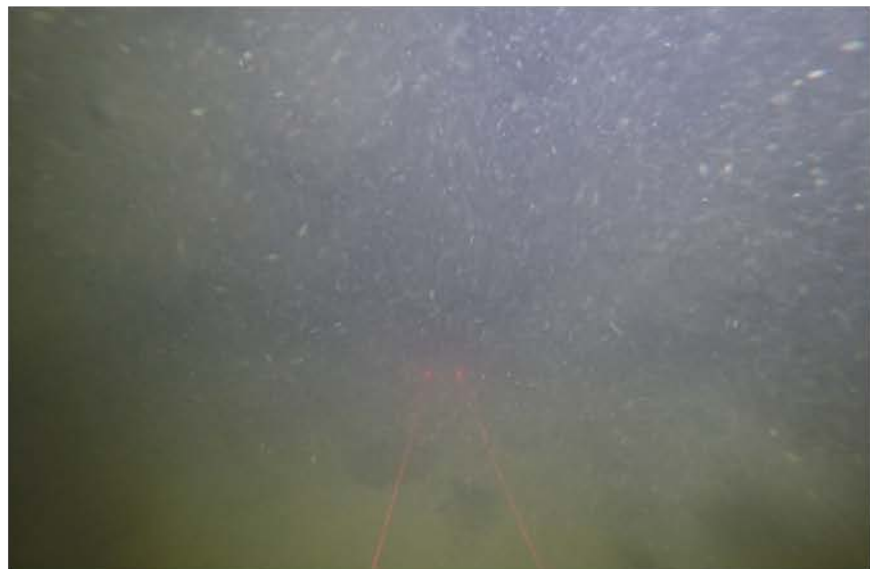
Sample ID:	CBIW-59	
Date/Time (EST):	10/19/21 10:51	
Depth (real-time, m):	8.8	
Easting (WGS84 UTM Zone 19N, m):	409729.3	79
Northing (WGS84 UTM Zone 19N, m):	4845341

Laser spacing = 10 cm

**Substrate Type:** silty clayey mud with trace sand

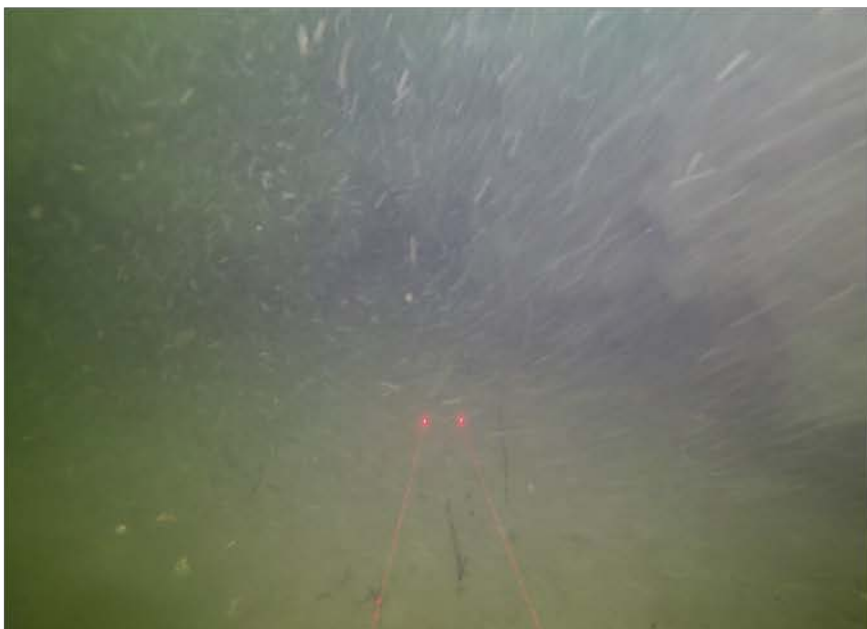
Sample ID:	CBIW-62	
Date/Time (EST):	11/03/21 07:32	
Depth (real-time, m):	15.3	
Easting (WGS84 UTM Zone 19N, m):	405348.9	82
Northing (WGS84 UTM Zone 19N, m):	4841069

Laser spacing = 10 cm

**Substrate Type:** muddy sand with gravel, large cobbles present

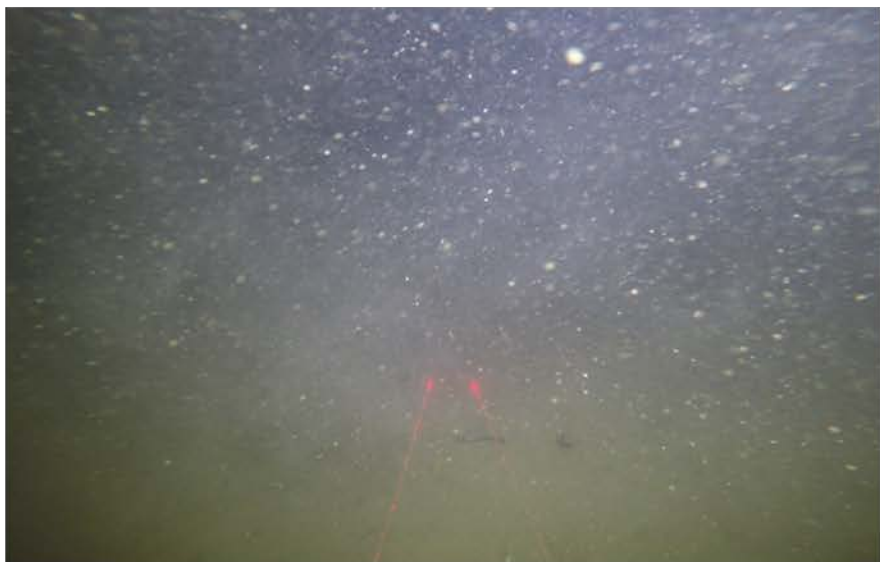
Sample ID:	CBIW-63	
Date/Time (EST):	11/03/21 11:07	
Depth (real-time, m):	12.7	
Easting (WGS84 UTM Zone 19N, m):	406643.5	83
Northing (WGS84 UTM Zone 19N, m):	4839674

Laser spacing = 10 cm

**Substrate Type:** muddy sand with gravel

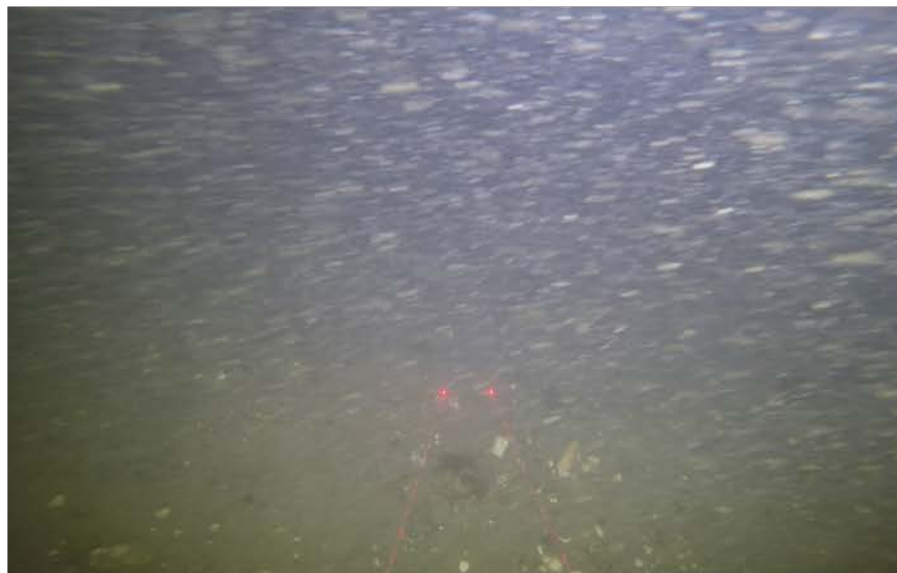
Sample ID:	CBIW-64	
Date/Time (EST):	11/03/21 12:06	
Depth (real-time, m):	29.0	
Easting (WGS84 UTM Zone 19N, m):	405604.4	84
Northing (WGS84 UTM Zone 19N, m):	4838816

Laser spacing = 10 cm

**Substrate Type:** muddy sand with gravel

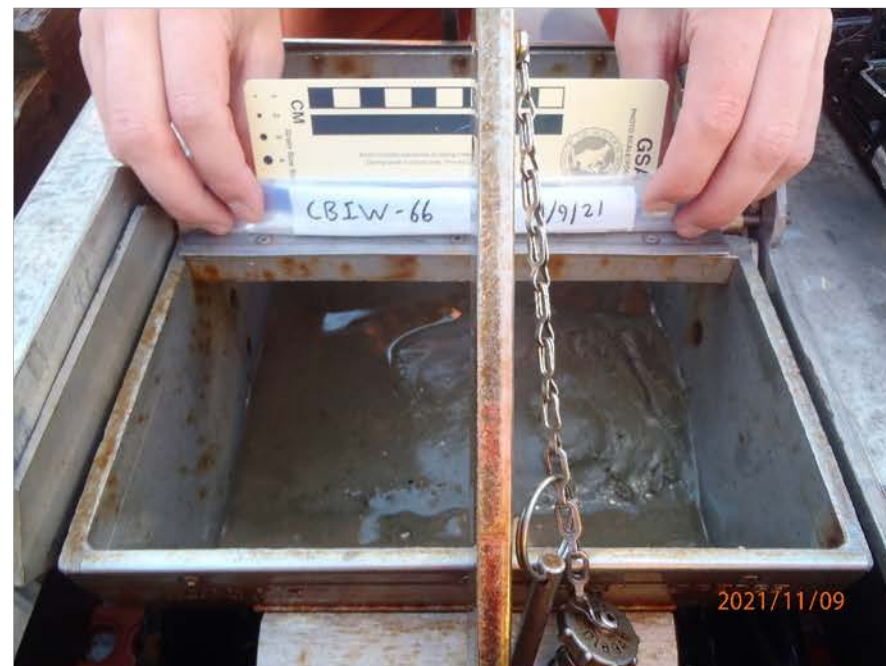
Field Picture

**Substrate Type: fine sand**
