# Interim 2021 Memo Report: Seafloor Mapping and Field Sampling in Casco Bay, Maine

Maine Coastal Mapping Initiative, September 2021

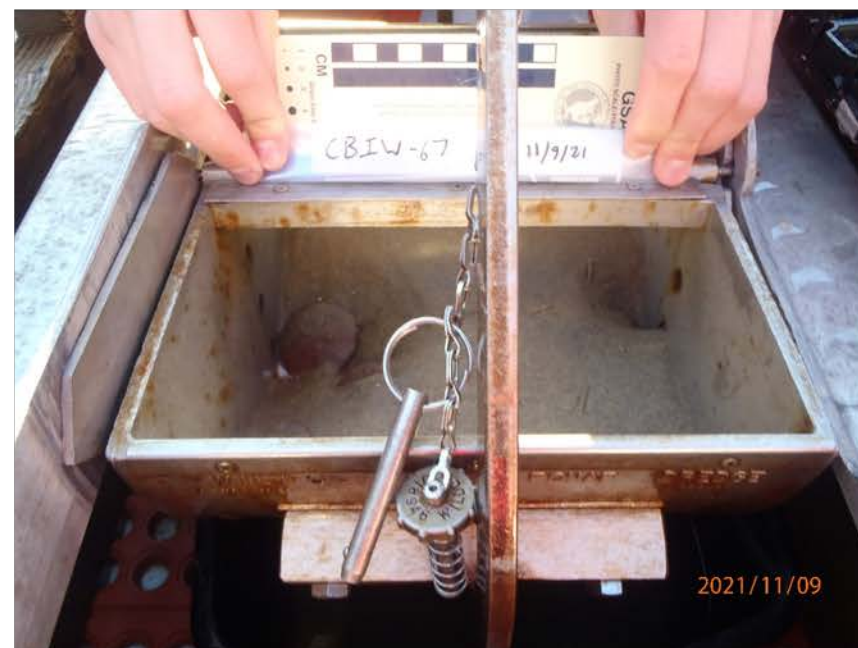
**Field Picture**

**Substrate Type: fine sand**

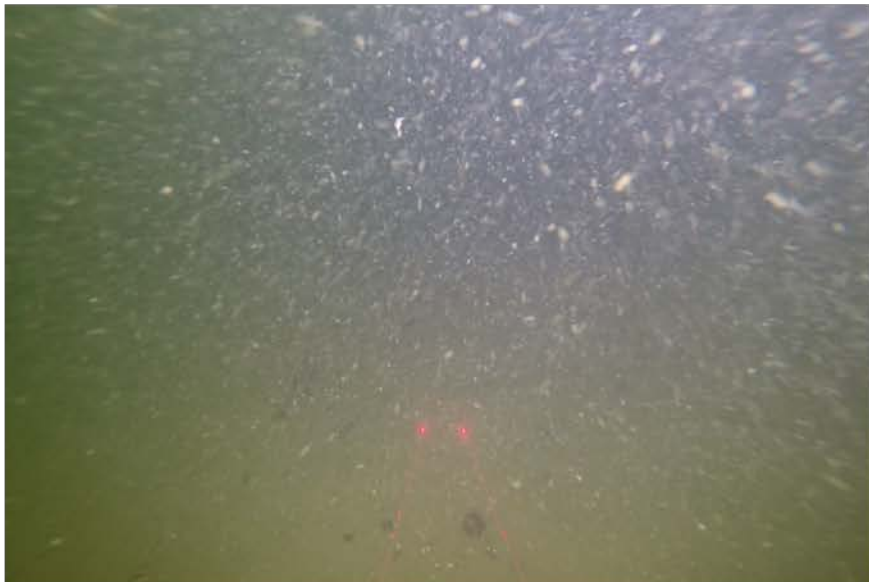
Sample ID:	CBIW-67	
Date/Time (EST):	11/09/21 08:22	
Depth (real-time, m):	15.3	
Easting (WGS84 UTM Zone 19N, m):	403349.4	87
Northing (WGS84 UTM Zone 19N, m):	4830511

Laser spacing = 10 cm

**Substrate Type:** muddy sand with trace shell hash

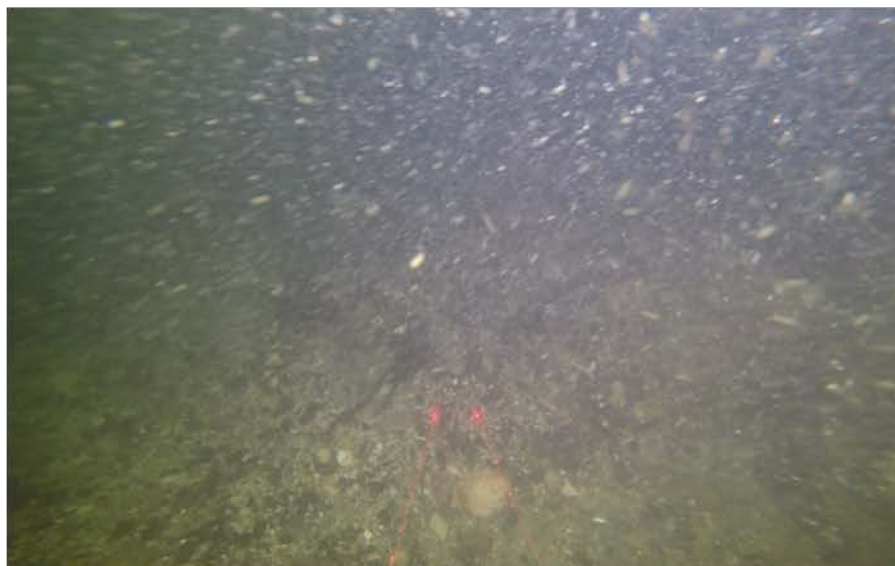
**Still Image from Video**

Laser spacing = 10 cm

**Substrate Type:** sandy gravel with shell hash,  
many large cobbles present

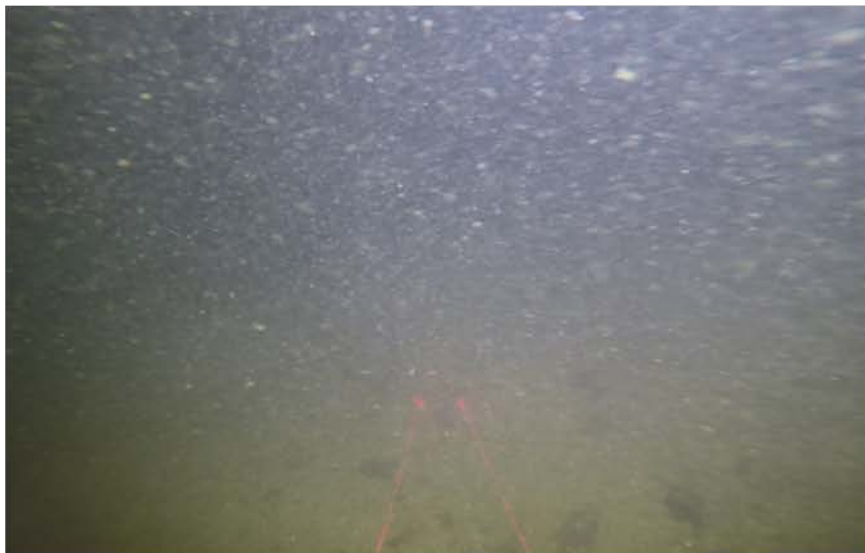
Sample ID:	CBIW-69	
Date/Time (EST):	11/09/21 09:53	
Depth (real-time, m):	15.4	
Easting (WGS84 UTM Zone 19N, m):	403568.1	89
Northing (WGS84 UTM Zone 19N, m):	4831959

Laser spacing = 10 cm

**Substrate Type: shell hash**

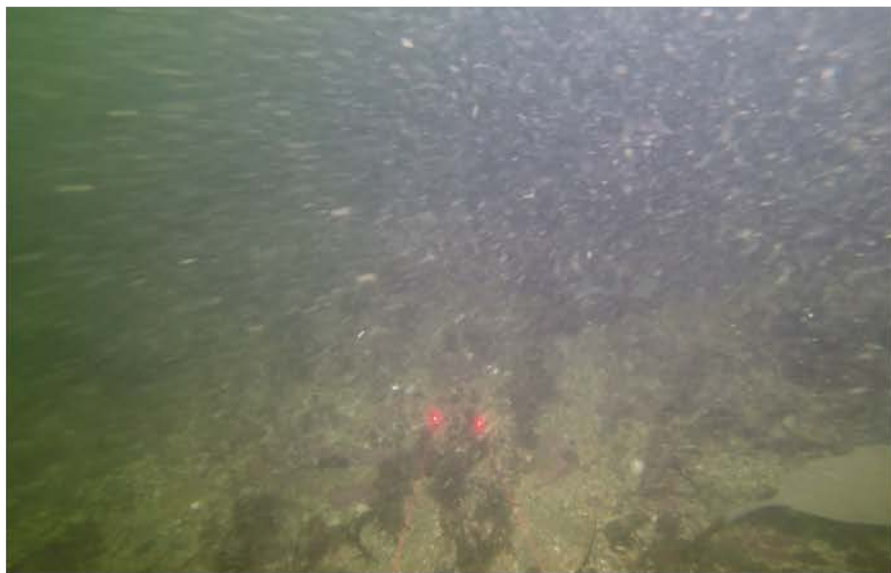
**Still Image from Video**

Laser spacing = 10 cm

**Substrate Type: rock**
