Maine CDC's Response to an Outbreak of Hepatitis A on Swan's Island.

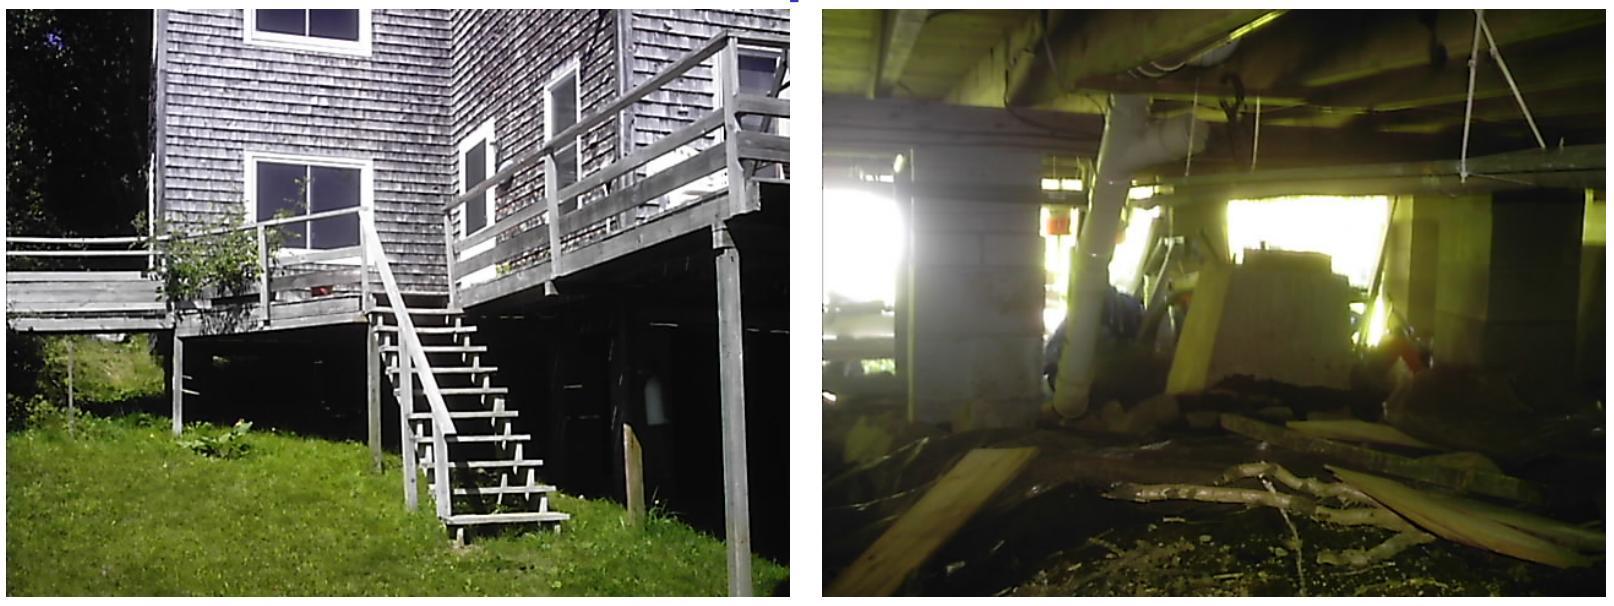
The property was unoccupied during the inspection. Access to the property was given by an abutter on behalf of the owners. Division staff inspected beneath the dwelling, which rests on piers, since the Division had been advised that there may be a leaking building drain beneath a toilet. There was no evidence under the building drain of any leaks.

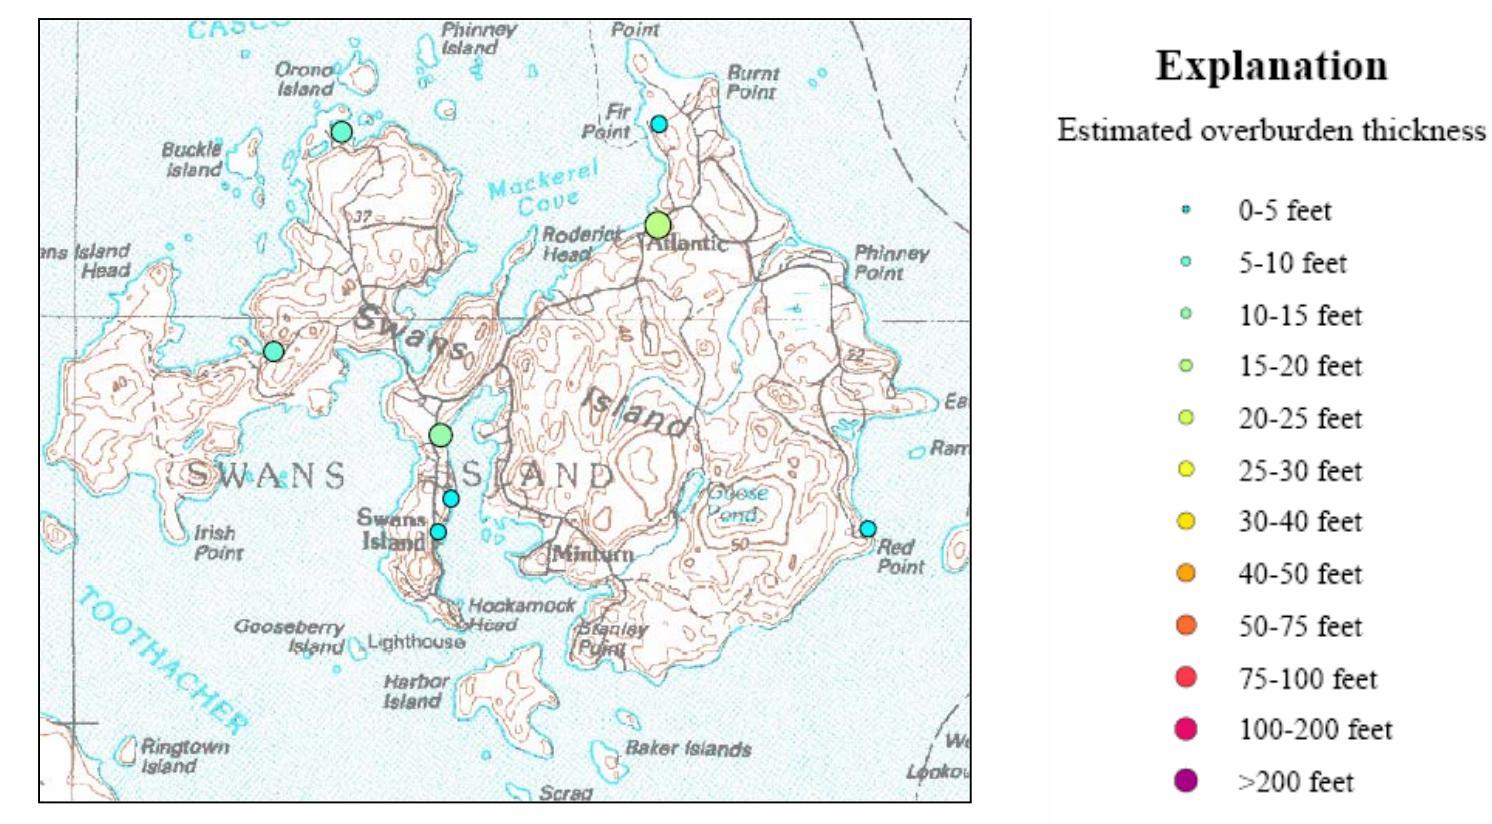
Geology in the vicinity of the dwelling is comprised of shallow soils and glacial erratics. The abutting property displays exposed bedrock in several locations.

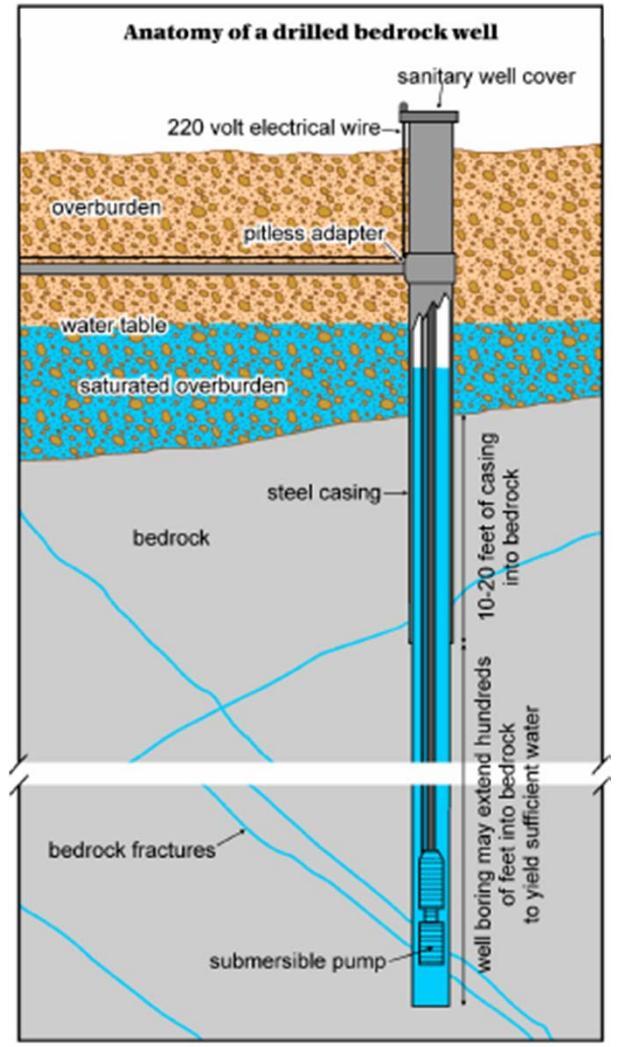
Contamination of drilled wells generally occurs through poor sealing or broken casing, or through transmission of pollutants through bedrock fractures.

The property's well is approximately 300 feet deep, and is located in granite bedrock which is reported by the Maine Geological Service as largely unfractured.

The well is located approximately 127 feet upslope of the malfunctioning disposal area.
