LOWER ELLIS POND
T7 R14 WELS, Piscataquis Co.
U.S.G.S. Allagash Lake and Churchill Lake, Maine

LOWER ELLIS POND
T7R14 WELS, PISCATAQUIS CO., MAINE
AREA 77 ACRES

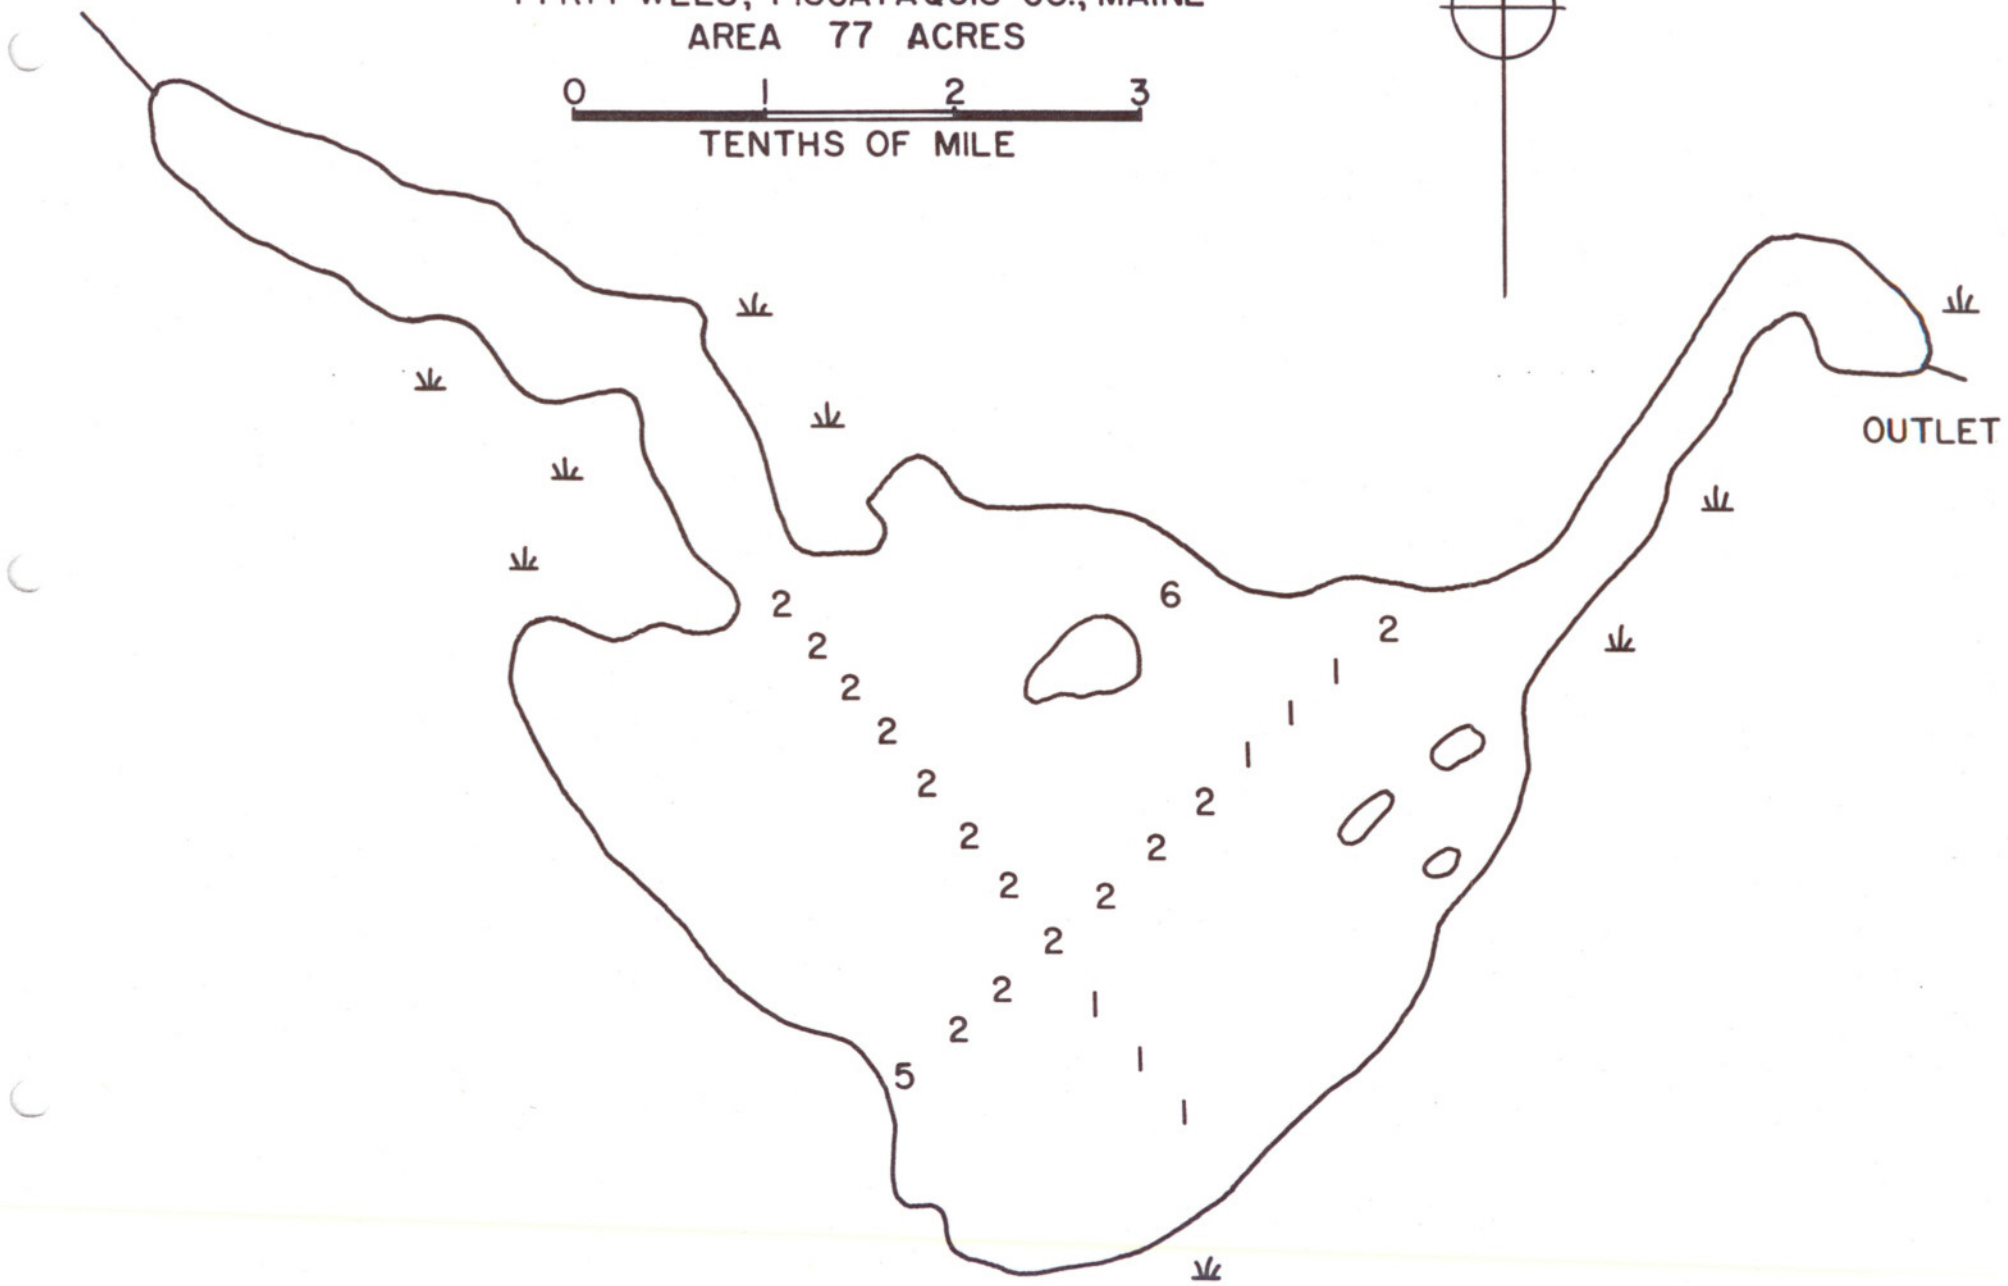
Area — 77 acres
Maximum depth — 6 feet
Principal Fishery: Brook trout
